# LABS

Life And Building Safety

**LABS - GOOD PRACTICES SHARING**

19th June 2026

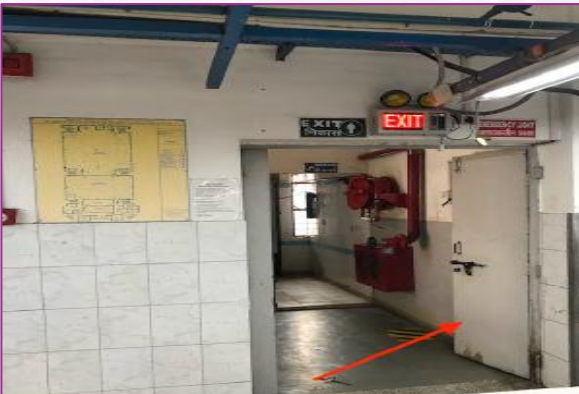
- Absence of fire-rated doors in the main exit at the production building.
- Fire-rated self-closing doors are not provided at protected staircases.
- Factory Building has more than two floors and the FR self-closing doors are not found provided on the stairs.

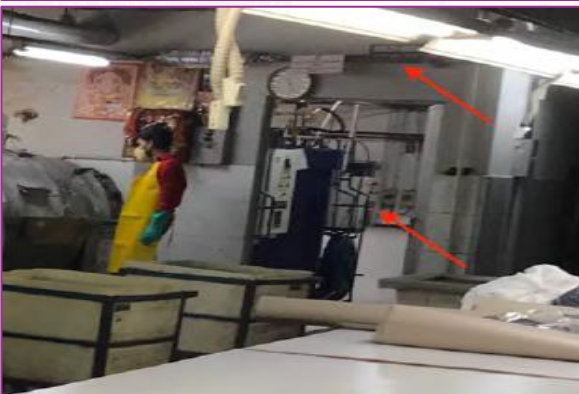
- Boilers installed on 2nd floor with washing without enclosure.
- Designated storage areas not separated by FR construction.
- Transformer room at Building 2 without FR-rated construction.

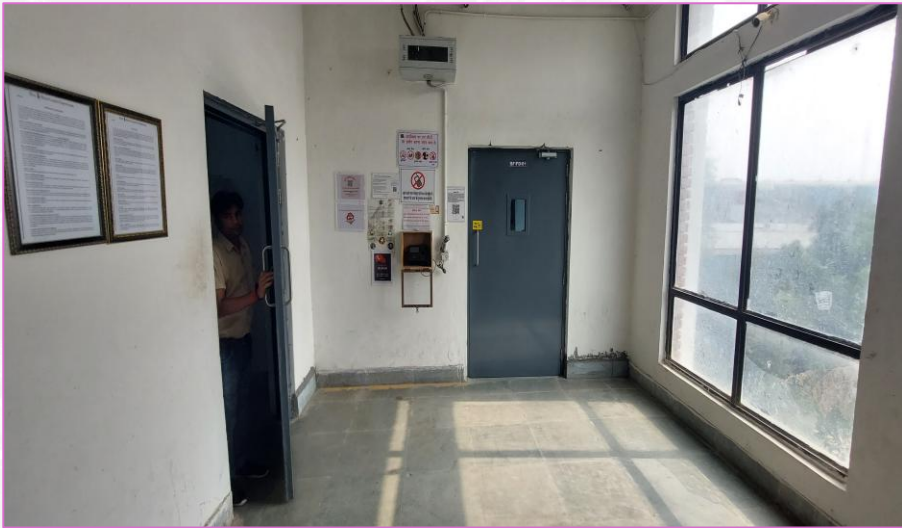
**Observation** - Factory Building has more than two floors and the enclosure for stairs is not found provided.

Staircase compartmentation with Fire doors

**CAP-** Provide an enclosure in staircase that conceals all openings with fire-rated material to ensure the safety.

**Remediation-** The factory has replaced the normal doors with self-closing, fire-rated doors and sealed openings with brick walls

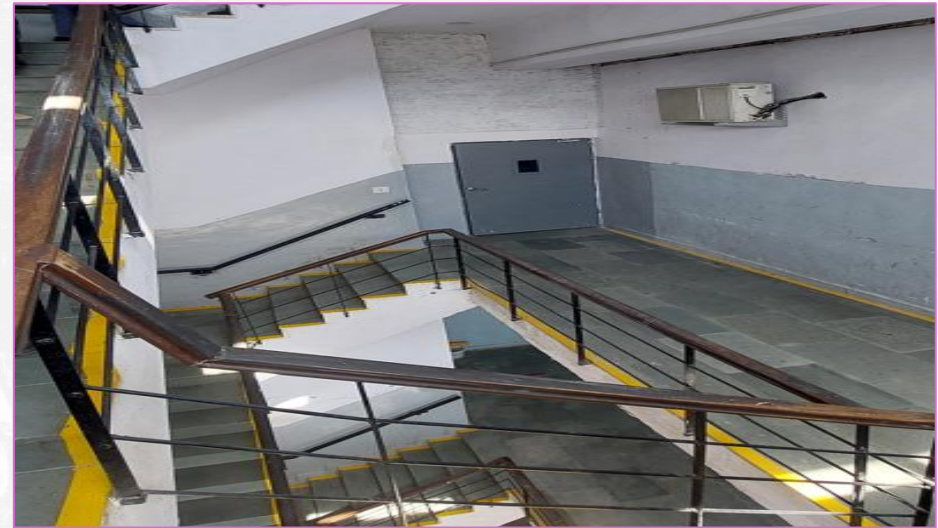
Staircase compartmentation with Fire doors & Brick work

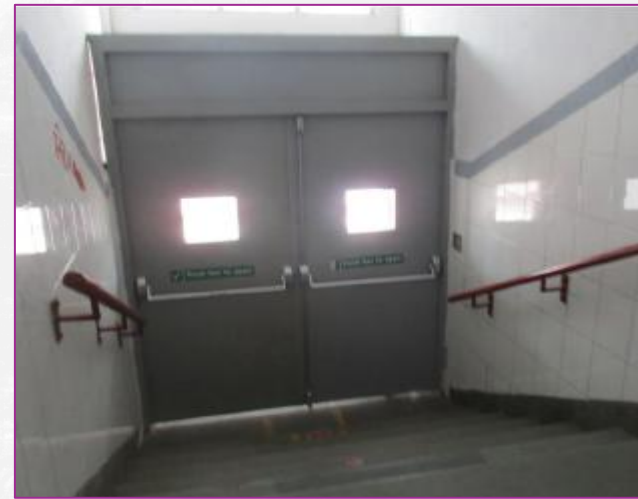
**Observation-** Fire-rated self-closing doors are not provided in any of the exits leading to staircase

Self-closing Fire door

**CAP-** Emergency exit to be provided with self-closing fire-rated door as per IS 3614

**Remediation-** The factory has replaced the normal doors with self-closing, fire-rated doors.

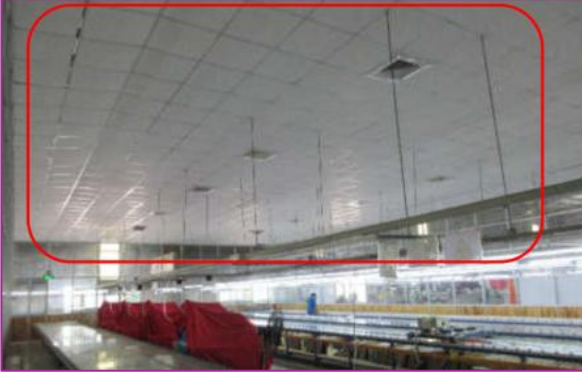
- Inadequate Fire Detector coverage.
- The provided smoke detection system is insufficient to cover the entire area of the factory.

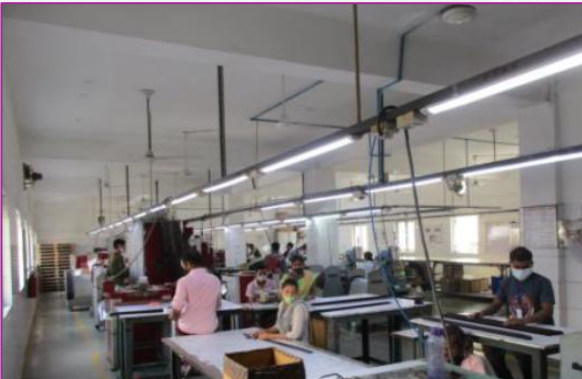
- Audible alarms with less commute observed in the basement and ground floor.
- Fire Alarm System were not installed in few locations.

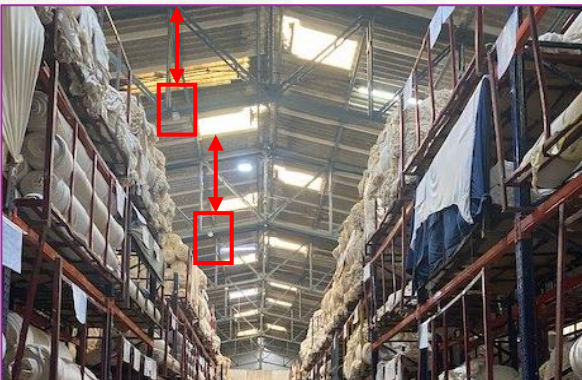
- Detectors are installed at low level from the true ceiling.
- Incorrect fire detector positioning was found at some places.

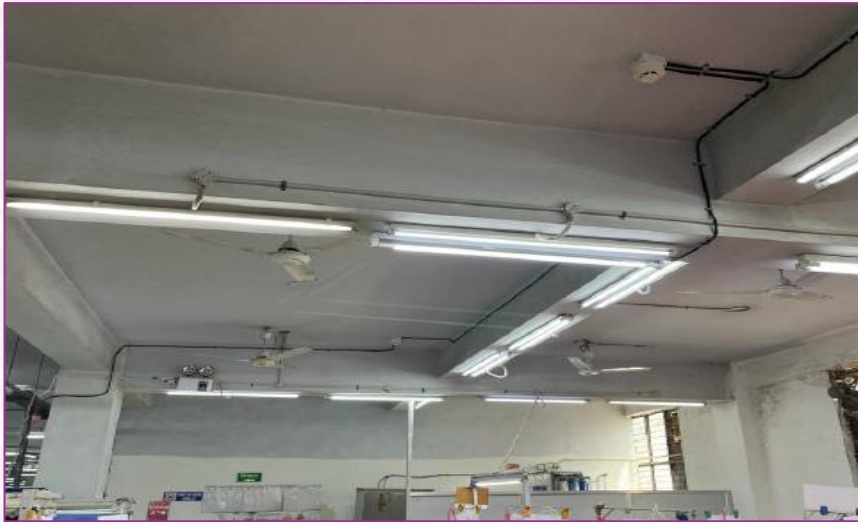
**Observation** - Factory basement section, Nort-East does not have any coverage of smoke detector .

Smoke detector installed

**CAP-** Smoke detection coverage would be provided in every location.

**Remediation-** The factory has installed a smoke detector synchronized with fire alarm panel.

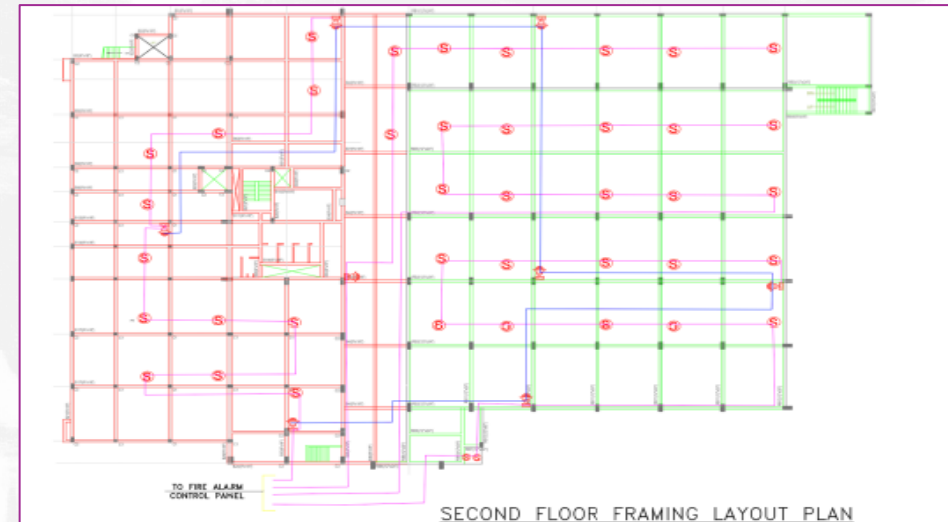
Smoke detector layout Plan

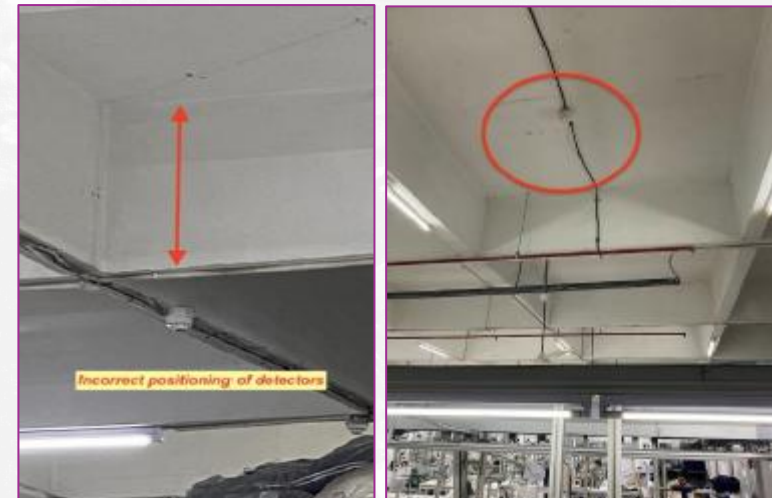
**Observation** – Smoke detector positioning was inadequate and found installed below ceiling level.

Smoke detector positioning before and after

**CAP-** Smoke detector would be installed over the highest and flat part of ceiling .

**Remediation-** The factory has installed beam type smoke detector over ceiling more than 20 feet and replaced smoke detector to the highest point of the ceiling in 14 ft ceiling.

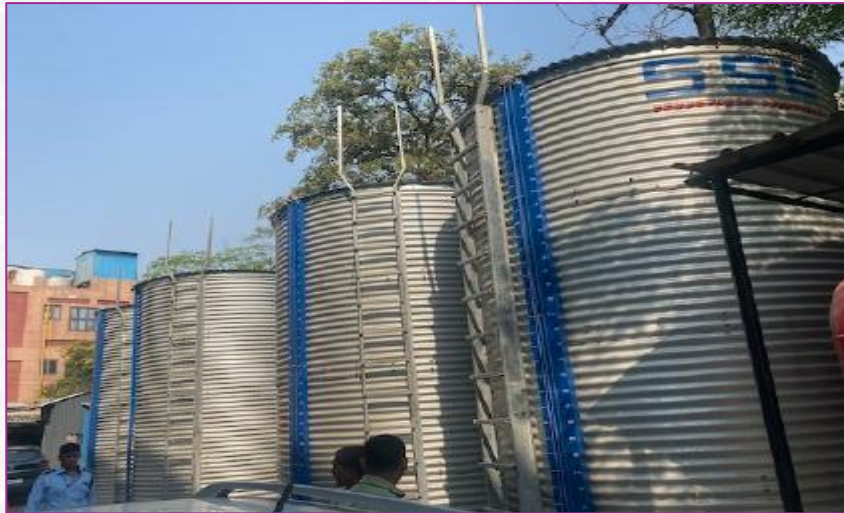
Additional water tanks installed by factory

**Remediation-** The factory has installed additional water tanks, either overhead or underground, to address the issue of water shortage.

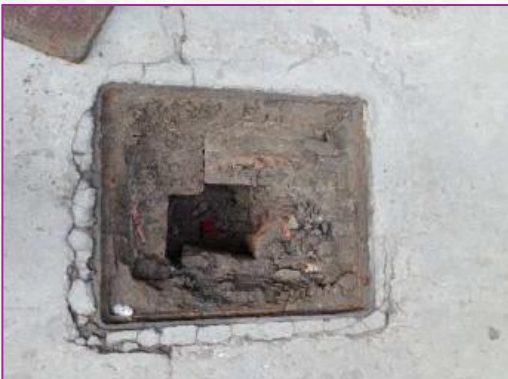
- Earth pits were found not maintained properly.
- Detail & layout plan of earth pit not available with the factory.

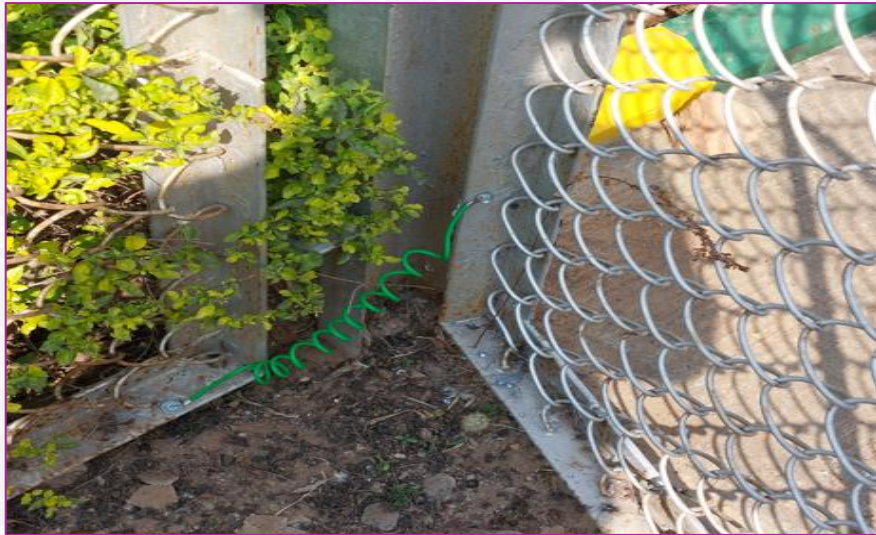
**Observation** — Bonding not provided over transformer gate/diesel tank .

Bonding provided over transformer gate

**Remediation-** The factory has provided bonding to dissipate the static charge and to keep all conductors at the same potential.

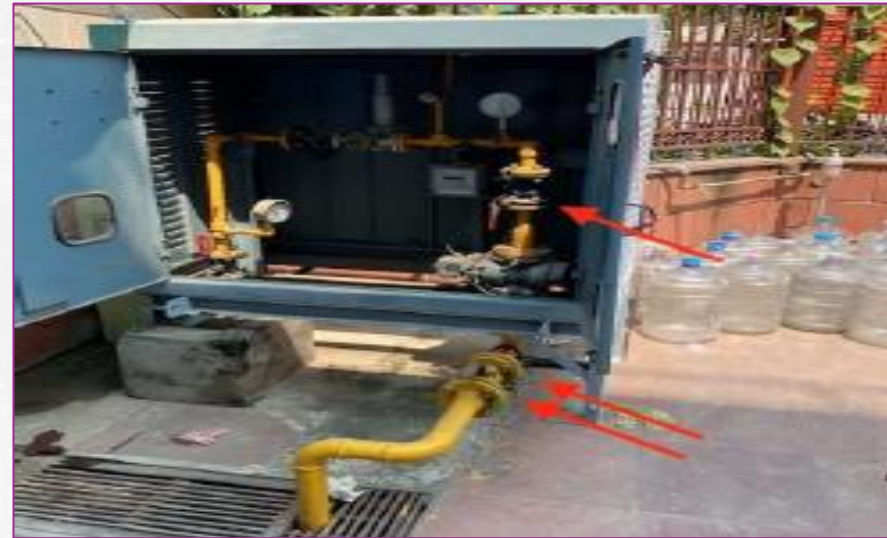
Bonding provided over LPG gas pipeline

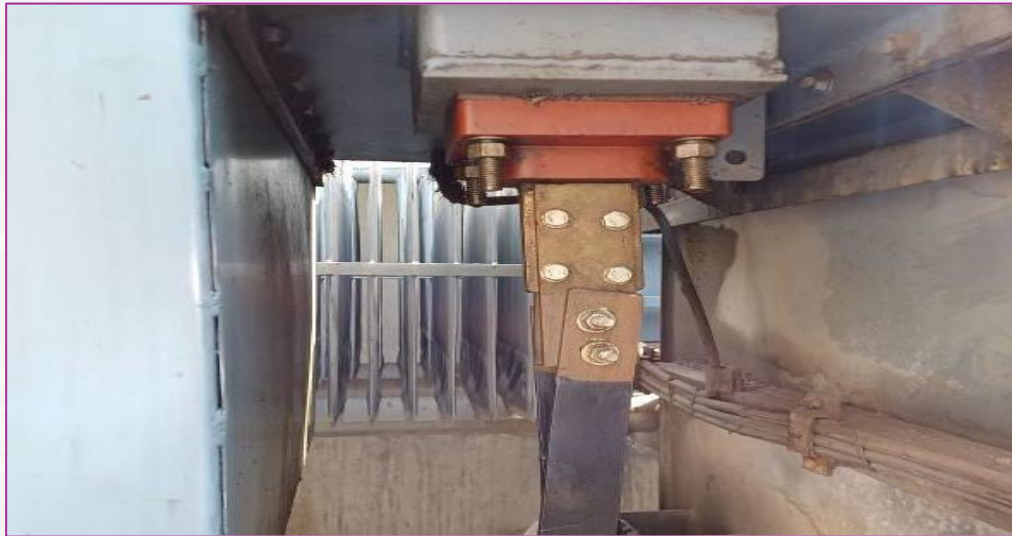
double Earthing provided to transformer

**CAP-** Factory will identify missing earthing in panels and provide earthing as per electrical standards.

**Remediation-** The factory has installed copper strips for earthing in specific locations as a remedial measure.

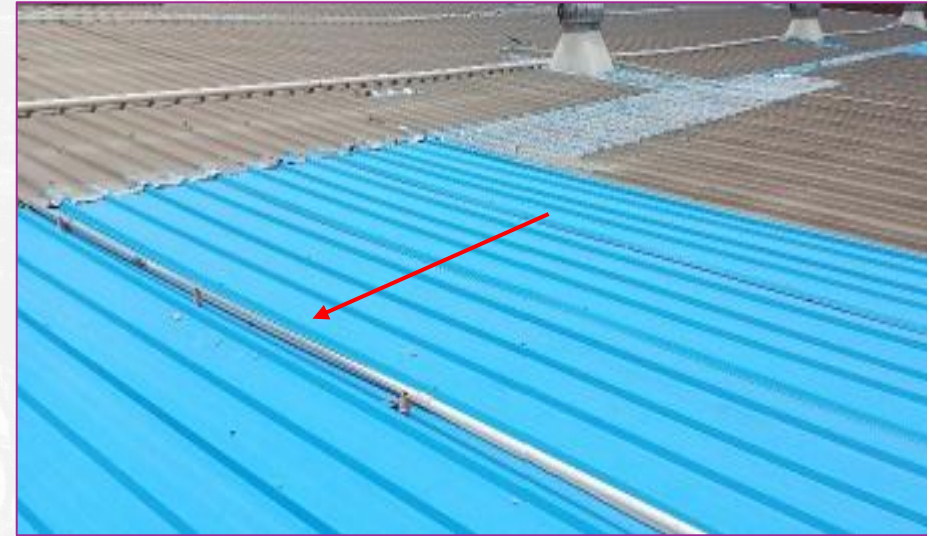
Earthing provided to MS truss

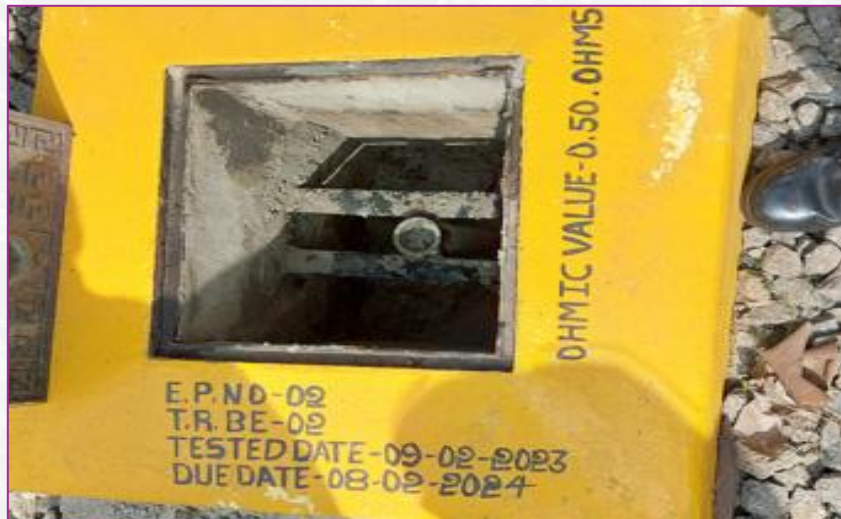
**Observation** – Earth pit were found poorly maintained/Earthing were found disconnected with earth strips

Earth pit maintained and monitored

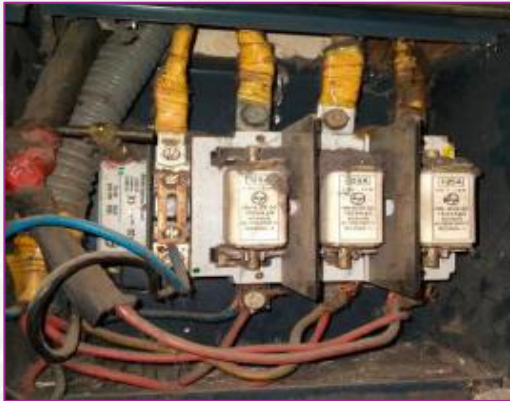
- Lint & Dust observed inside electrical panels.

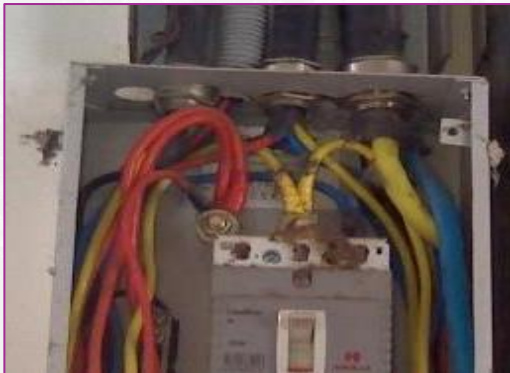
- Cables were not terminated with proper lugs and glands
- Glands were missing inside the electrical panel, allowing access for insects.

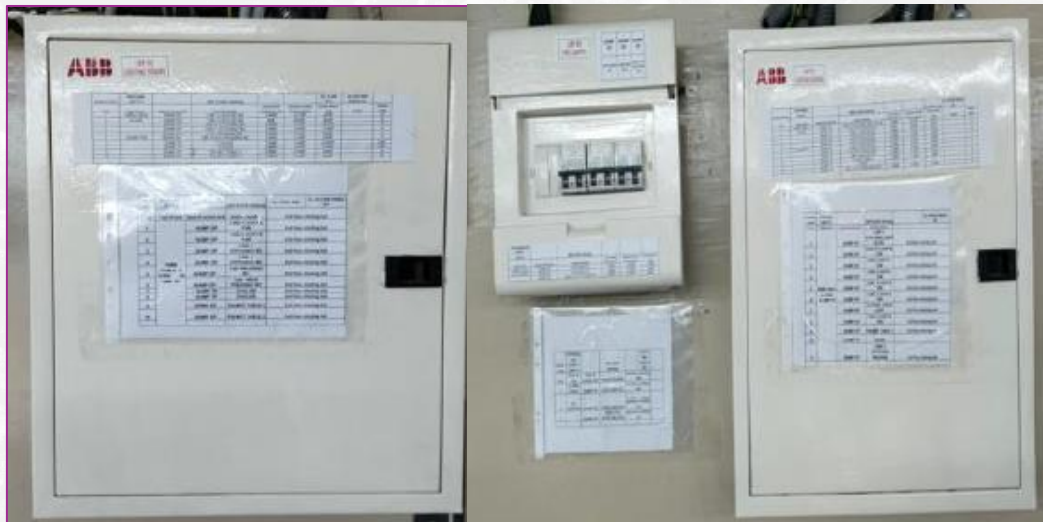
**Observation** – Proper identification markings were not provided on distribution boards, and current carrying capacity not calculated.

Current carrying capacity calculated and posted over DB

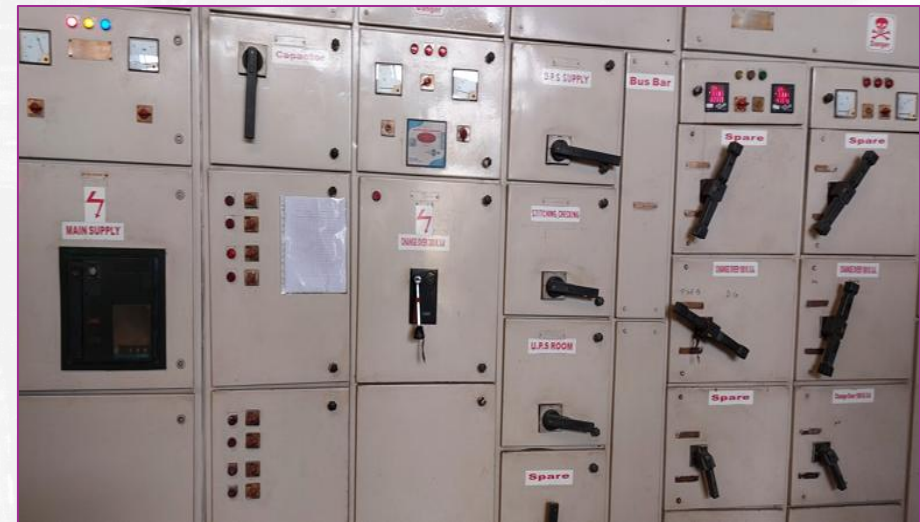
Proper identification provided over panel

**Remediation-** The factory has provided proper identification over panel.

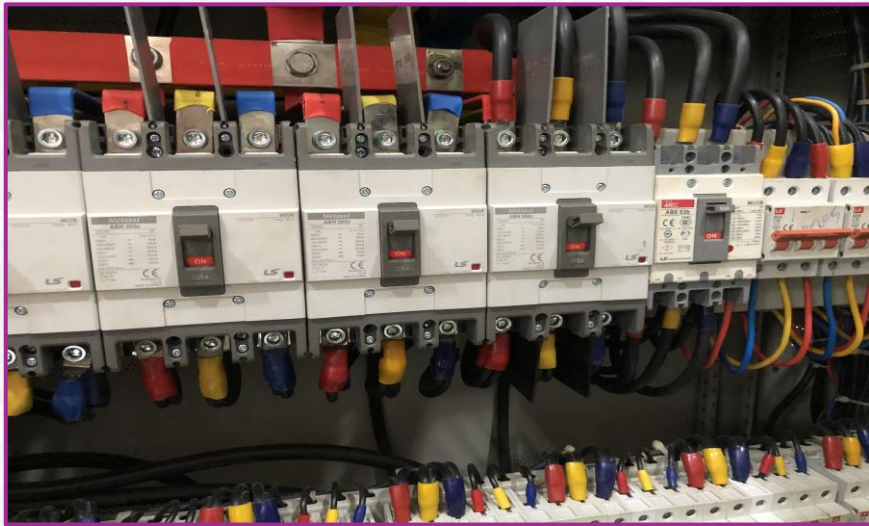
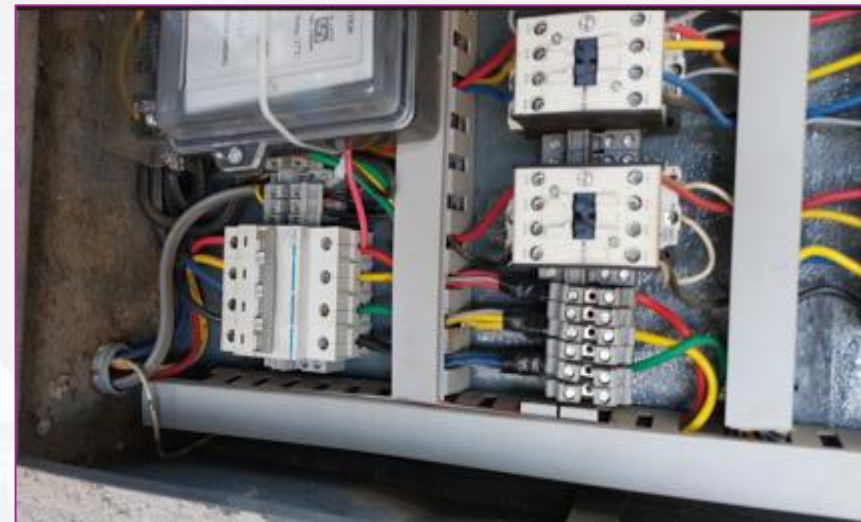
**Observation** – Lint & dust were observed inside the electrical panel.

Electrical panel has been cleaned.

**Remediation-** The factory has cleaned electrical panel and implemented a weekly checklist to prevent lint accumulation in panel.

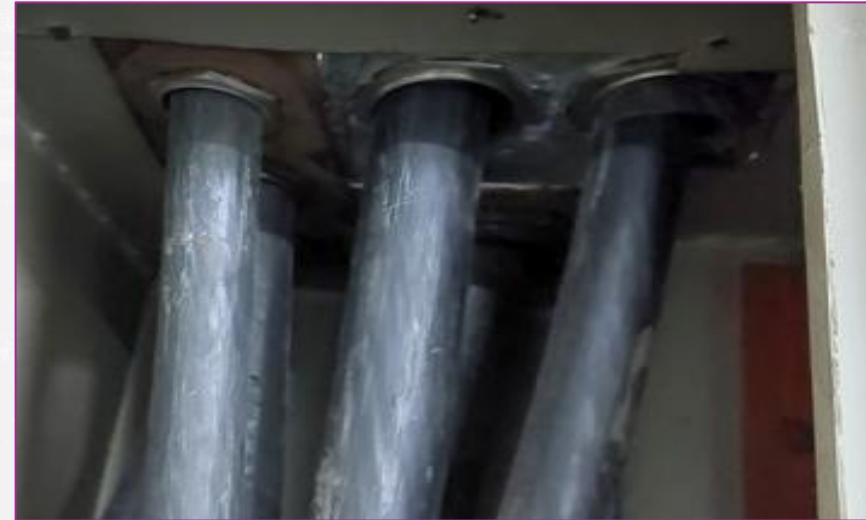
Glands provided over electrical panel

**Remediation-** The factory has provided lugs and glands in electrical panel.use of lugs and glands incorporated in SOP

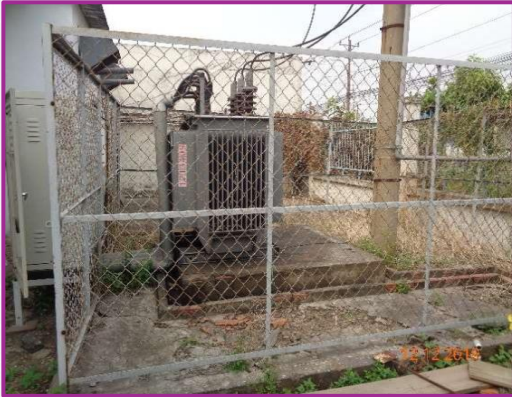
- Adequate warning/danger, voltage level signage were not posted over transformer, substation.

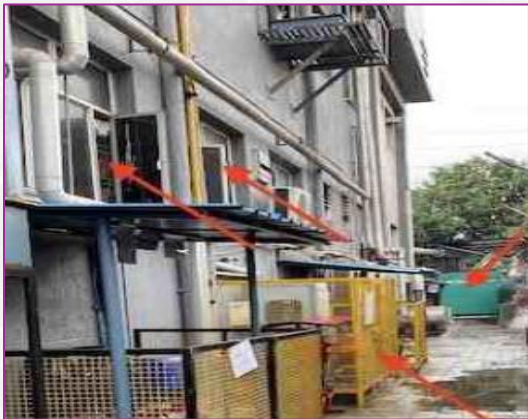
- Testing Report, Service record/maintenance record for Transformer and MV VCB MV/LV Switchgears were not available..

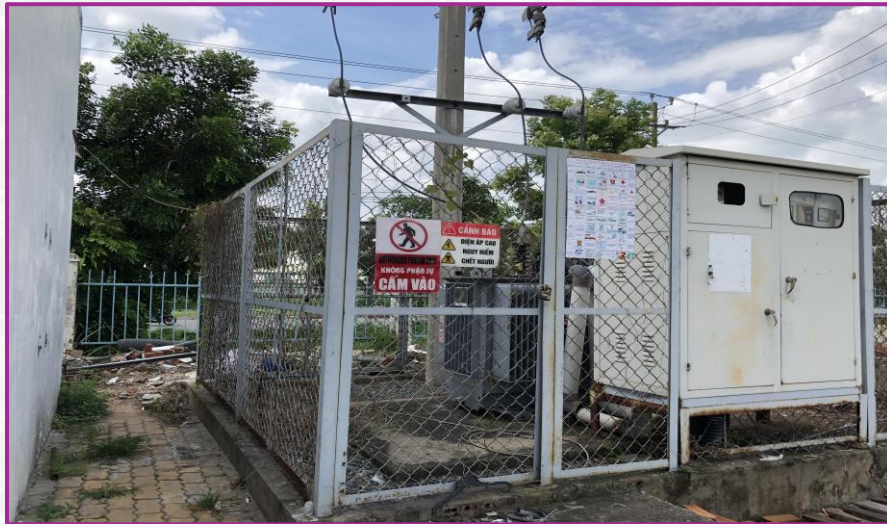
**Observation** – No proper danger or warning signage near HT meter room and transformer area.

Sign age provided over substation

**Remediation-** The factory has provided warning signage over hazardous electrical installation.

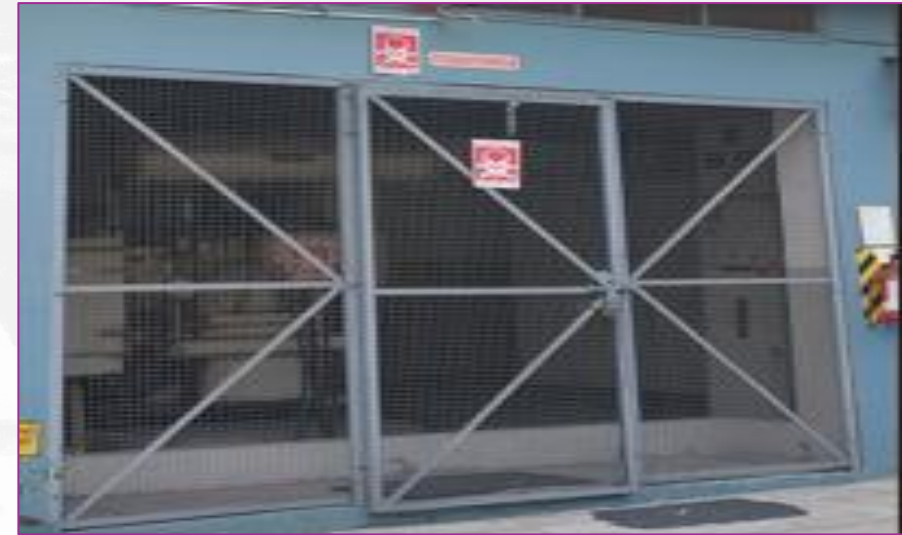
Warning signage provided

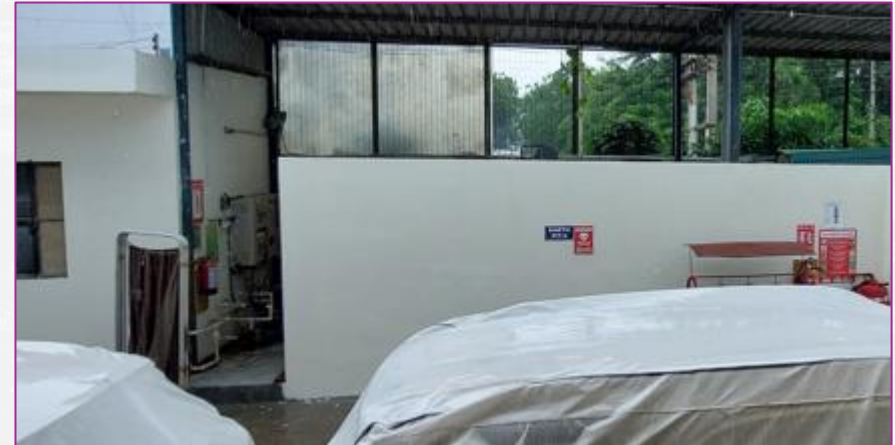
**Observation** – Hazardous installation installed adjacent to production with glass window towards production.

Wall separation provided between transformer & evacuation route

**Remediation-** The factory has provided separation between hazardous installation and production.

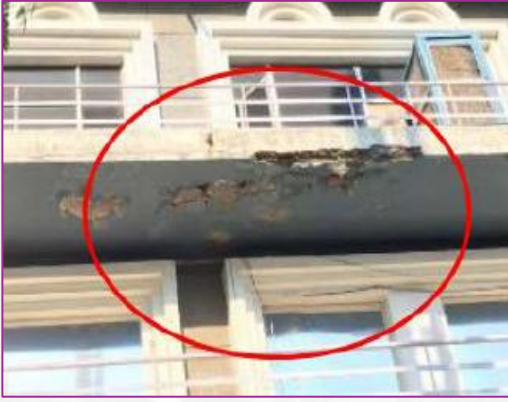
- Significant corrosion making the structural element (beams, columns, truss) etc ineffective that may lead further structural damage.

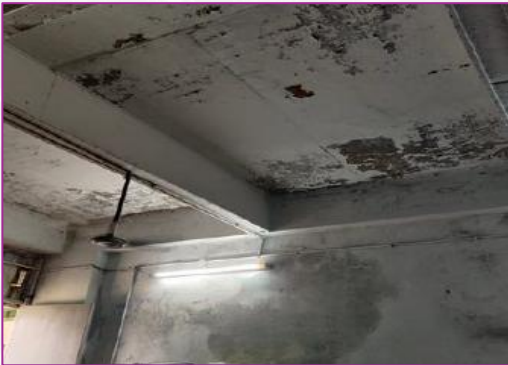
- Dampness observed over Floor Roof and walls.

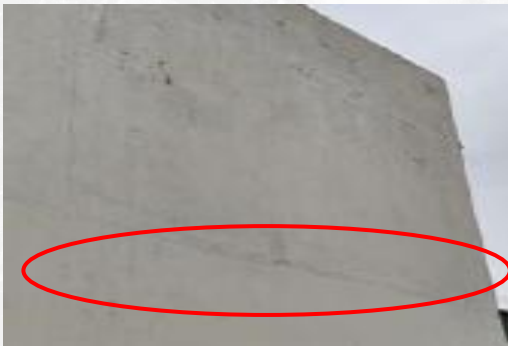
- Cracking observed over back side of building
- Cracks were observed over columns/beams

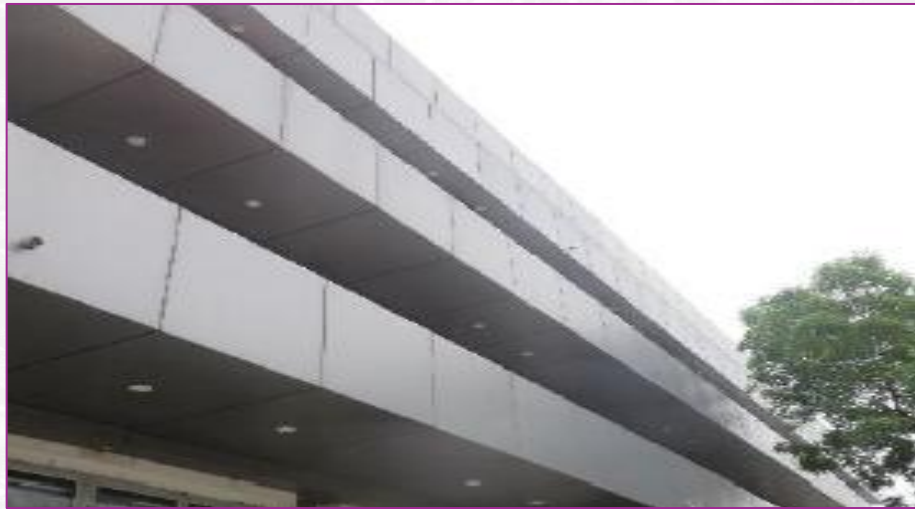
**Observation** — The structure element was found corroded.

Corroded structure repaired and covered

**CAP-** Will review the corroded structure and repair it.

**Remediation-** The factory has repaired corroded structure members .

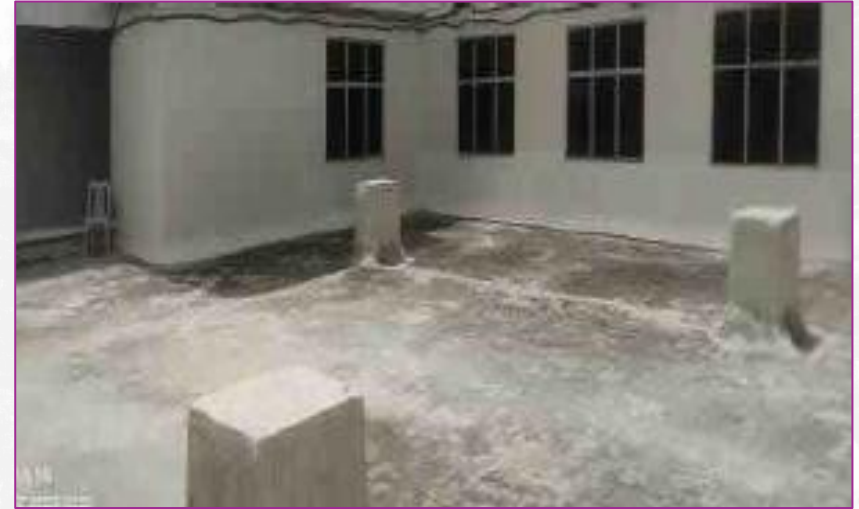
Corroded bars were repaired from column

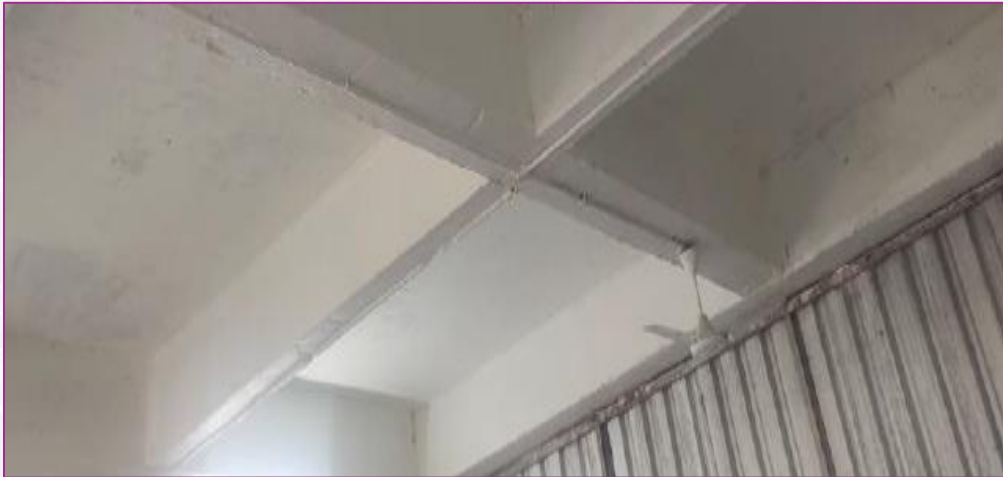
**Observation** – wall cladding/backside wall observed for dampness

Dampness has been addressed

**CAP-** Factory will review structure with NDT test for impact of dampness over structure and repair dampness.

**Remediation-** The factory has repaired dampness and removed leakages causing dampness.

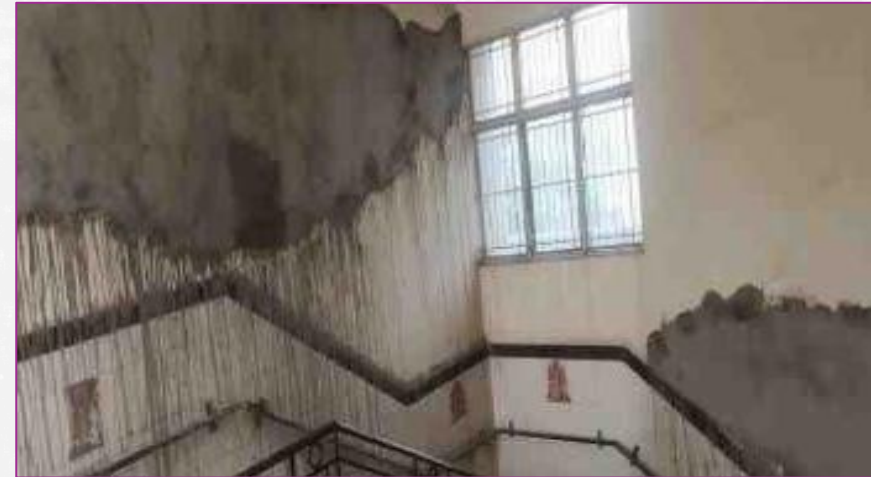
Dampness Repairs work has been done

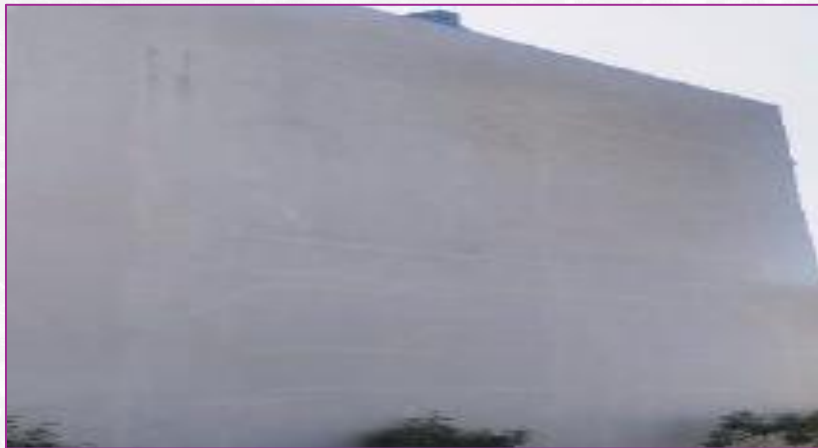
**Observation** – Cracks were observed on external wall/internal wall.

Non structural cracks were repaired

**CAP-** Will review cracks and get them repaired as per structural review.

**Remediation-** The factory has repaired cracks and initiated a structure audit to prevent reoccurrence of cracks

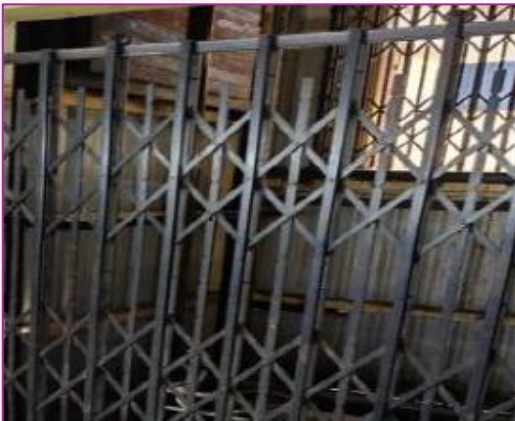
- Goods Lift Side walls & 2nd floor External walls at North, West Side found to be inadequate to resist later forces

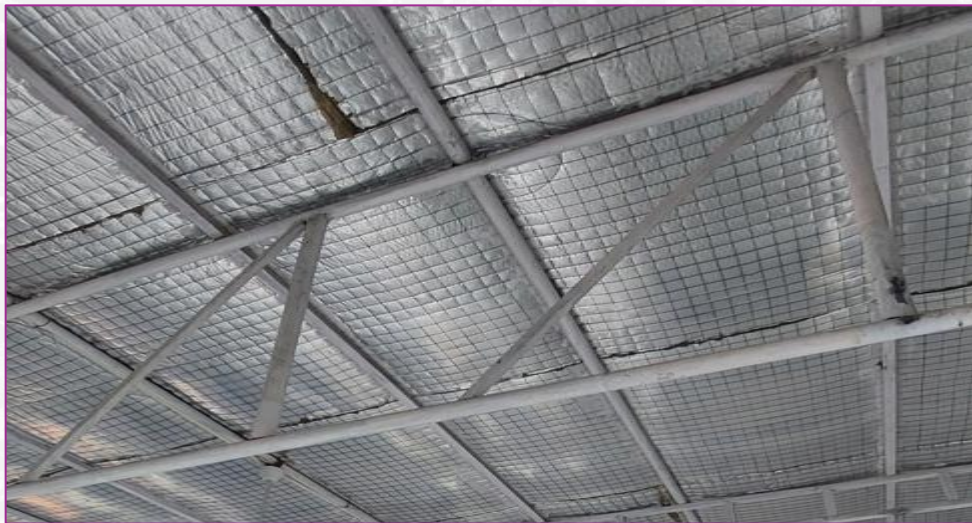
Bracing to MS structure

**Remediation-** The factory has appointed structural consultant and provided bracing along with survey report
