LABS

Life And Building Safety

LABS - GOOD PRACTICES SHARING

29th Dec 2025

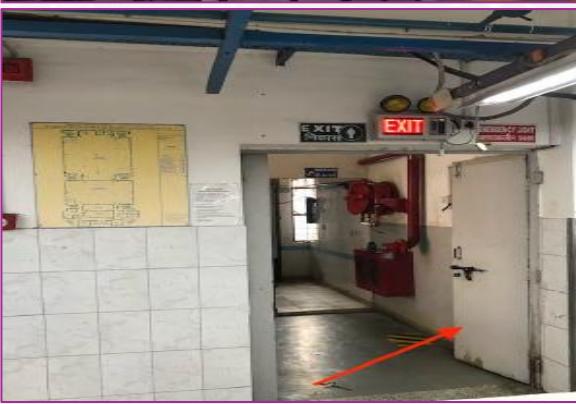
- Lack of enclosure of Stairs connecting more than 2 floors.
- Unsealed penetrations in stair enclosures

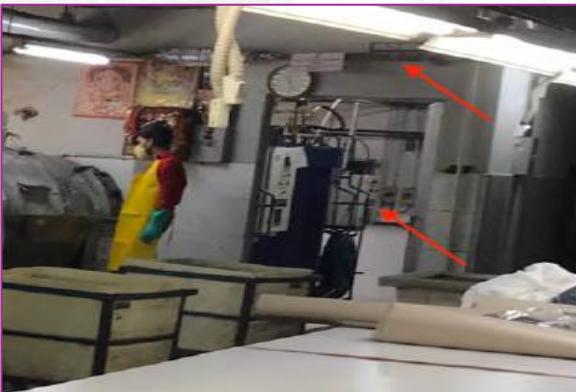
- Absence of fire-rated doors in the main exit at the production building.
- Fire-rated self-closing doors are not provided at protected staircases.
- Factory Building has more than two floors and the FR self-closing doors are not found provided on the stairs.

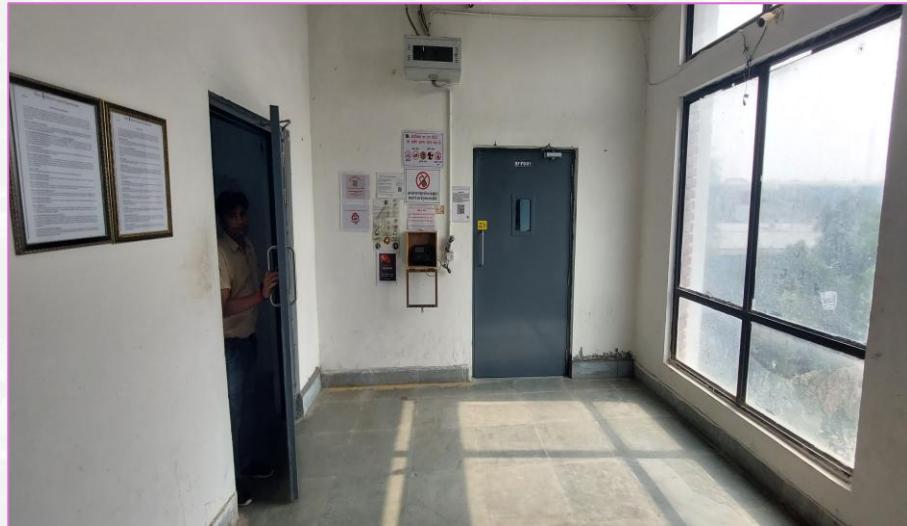
Observation - Factory Building has more than two floors and the enclosure for stairs is not found provided.

Staircase compartmentation with Fire doors

CAP- Provide an enclosure in staircase that conceals all openings with fire-rated material to ensure the safety.

Remediation- The factory has replaced the normal doors with self-closing, fire-rated doors and sealed openings with brick walls

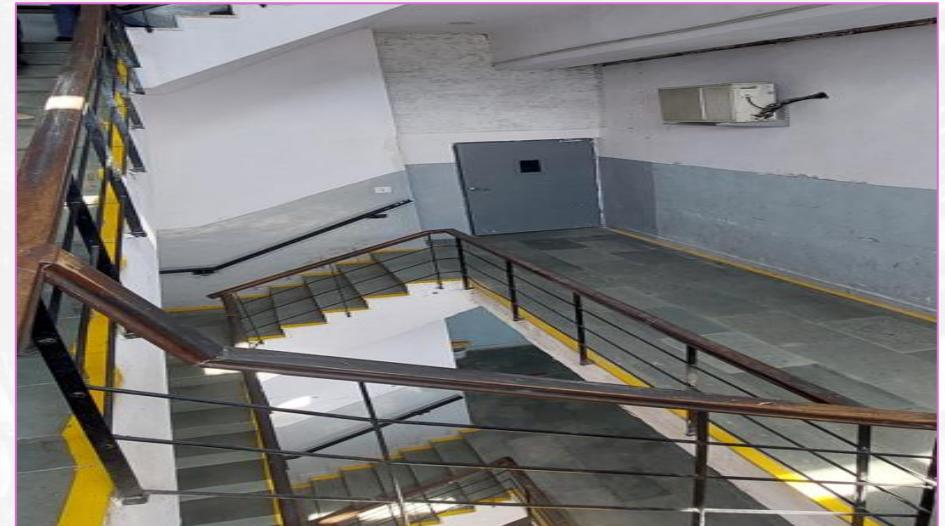
Staircase compartmentation with Fire doors & Brick work

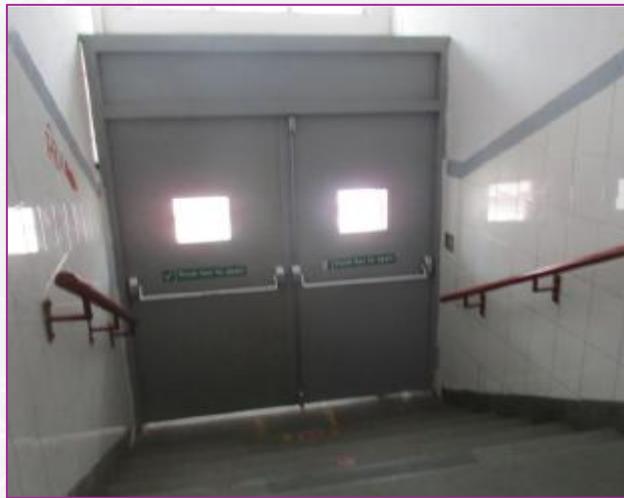
Observation- Fire-rated self-closing doors are not provided in any of the exits leading to staircase

Self-closing Fire door

CAP- Emergency exit to be provided with self-closing fire-rated door as per IS 3614

Remediation- The factory has replaced the normal doors with self-closing, fire-rated doors.

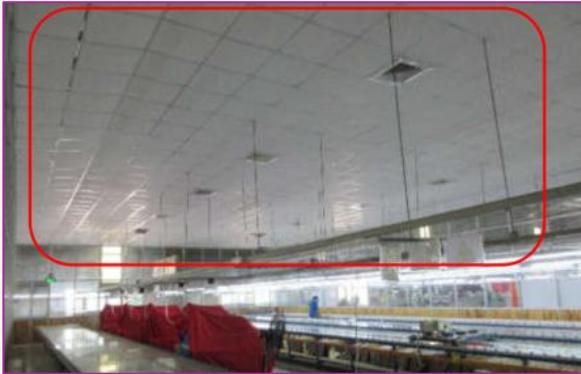
- Inadequate Fire Detector coverage.
- The provided smoke detection system is insufficient to cover the entire area of the factory.

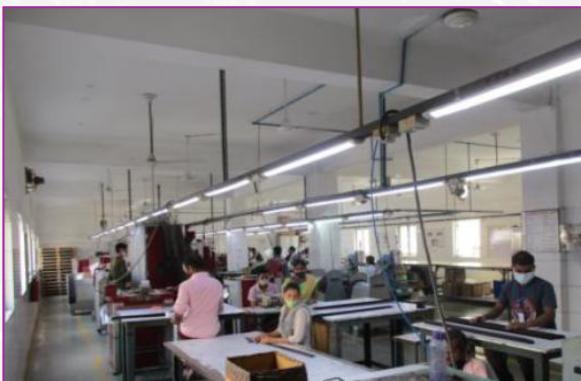
- Audible alarms with less commute observed in the basement and ground floor.
- Fire Alarm System were not installed in few locations.

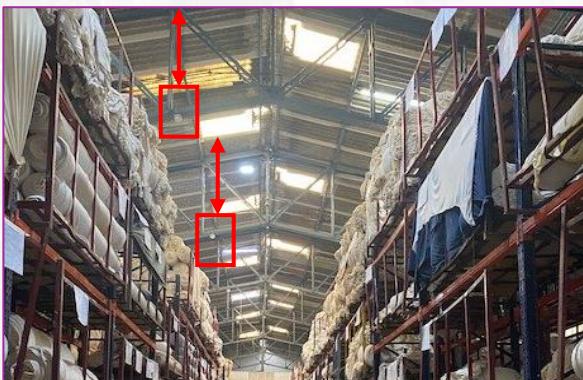
- Detectors are installed at low level from the true ceiling.
- Incorrect fire detector positioning was found at some places.

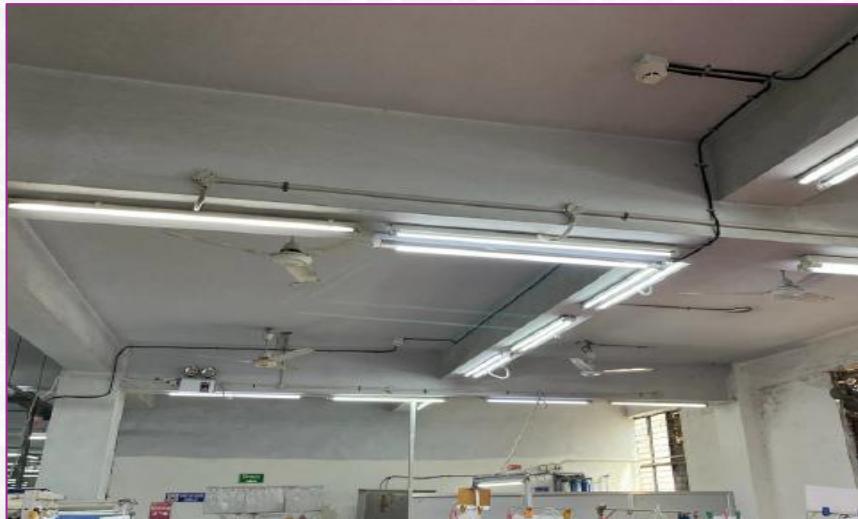
Observation - Factory basement section, Nort-East does not have any coverage of smoke detector .

Smoke detector installed

CAP- Smoke detection coverage would be provided in every location.

Remediation- The factory has installed a smoke detector synchronized with fire alarm panel.

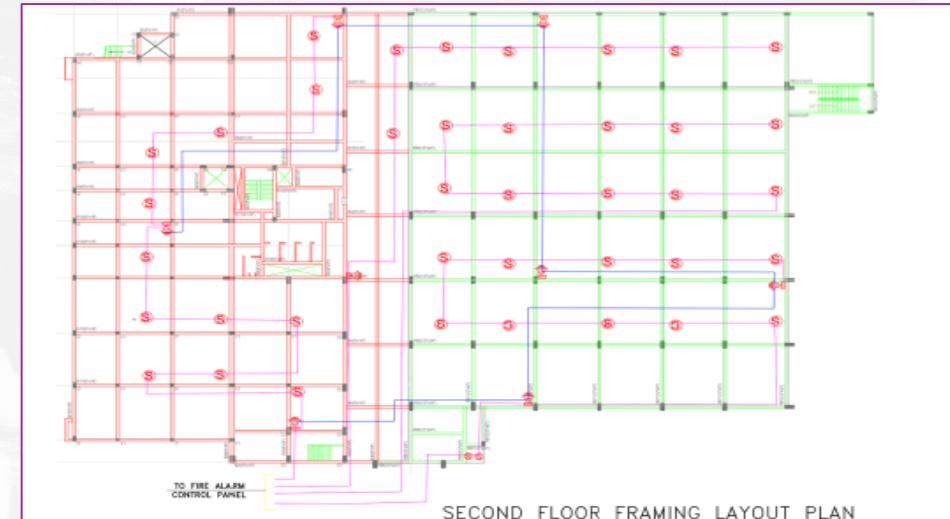
Smoke detector layout Plan

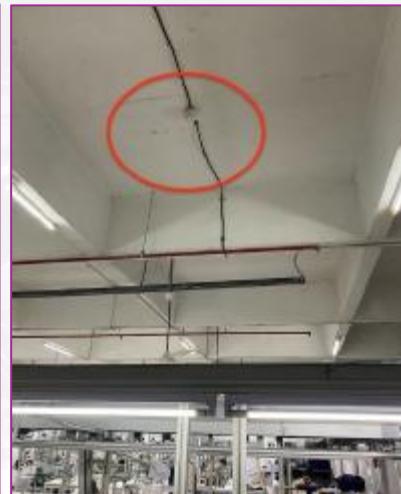
Observation — Smoke detector positioning was inadequate and found installed below ceiling level.

Smoke detector positioning before and after

CAP- Smoke detector would be installed over the highest and flat part of ceiling .

Remediation- The factory has installed beam type smoke detector over ceiling more than 20 feet and replaced smoke detector to the highest point of the ceiling in 14 ft ceiling.

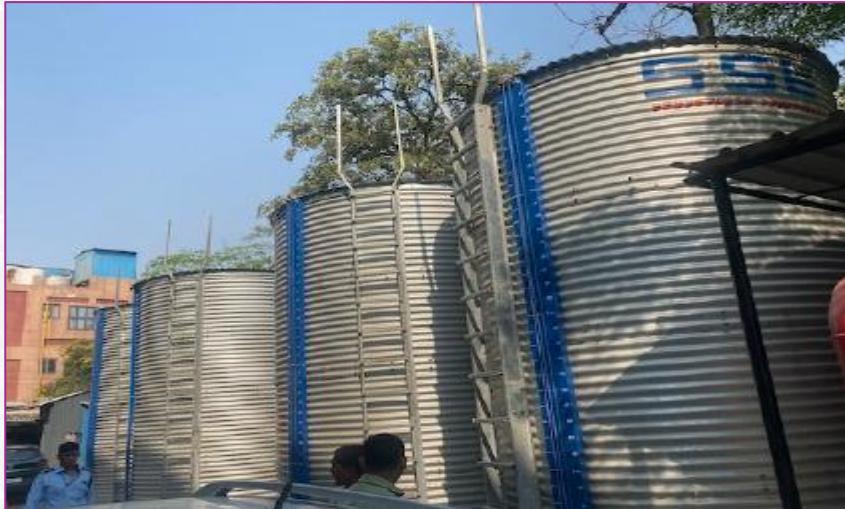
Additional water tanks installed by factory

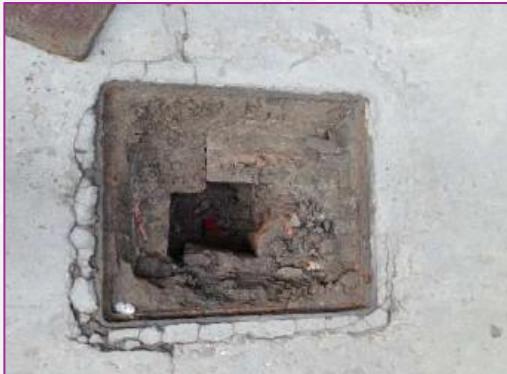
- Earth pits were found not maintained properly.
- Detail & layout plan of earth pit not available with the factory.

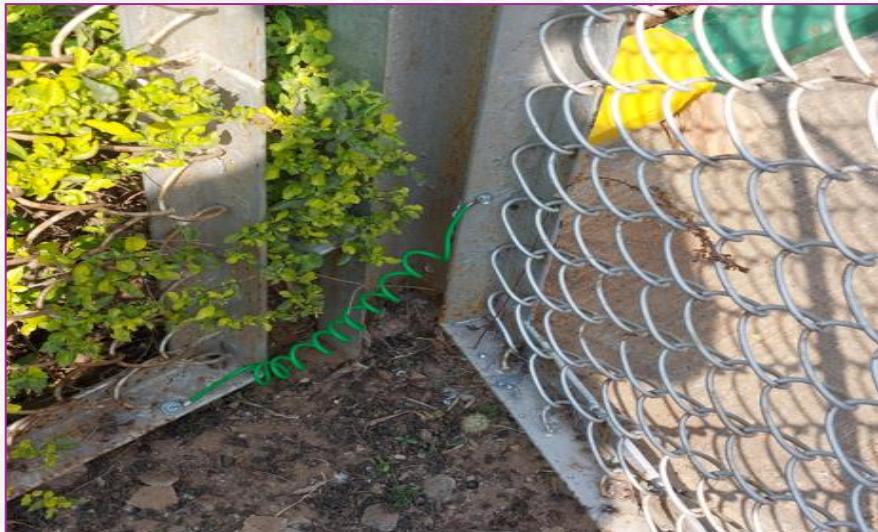
Observation – Bonding not provided over transformer gate/diesel tank .

Bonding provided over transformer gate

Remediation- The factory has provided bonding to dissipate the static charge and to keep all conductors at the same potential.

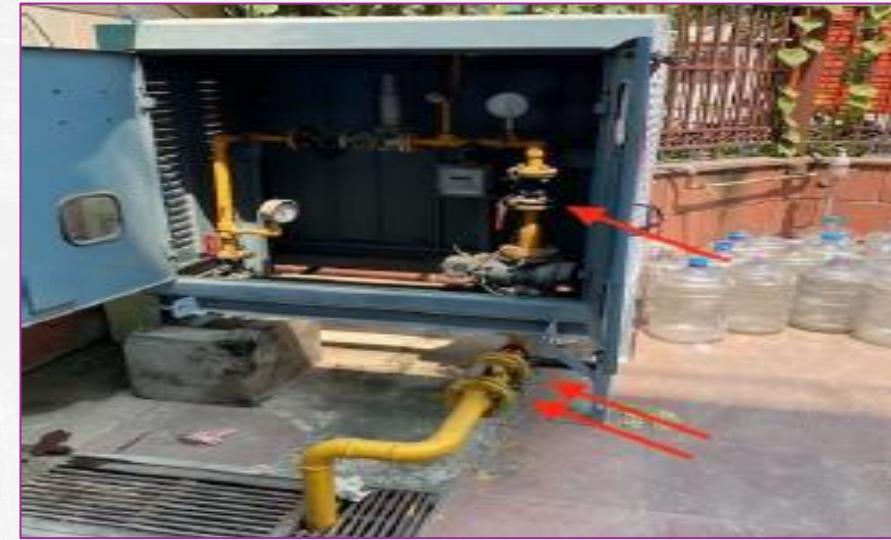
Bonding provided over LPG gas pipeline

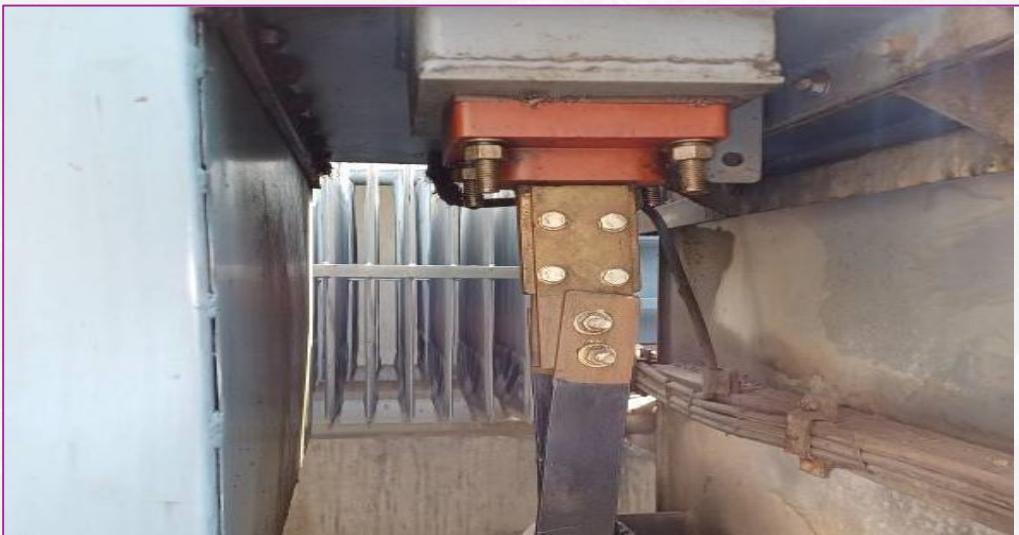
double Earthing provided to transformer

CAP- Factory will identify missing earthing in panels and provide earthing as per electrical standards.

Remediation- The factory has installed copper strips for earthing in specific locations as a remedial measure.

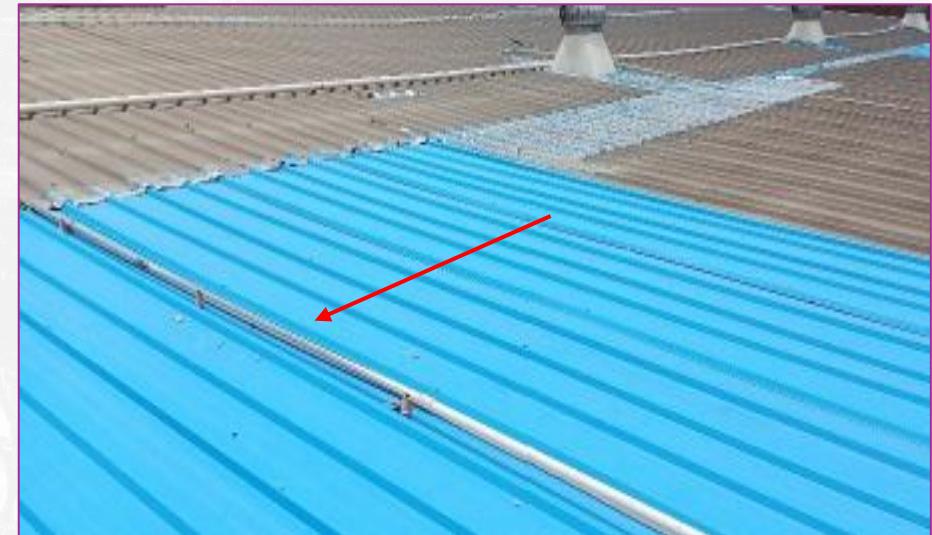
Earthing provided to MS truss

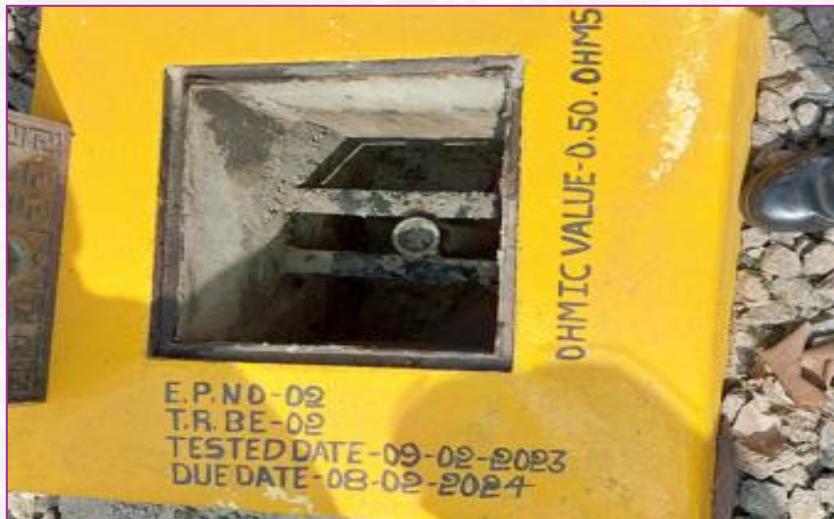
Observation — Earth pit were found poorly maintained/Earthing were found disconnected with earth strips

Earth pit maintained and monitored

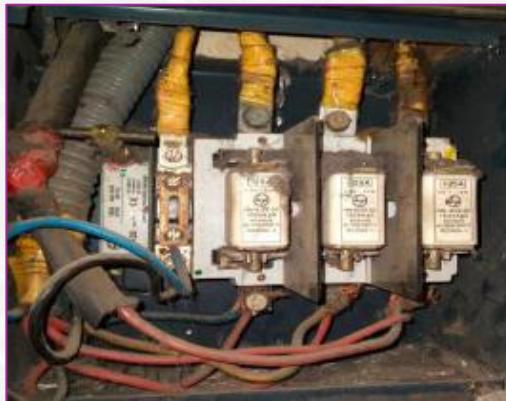
- Lint & Dust observed inside electrical panels.

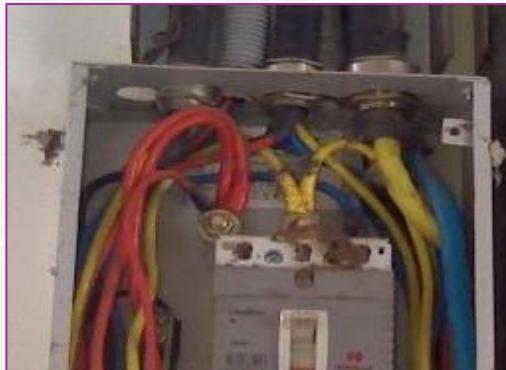
- Cables were not terminated with proper lugs and glands
- Glands were missing inside the electrical panel, allowing access for insects.

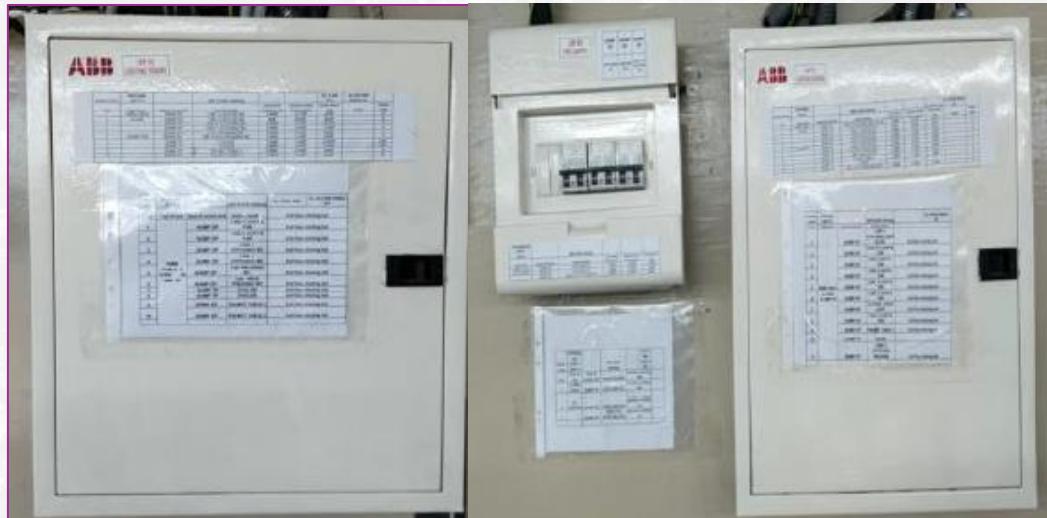
Observation — Proper identification markings were not provided on distribution boards, and current carrying capacity not calculated.

Current carrying capacity calculated and posted over DB

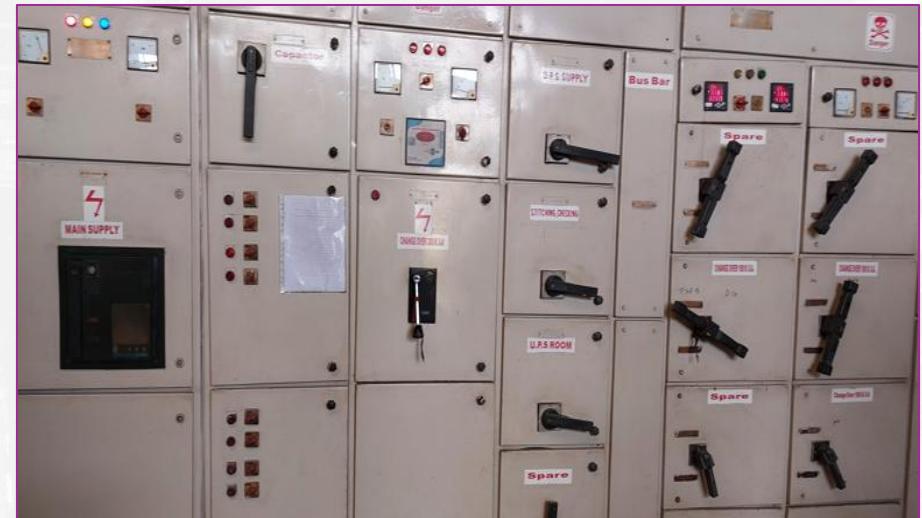
Proper identification provided over panel

Remediation- The factory has provided proper identification over panel.

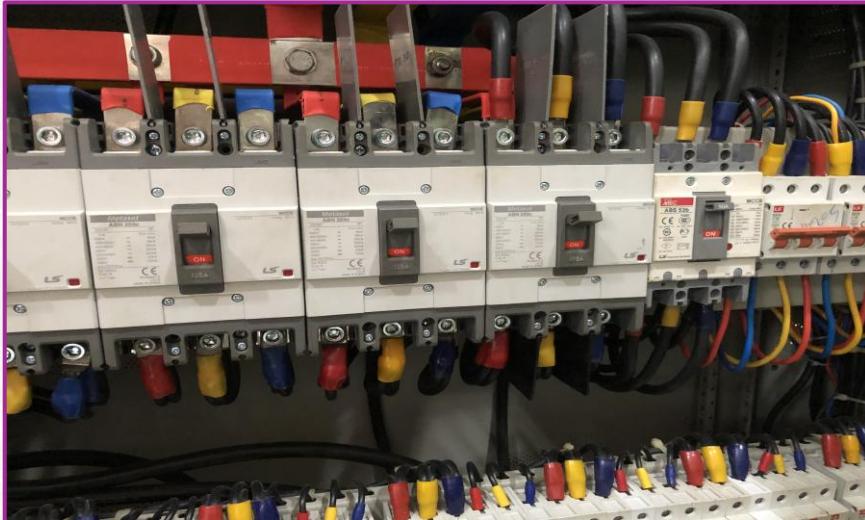
Observation – Lint & dust were observed inside the electrical panel.

Electrical panel has bee cleaned

Remediation- The factory has cleaned electrical panel and implemented a weekly checklist to prevent lint accumulation in panel.

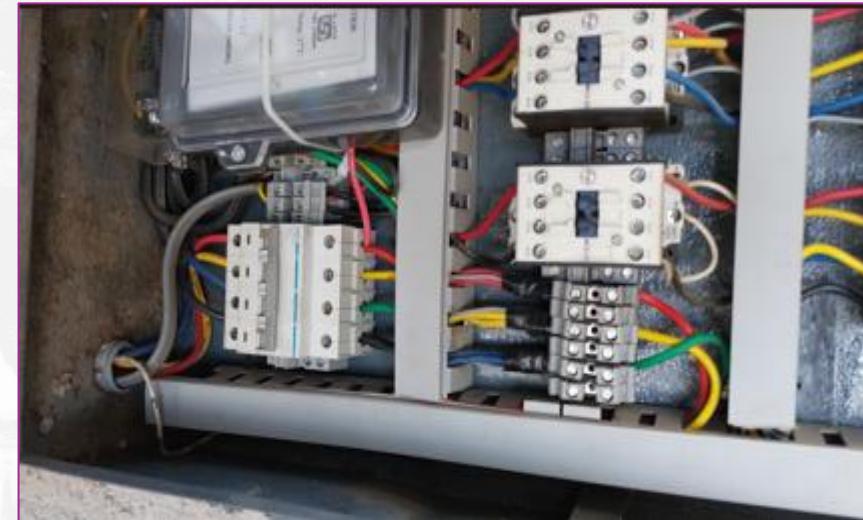
Electrical panel has bee cleaned

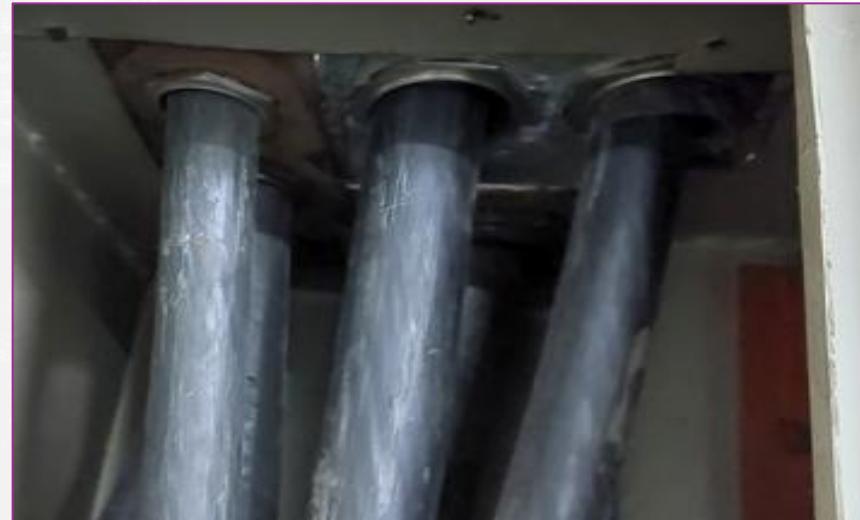
Glands provided over electrical panel

Remediation- The factory has provided lugs and glands in electrical panel.use of lugs and glands incorporated in SOP

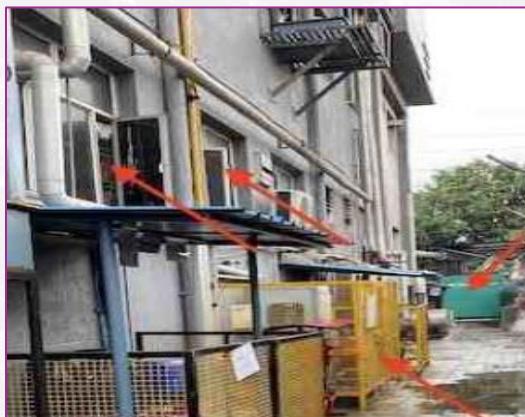
- Hazardous installations such as compressors, PNG skid, DG etc are found installed adjacent to the production floor or in exit route.

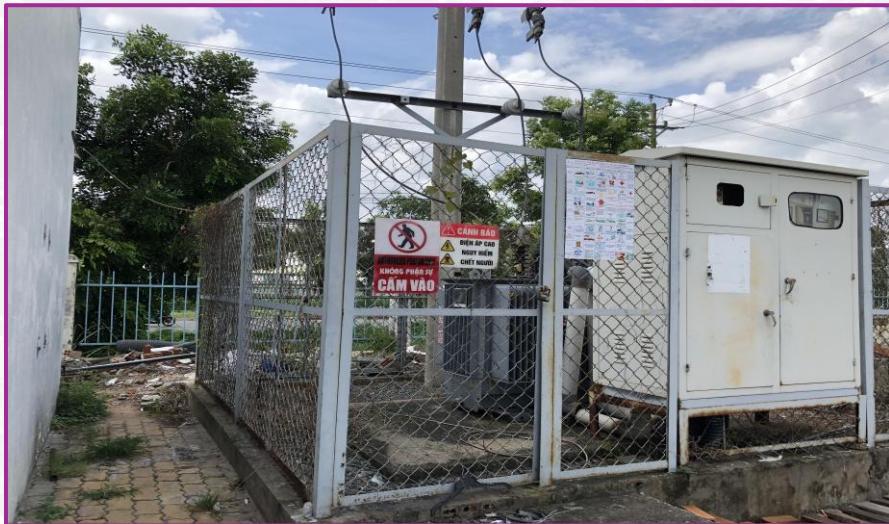
Signage provided over substation

Remediation- The factory has provided warning signage over hazardous electrical installation.

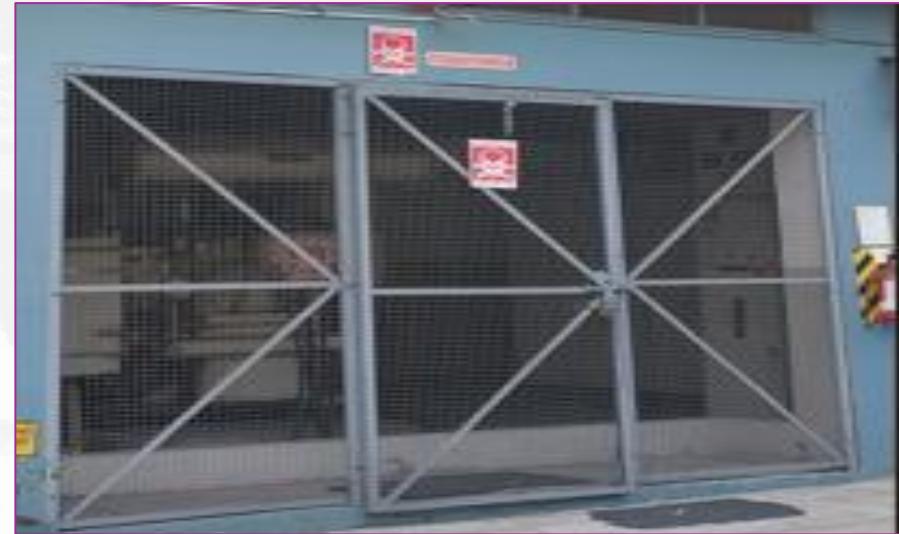
Warning signage provided

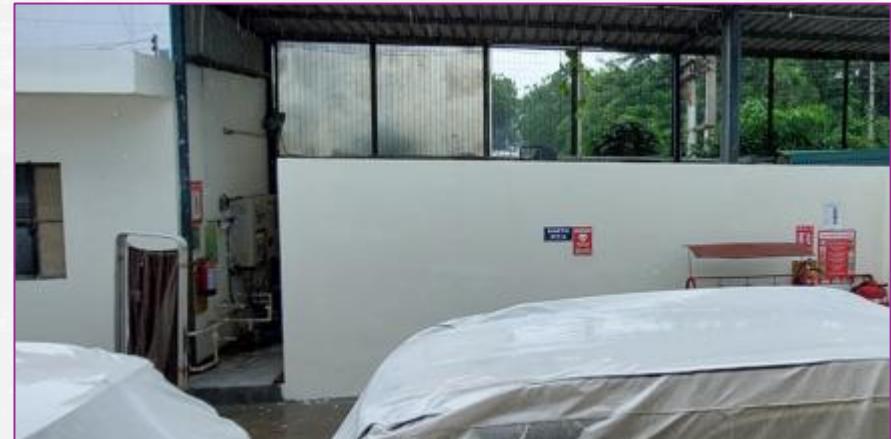
Observation – Hazardous installation installed adjacent to production with glass window towards production.

Wall separation provided between transformer & evacuation route

Remediation- The factory has provided separation between hazardous installation and production.

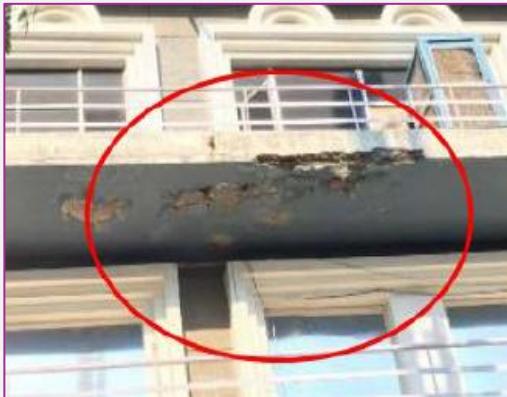
- Significant corrosion making the structural element (beams, columns, truss) etc ineffective that may lead further structural damage.

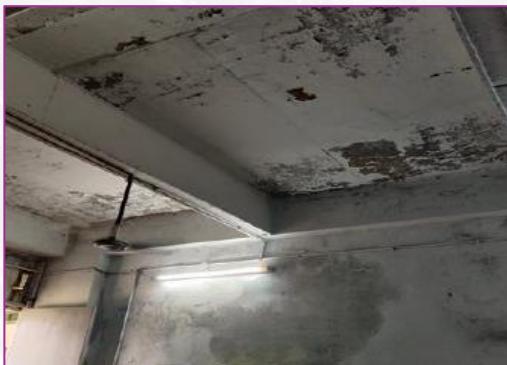
- Dampness observed over Floor Roof and walls.

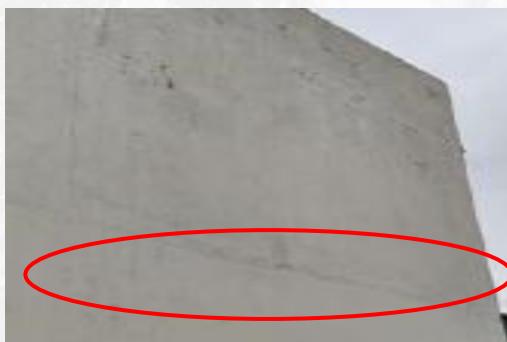
- Cracking observed over back side of building
- Cracks were observed over columns/beams

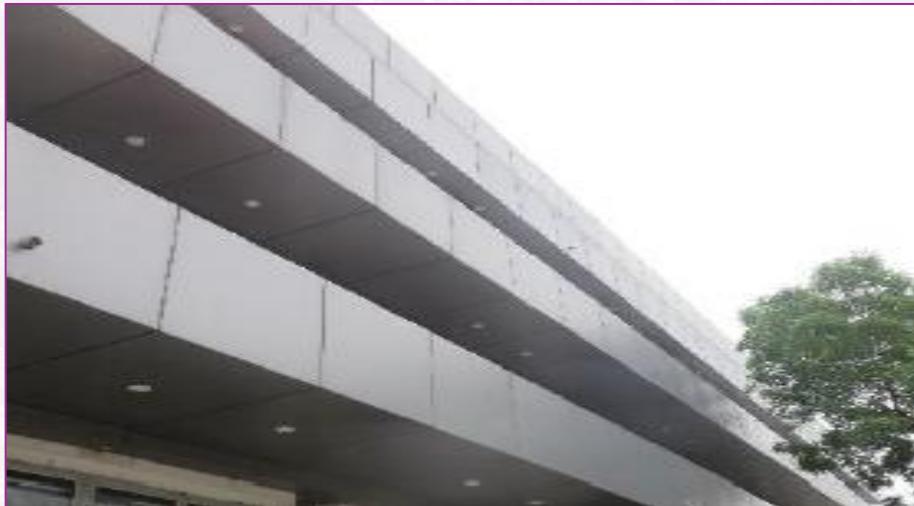
Observation — The structure element was found corroded.

Corroded structure repaired and covered

CAP- Will review the corroded structure and repair it.

Remediation- The factory has repaired corroded structure members .

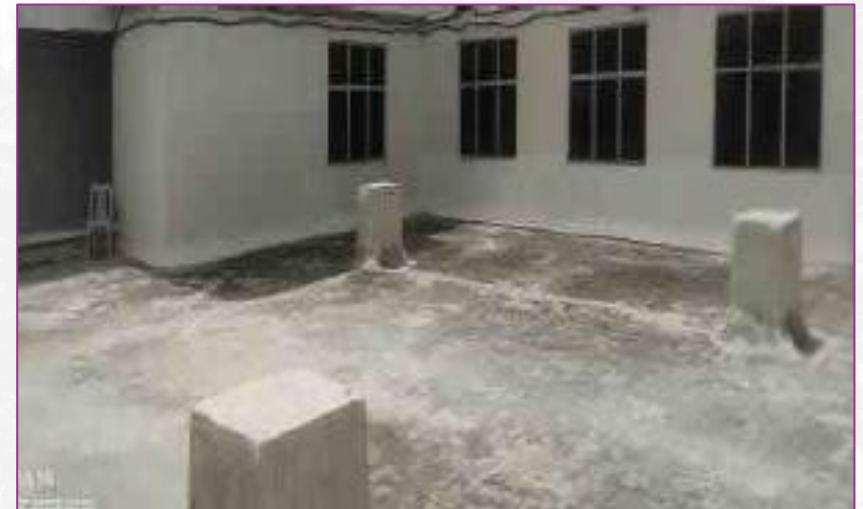
Corroded bars were repaired from column

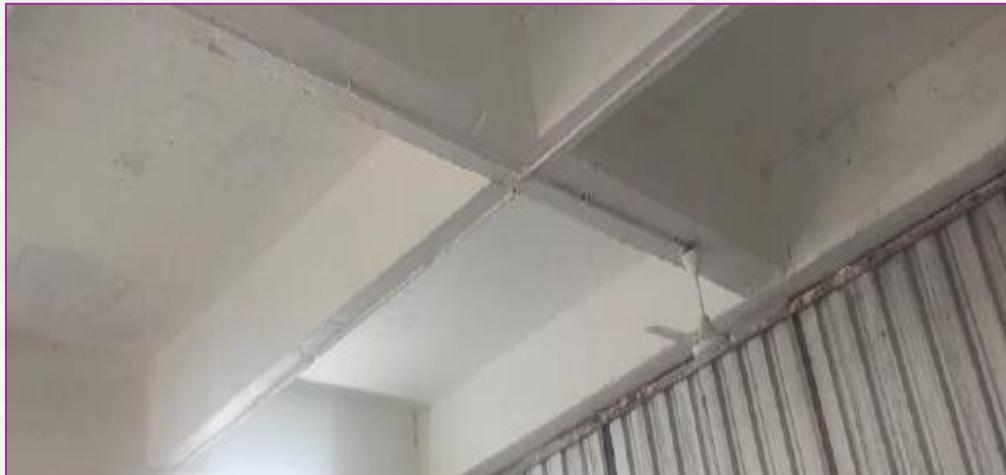
Observation — wall cladding/backside wall observed for dampness

Dampness has been addressed

CAP- Factory will review structure with NDT test for impact of dampness over structure and repair dampness.

Remediation- The factory has repaired dampness and removed leakages causing dampness.

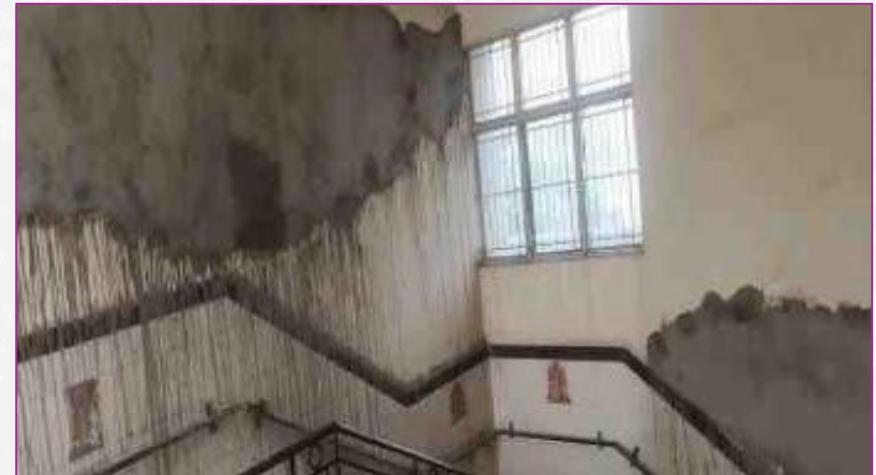
Dampness Repairs work has been done

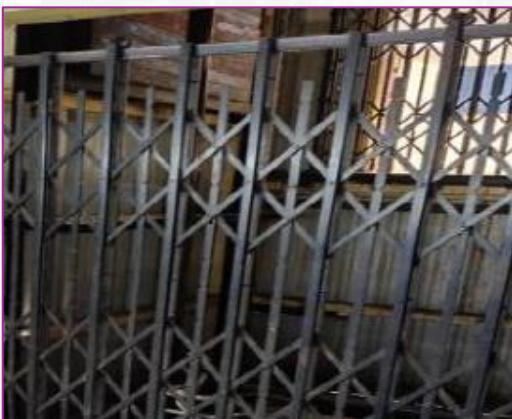
- Goods Lift Side walls & 2nd floor External walls at North, West Side found to be inadequate to resist later forces

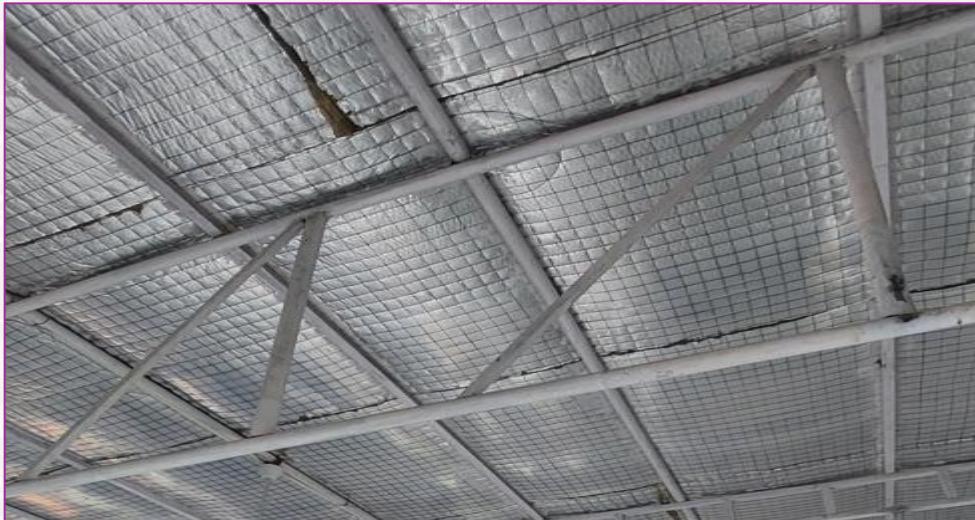
Bracing to MS structure

Remediation- The factory has appointed structural consultant and provided bracing along with survey report
