# LABS

Life And Building Safety

**LABS - GOOD PRACTICES SHARING**

19th June 2026

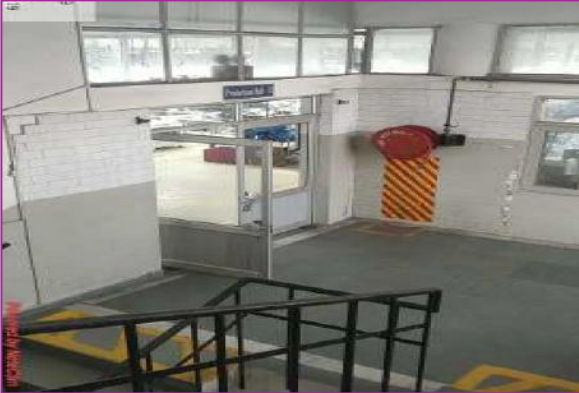
- Lack of enclosure of Stairs connecting more than 2 floors.
- Unsealed penetrations in stair enclosures

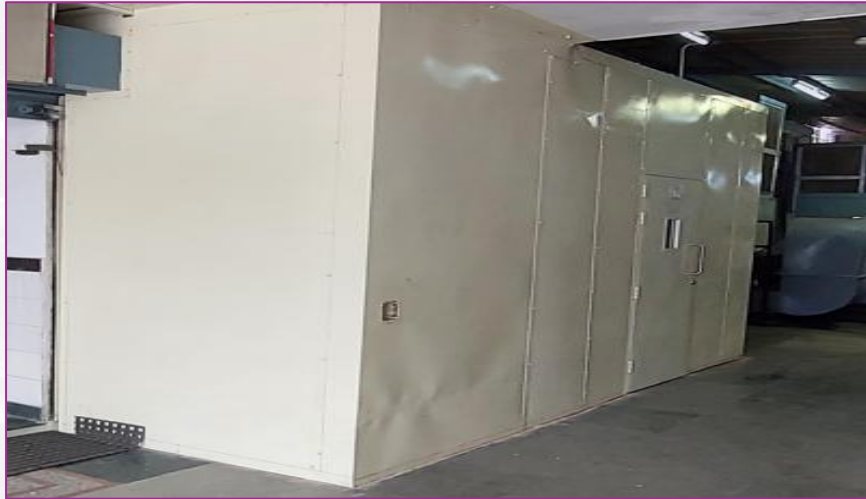
**CAP-** Provide separate enclosure with fire-rated material of up to 120 min resistance to ensure if any incident occurs in boiler it can be contained.

Boiler enclosure by Fire rated material and fire door

**Remediation-** The factory has replaced the normal doors with self-closing, fire-rated doors and sealed openings with brick walls/fire rated material

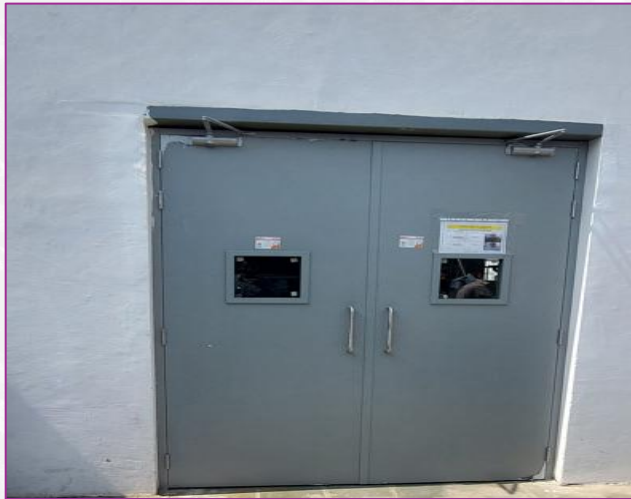
**CAP-** Emergency exit to be provided with self-closing fire-rated door as per IS 3614

Self-closing Fire door

**Remediation-** The factory has replaced the normal doors with self-closing, fire-rated doors.

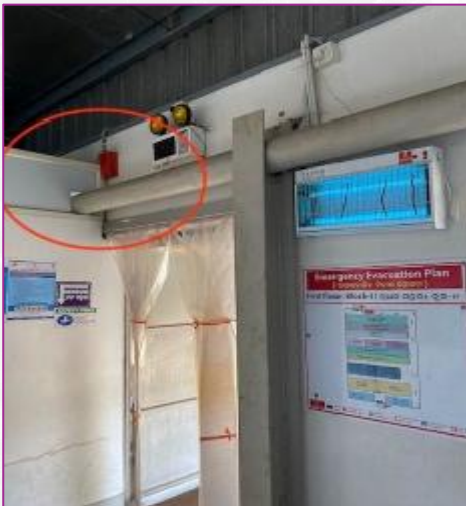
**CAP-** To improve the audibility of the fire alarm, an additional fire alarm will be installed.

Extra hooters are added near exits

**Remediation-** The factory has installed extra hooters to enhance the audibility of alarm system.

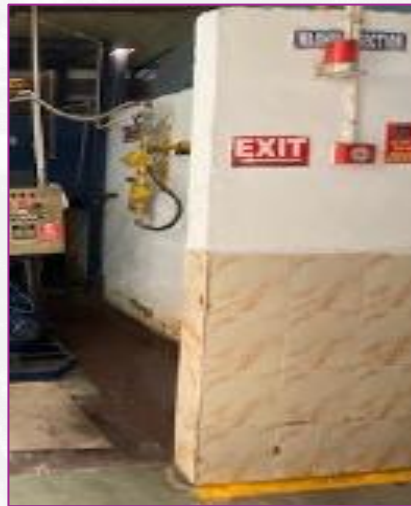
Visual hooters are added in utility area

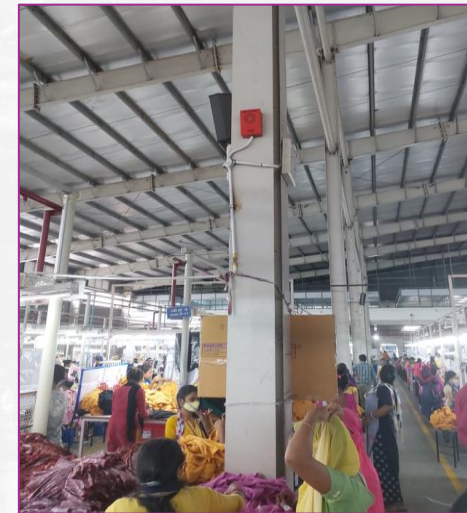
Extra hooters are added in floor

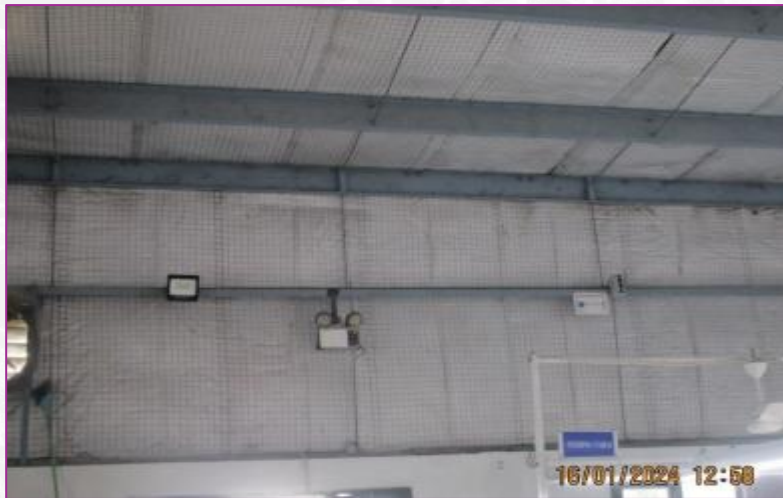
**Observation** – Smoke detector positioning was inadequate and found installed below ceiling level.

Beam type smoke detector installed for high roof

**Remediation-** The factory has installed beam type smoke detector over ceiling more than 20 feet and replaced smoke detector to the highest point of the ceiling in 14 ft ceiling.

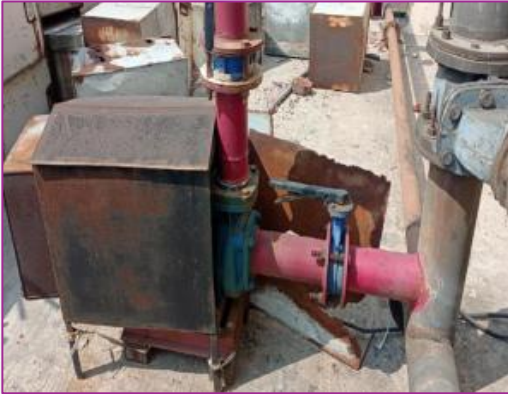
- Absence of fire pumps in the installed fire water line at the premises.
- Pump-set back-up not provided
- Only single fire pump installed for fire-fighting purpose.
- Diesel backup fire pump not provided.

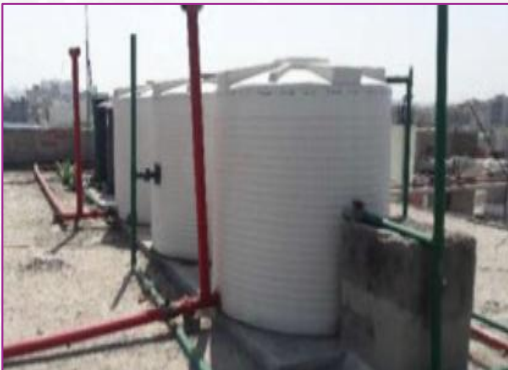
- Insufficient water storage on premises for firefighting systems.
- Only 10 KL dedicated water available for fire fighting.

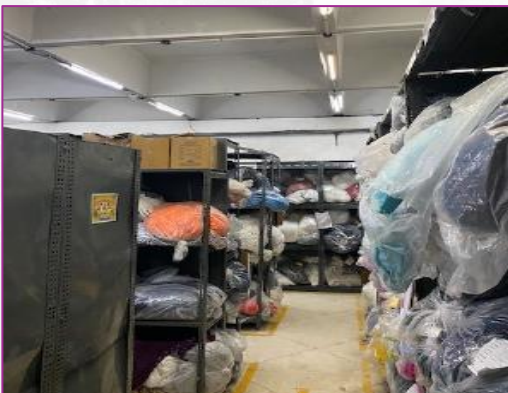
- A Non-Sprinklered storage area exists with excessive storage and is not effectively separated by FR separation with production areas.
- No fire-rated compartmentation is provided between the non-sprinklered storage area.

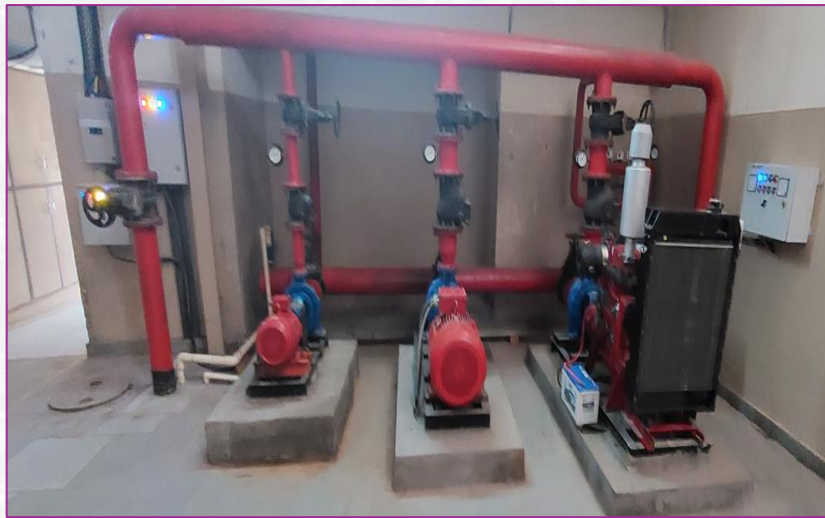
**Observation** – Only single fire pump installed for fire-fighting purpose. .

All 3 Fire pumps are installed

**Remediation-** The factory has installed 3 fire pump jockey pump, main pump and diesel powered pump in the premises.

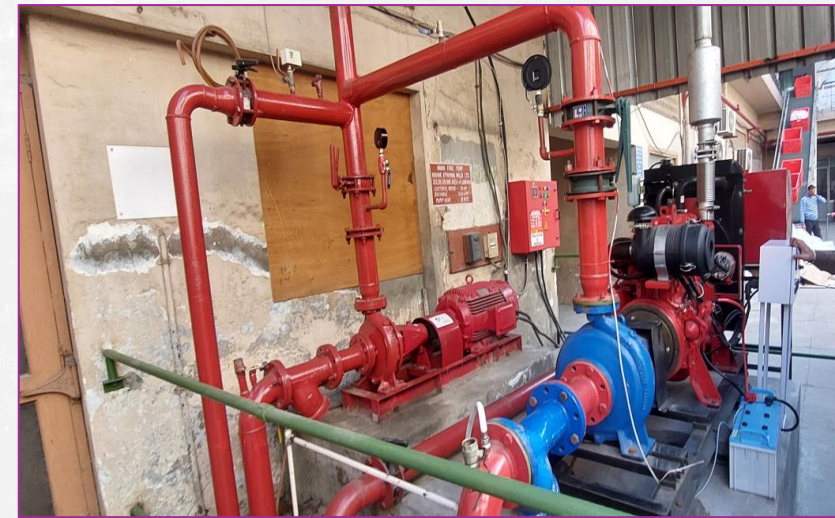
Backup Fire pumps are installed

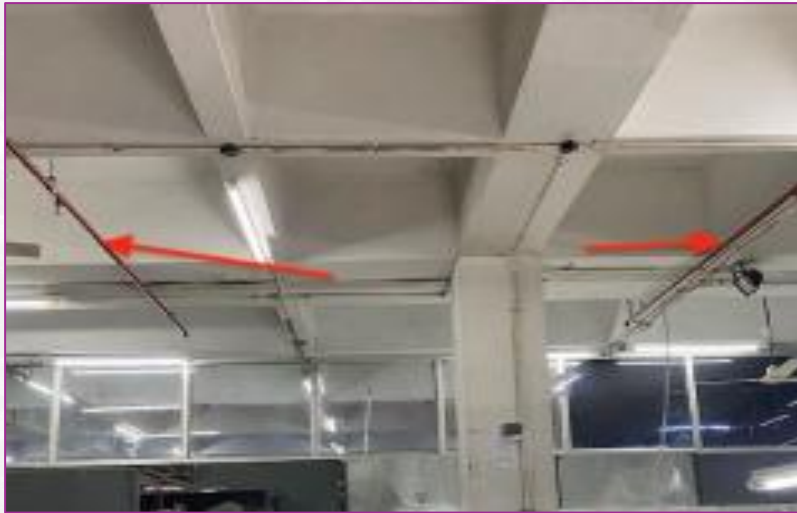
Additional water tanks installed by factory

**Remediation-** The factory has installed sprinklers in storage areas.

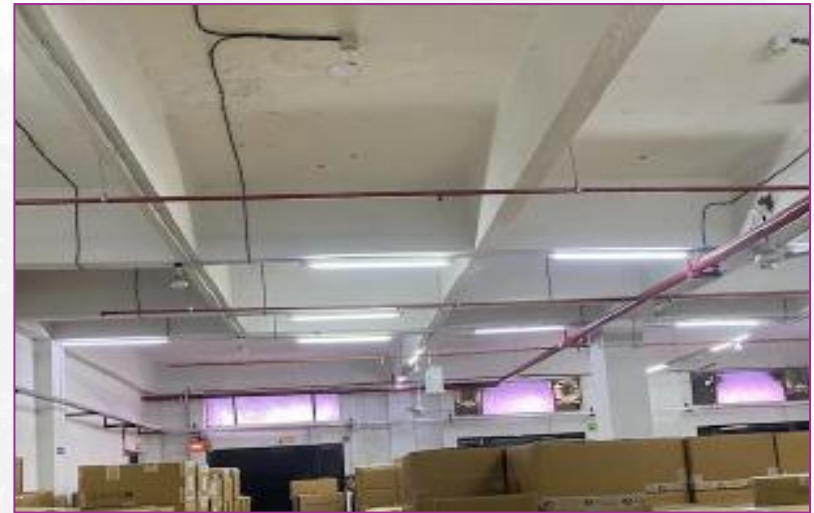
**CAP-** Provide sprinkler system in storages areas .

Sprinklers installed in material store

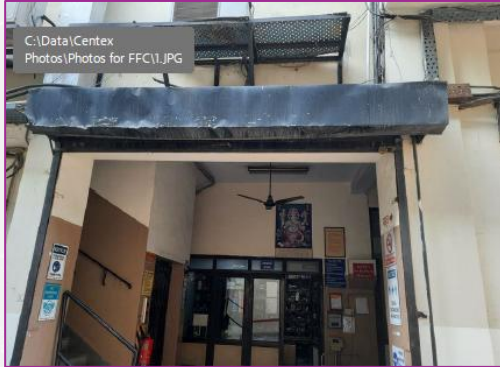
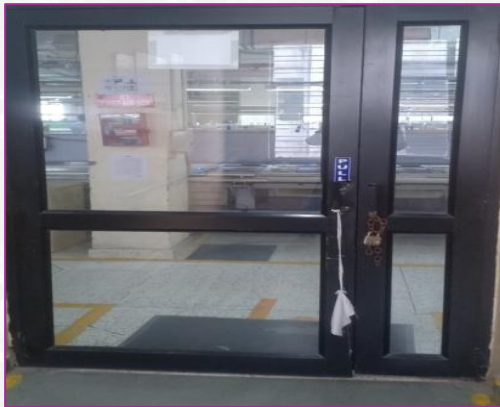
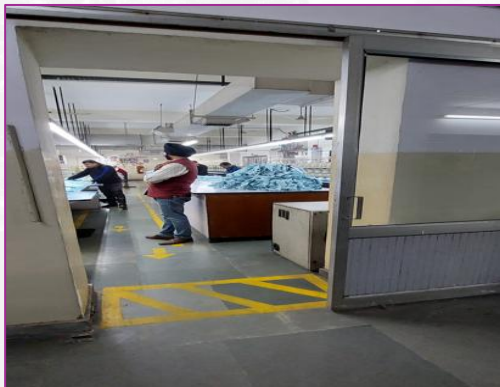
- Exit doors in the factory have locking devices /have rolling shutters with the locking mechanism.
- Exit doors not side hung to swing correctly in the direction of escape.
- Lockable device installed over exit door from outside.

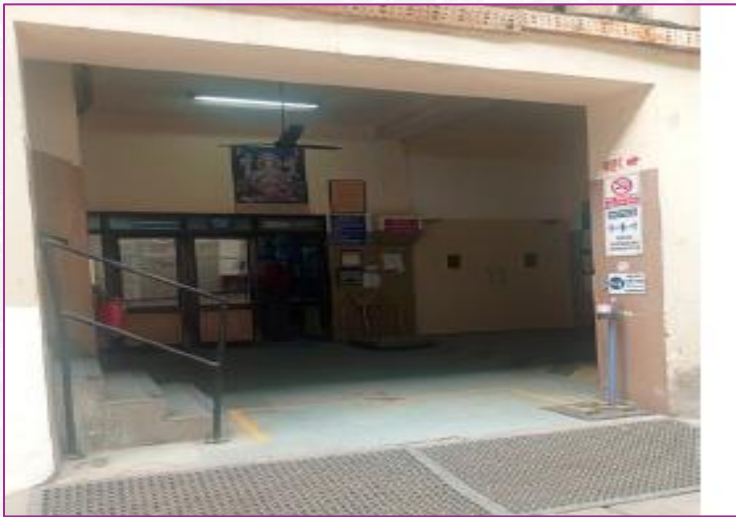
**Observation** – The factory exit door is equipped with a locking mechanism and a rolling shutter.

Rolling shutter has been removed

**Remediation-** The factory has installed Fire rated door at the final door with push bar in place of shutter or have removed shutter.

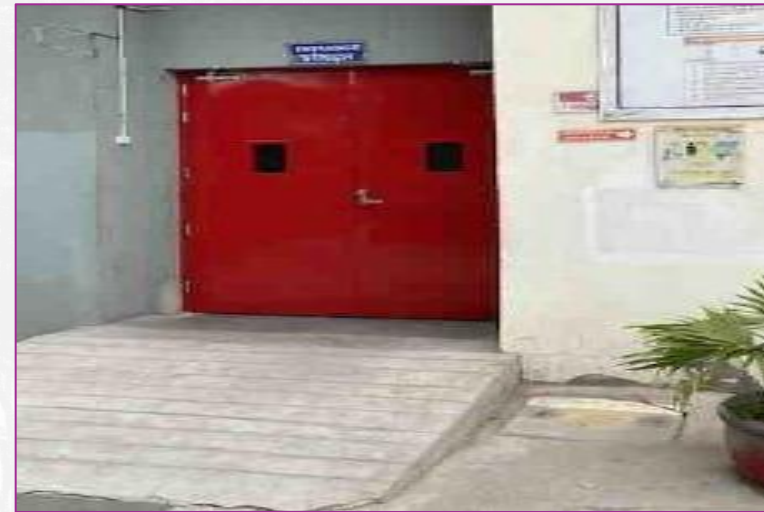
Fire door has been installed

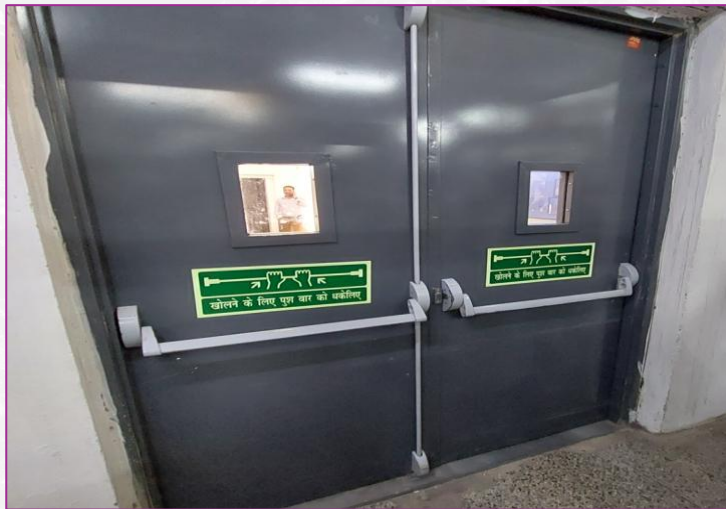
**Observation** — Lockable device installed on all exit doors from outside/inside .

Push bar has been install over doors

**Remediation-** The factory has installed a fire-rated door with a push bar or mechanism that allows for bypassing the outside lock from the inside.

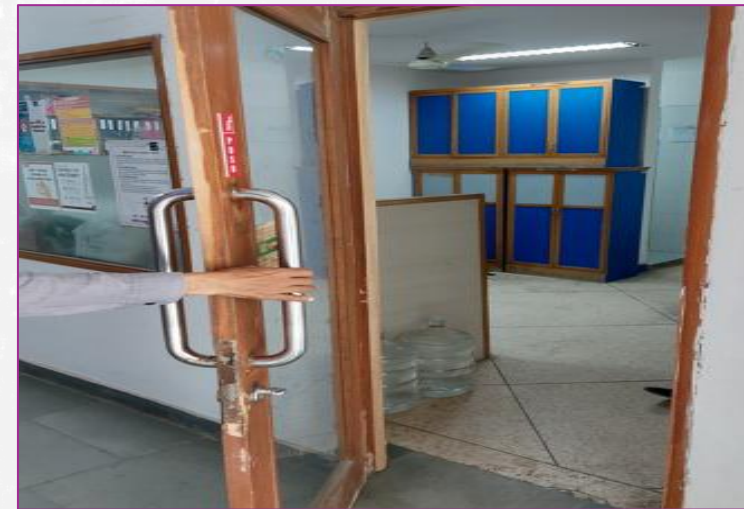
Rotating latch mechanism installed to bypass lock

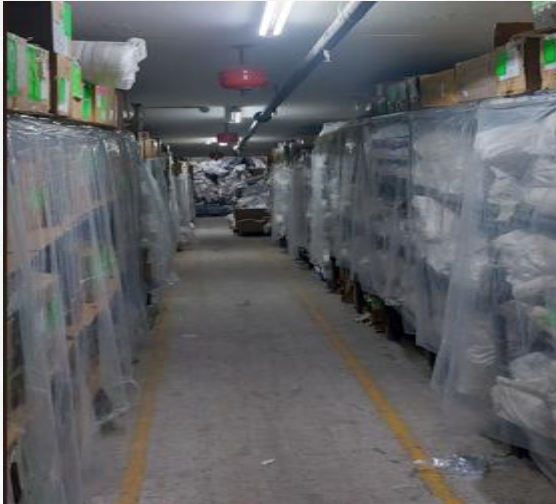
**Observation** – Use of loose polythene / fabric curtains for covering storage racks was noticed in the factory, which is a fire hazard. .

Plastic curtain over Material Racks

**CAP**-Curtains will be removed/Fire rated curtain will be installed.

**Remediation**- The factory has removed plastic curtain from material racks/ installed a fire-rated curtain over raw material rack.

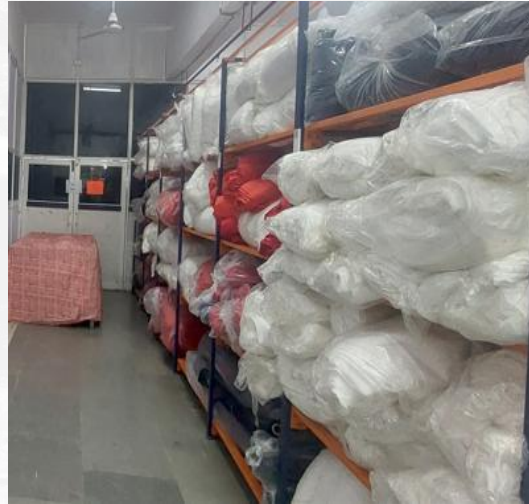
Plastic curtain removed from Material Racks

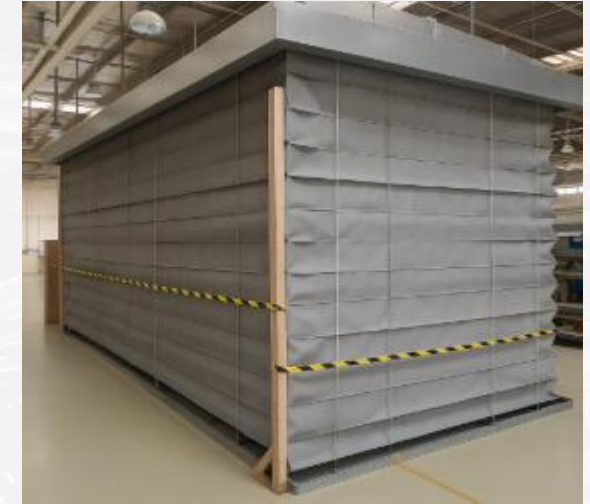
Fire curtain over raw Material Racks

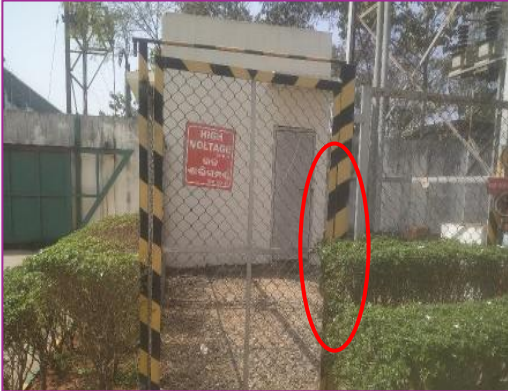
- Gate at the transformer yard is not looped with the fence for continuity of earthing
- Equipotential bonding (body earthing) to dissipate static charge not provided to Diesel day tank.

**Observation** — Bonding not provided over transformer gate/diesel tank .

**CAP-** Bonding will be provided over to dissipate charge safety from advised system.

**Remediation-** The factory has provided bonding to dissipate the static charge and to keep all conductors at the same potential.

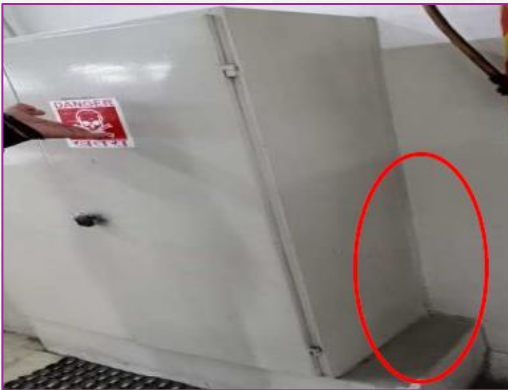
- Proper body earthing not evident in various distribution boards.
- Single body earthing provided to DG set.
- Earthing not provided to MS roof truss.

**Observation** — Body earthing not evident in distribution boards/Ms roof truss

**CAP-** Factory will identify missing earthing in panels and provide earthing as per electrical standards.

**Remediation-** The factory has installed copper strips for earthing in specific locations as a remedial measure.

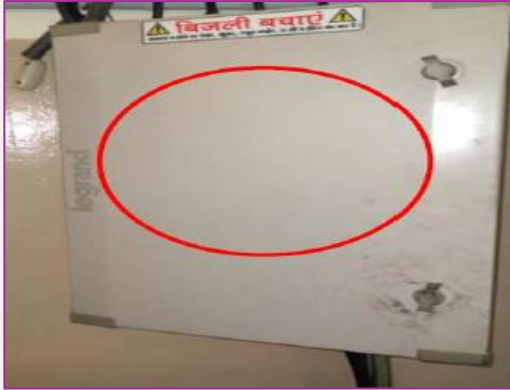
- Proper identification markings were not provided on distribution boards.
- Cable current carrying capacity chart provided on distribution boards.

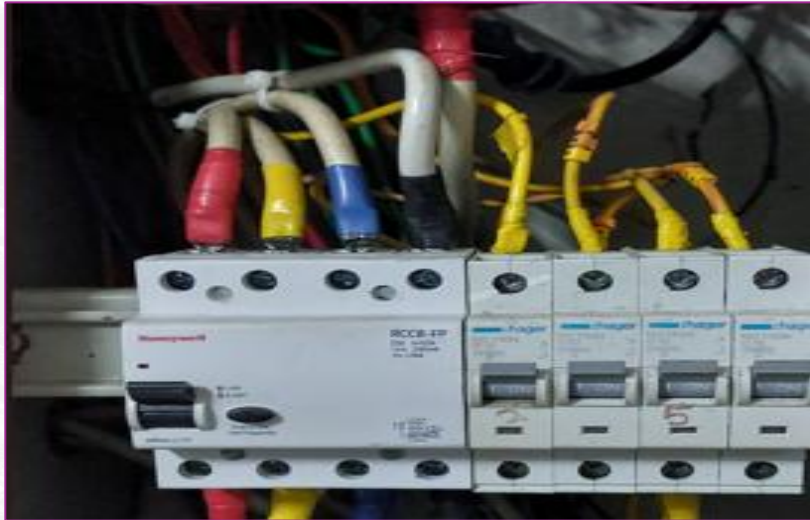
Lugs provided for electrical panel

**CAP-** Lugs and glands will be provided for electrical fitting.

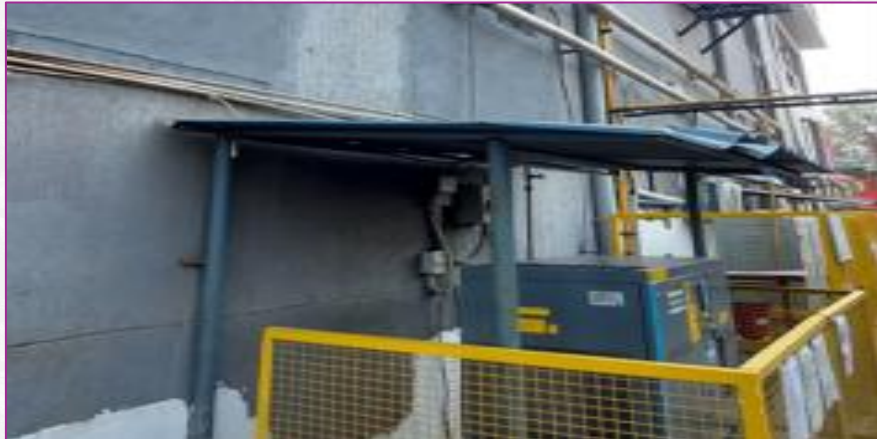
**Observation** – Hazardous installation installed adjacent to production with glass window towards production.

Window opening towards compressors has been closed

**CAP-** Separation need to be provided between production and high risk installation.

**Remediation-** The factory has provided separation between hazardous installation and production.

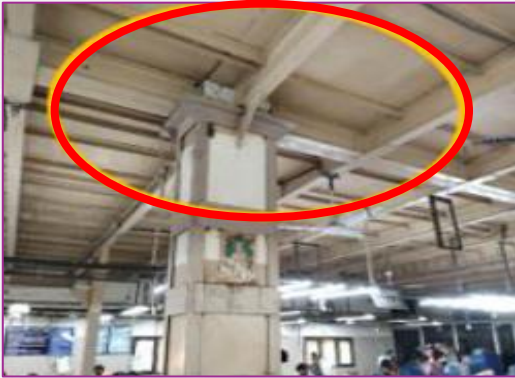
- Intermediate column stress check as jacketing work with steel angle section visible over column

**Observation** – Intermediate column were observed stress due to overloading.

**CAP-** Factory has appointed the Structural Consultant and the consultant has provided the stability certificate for first floor and below the floor level.

**Remediation-** The factory has assessed all column in building and provided jacketing of below column, verified through the structural engineer

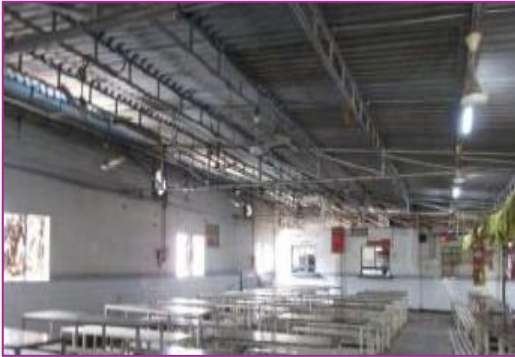
- Seismic bracings are not provided for added MS structures as lateral support structural system.

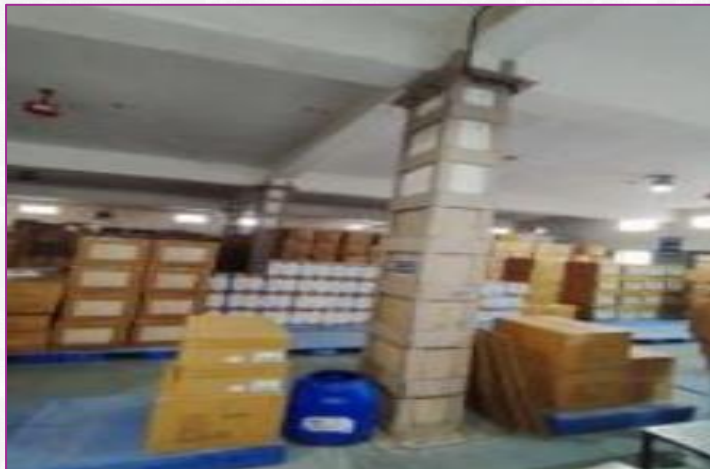
Jacketing provided for column level below

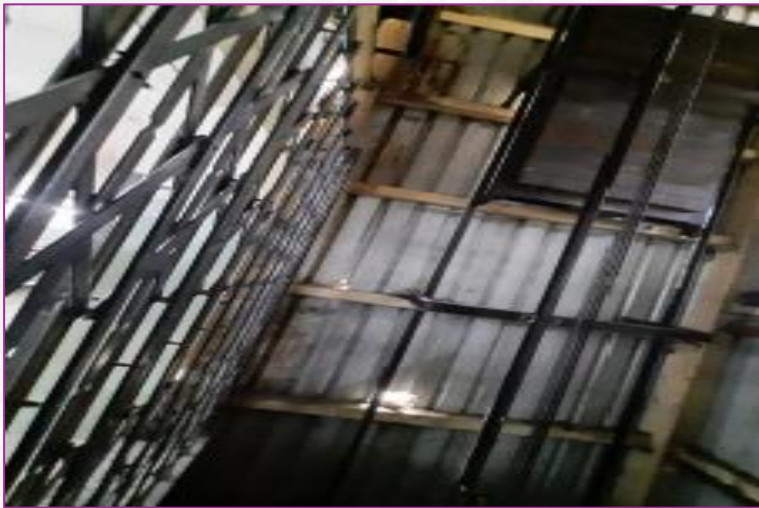
**Observation** – Goods Lift Side walls & 2nd floor External walls at North, West Side found to be inadequate to resist later forces.

Structural member has been reinforced

**CAP-** Factory to appoint a Structural Engineer to review the extent

**Remediation-** The factory has appointed structural consultant and provided support member in lift
