LABS

Life And Building Safety

LABS - GOOD PRACTICES SHARING

29th Dec 2025

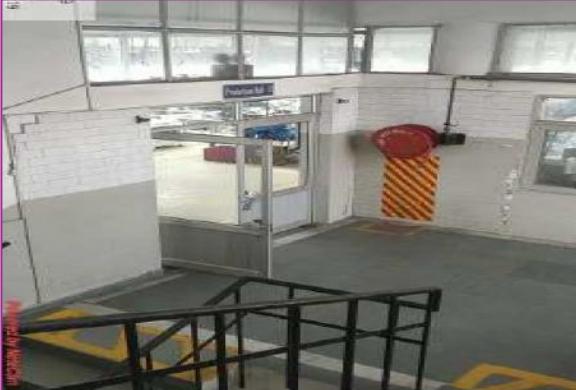
Fire compartmentation

- Lack of enclosure of Stairs connecting more than 2 floors.
- Unsealed penetrations in stair enclosures

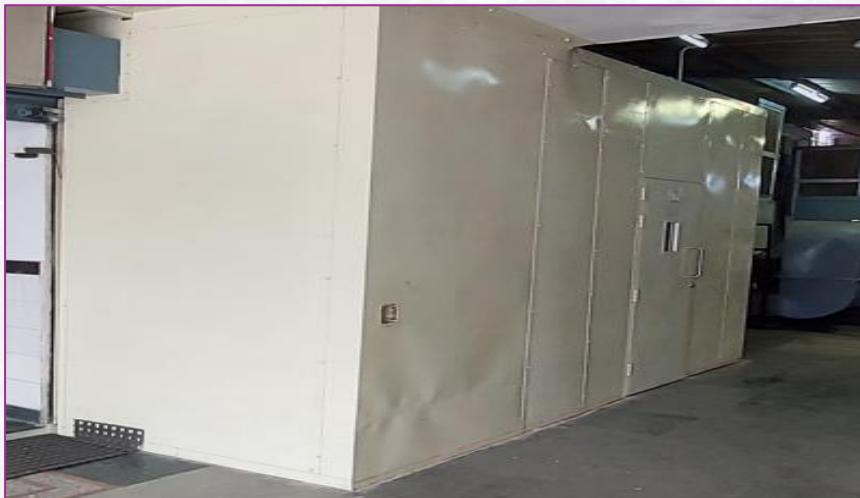
CAP- Provide separate enclosure with fire-rated material of up to 120 min resistance to ensure if any incident occurs in boiler it can be contained.

Boiler enclosure by Fire rated material and fire door

Remediation- The factory has replaced the normal doors with self-closing, fire-rated doors and sealed openings with brick walls/fire rated material

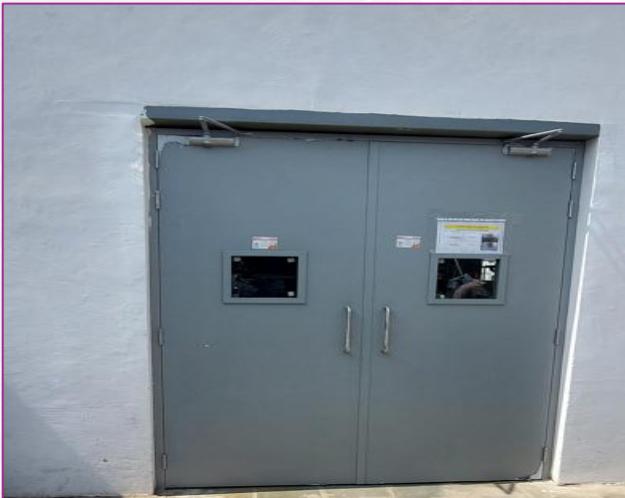
CAP- Emergency exit to be provided with self-closing fire-rated door as per IS 3614

Self-closing Fire door

Remediation- The factory has replaced the normal doors with self-closing, fire-rated doors.

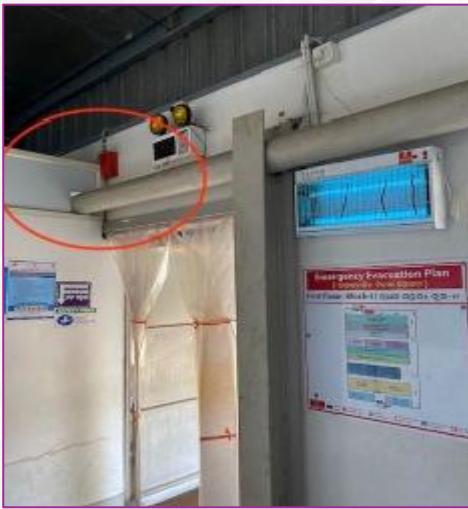
CAP- To improve the audibility of the fire alarm, an additional fire alarm will be installed.

Extra hooters are added near exits

Remediation- The factory has installed extra hooters to enhance the audibility of alarm system.

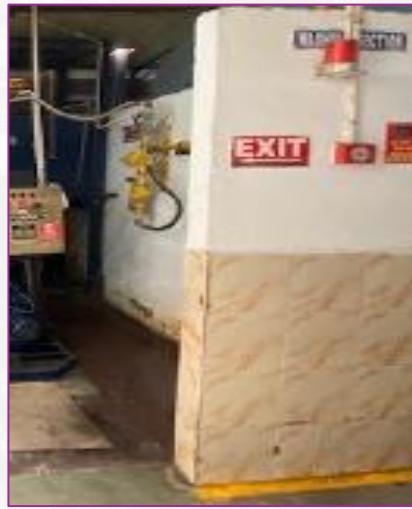
Visual hooters are added in utility area

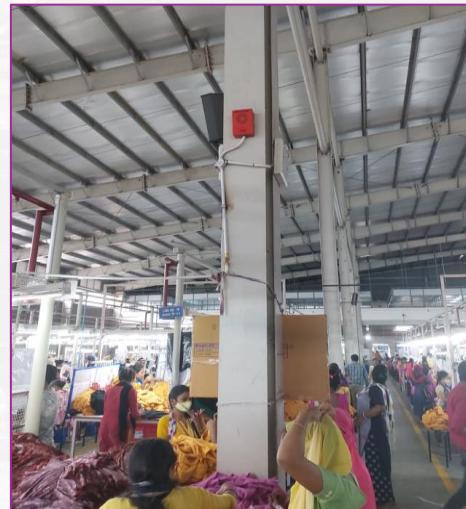
Extra hooters are added in floor

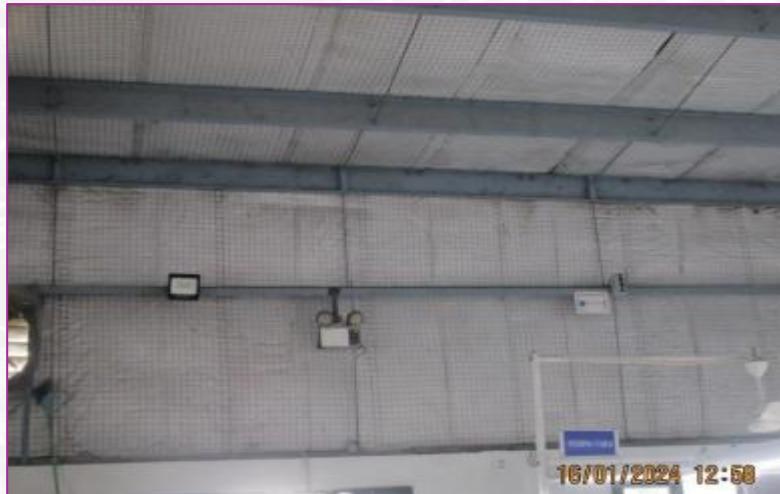
Observation — Smoke detector positioning was inadequate and found installed below ceiling level.

Beam type smoke detector installed for high roof

Remediation- The factory has installed beam type smoke detector over ceiling more than 20 feet and replaced smoke detector to the highest point of the ceiling in 14 ft ceiling.

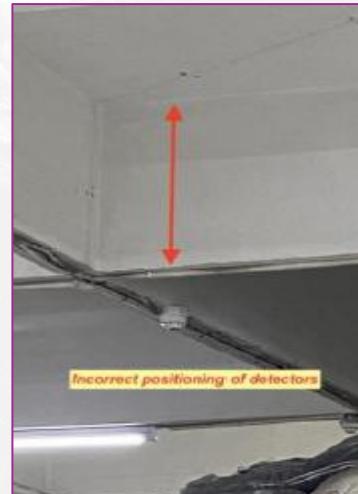
Incorrect positioning of detectors

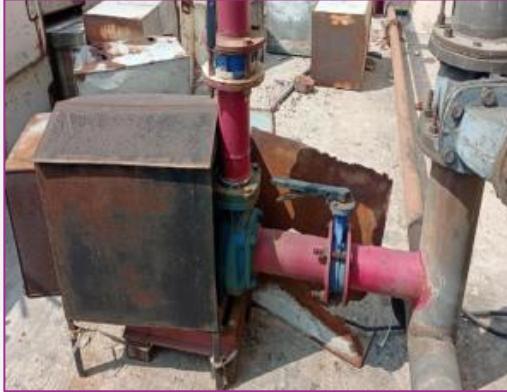
- Absence of fire pumps in the installed fire water line at the premises.
- Pump-set back-up not provided
- Only single fire pump installed for fire-fighting purpose.
- Diesel backup fire pump not provided.

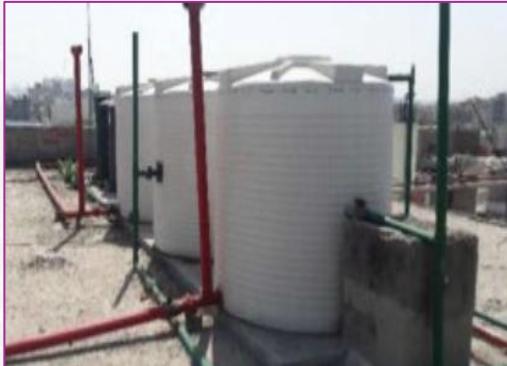
- Insufficient water storage on premises for firefighting systems.
- Only 10 KL dedicated water available for fire fighting.

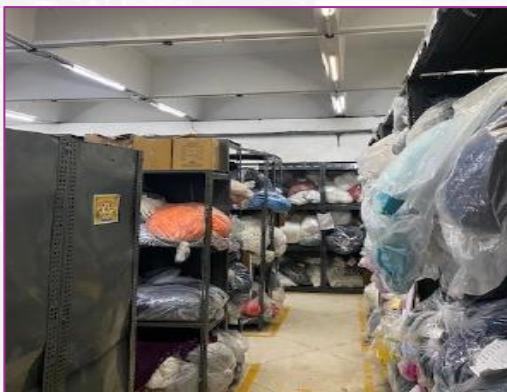
- A Non-Sprinklered storage area exists with excessive storage and is not effectively separated by FR separation with production areas.
- No fire-rated compartmentation is provided between the non-sprinklered storage area.

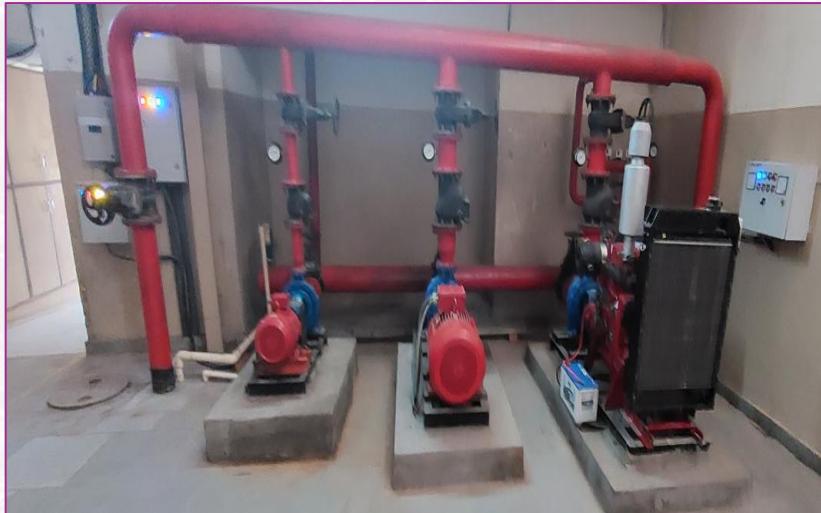
Observation – Only single fire pump installed for fire-fighting purpose. .

All 3 Fire pumps are installed

Remediation- The factory has installed 3 fire pump jockey pump, main pump and diesel powered pump in the premises.

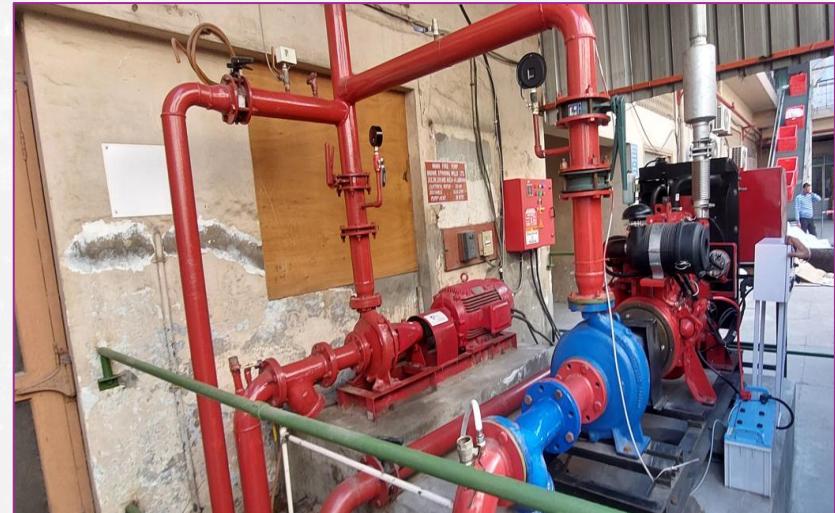
Backup Fire pumps are installed

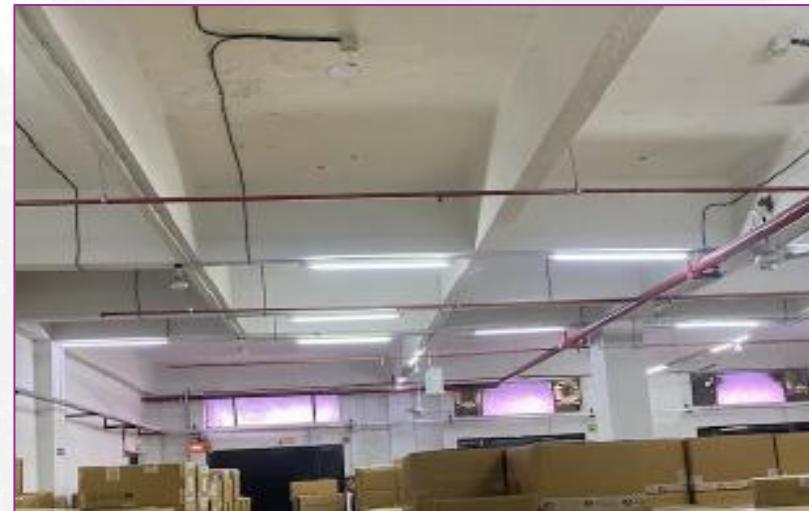
CAP- Provide sprinkler system in storages areas .

Sprinklers installed in material store

Remediation- The factory has installed sprinklers in storage areas.

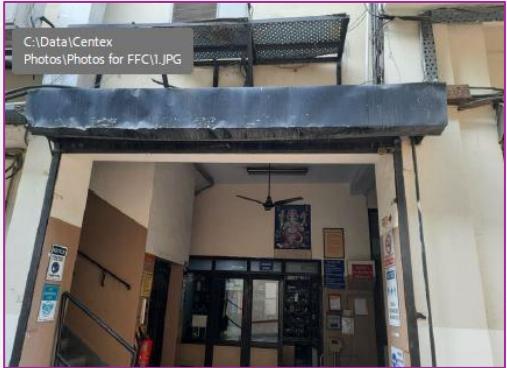
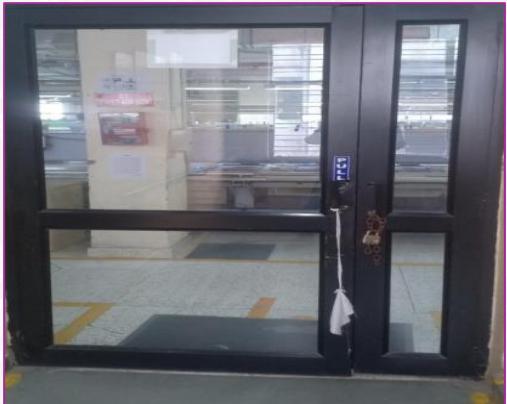
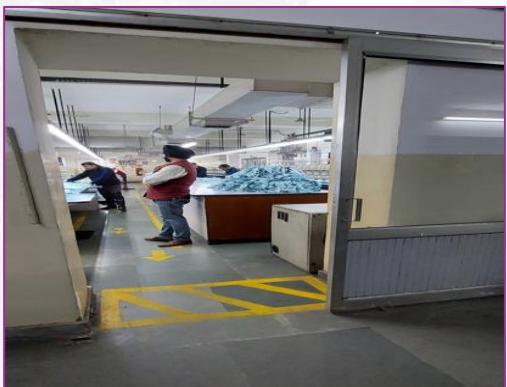
- Exit doors in the factory have locking devices /have rolling shutters with the locking mechanism.
- Exit doors not side hung to swing correctly in the direction of escape.
- Lockable device installed over exit door from outside.

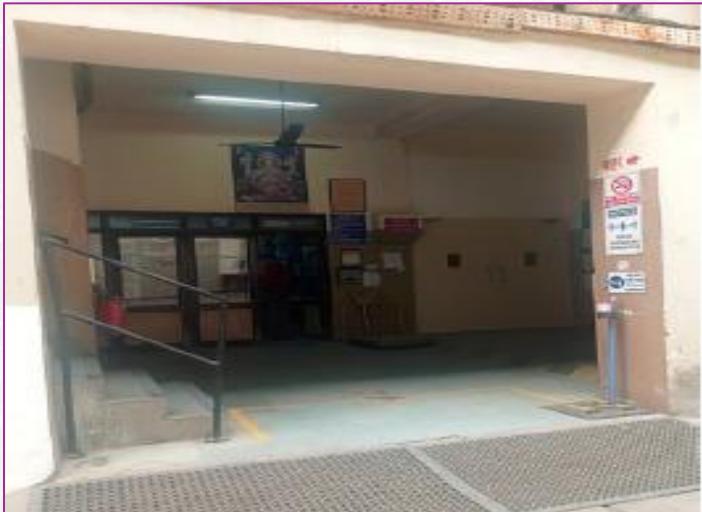
Observation — The factory exit door is equipped with a locking mechanism and a rolling shutter.

[Rolling shutter has been removed](#)

CAP- All rolling shutters will be removed with outward opening doors for safe evacuation.

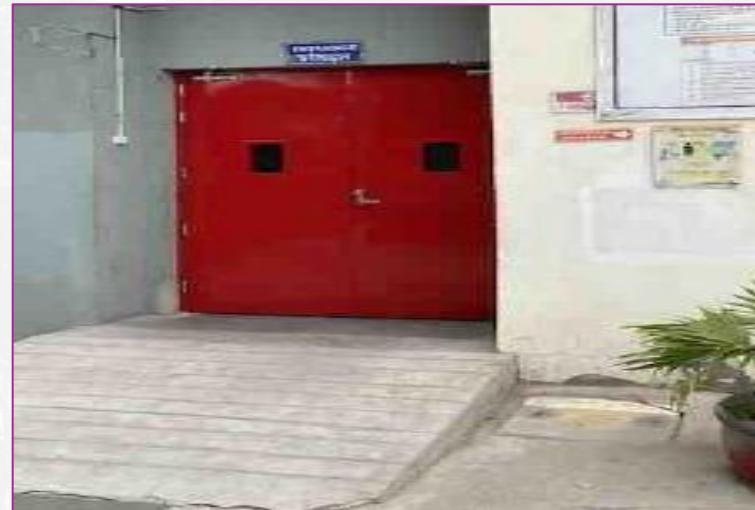
[Fire door has been installed](#)

Observation — The factory exit door is equipped with a locking mechanism and a rolling shutter.

Remediation- The factory has installed Fire rated door at the final door with push bar in place of shutter or have removed shutter.

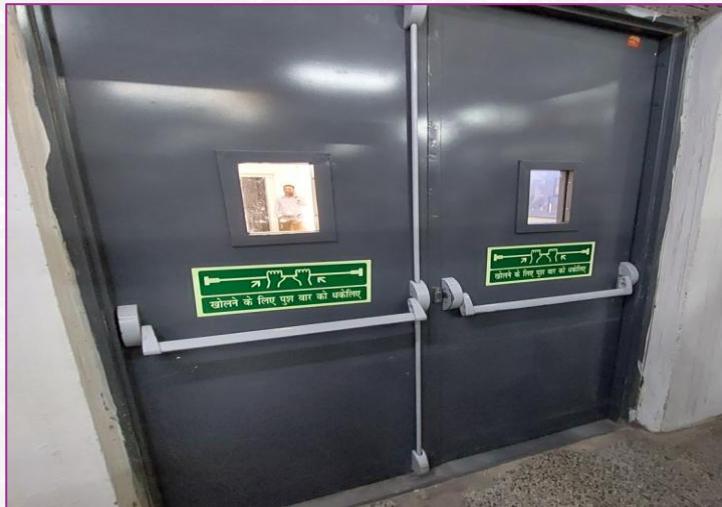
Observation — Lockable device installed on all exit doors from outside/inside .

Push bar has been install over doors

Remediation- The factory has installed a fire-rated door with a push bar or mechanism that allows for bypassing the outside lock from the inside.

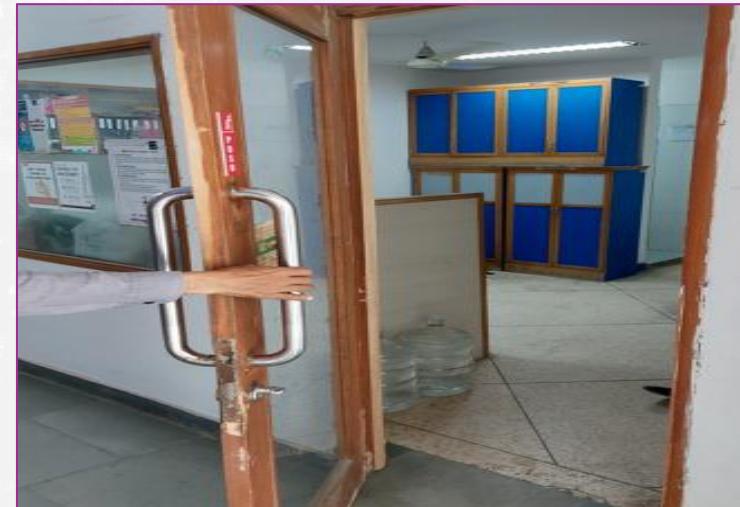
Rotating latch mechanism installed to bypass lock

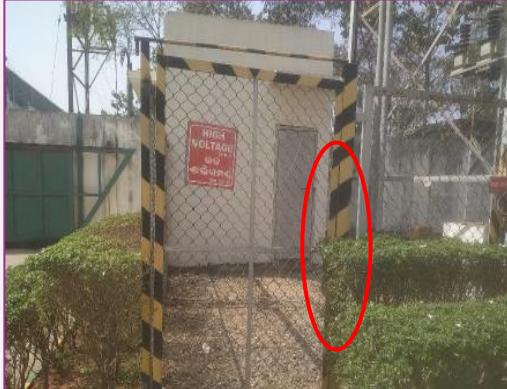
- Gate at the transformer yard is not looped with the fence for continuity of earthing
- Equipotential bonding (body earthing) to dissipate static charge not provided to Diesel day tank.

Observation – Bonding not provided over transformer gate/diesel tank .

CAP- Bonding will be provided over to dissipate charge safety from advised system.

Remediation- The factory has provided bonding to dissipate the static charge and to keep all conductors at the same potential.

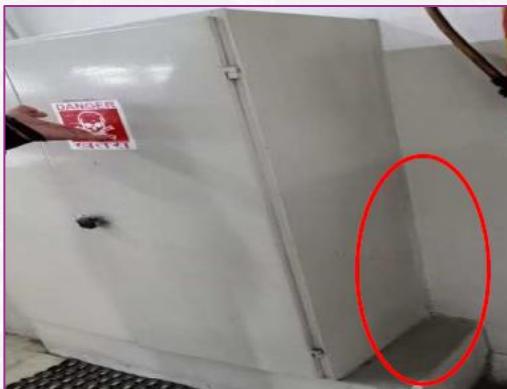
- Proper body earthing not evident in various distribution boards.
- Single body earthing provided to DG set.
- Earthing not provided to MS roof truss.

Observation – Body earthing not evident in distribution boards/Ms roof truss

CAP- Factory will identify missing earthing in panels and provide earthing as per electrical standards.

Remediation- The factory has installed copper strips for earthing in specific locations as a remedial measure.

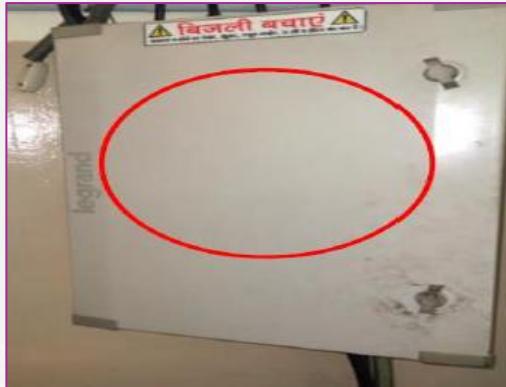
- Proper identification markings were not provided on distribution boards.
- Cable current carrying capacity chart provided on distribution boards.

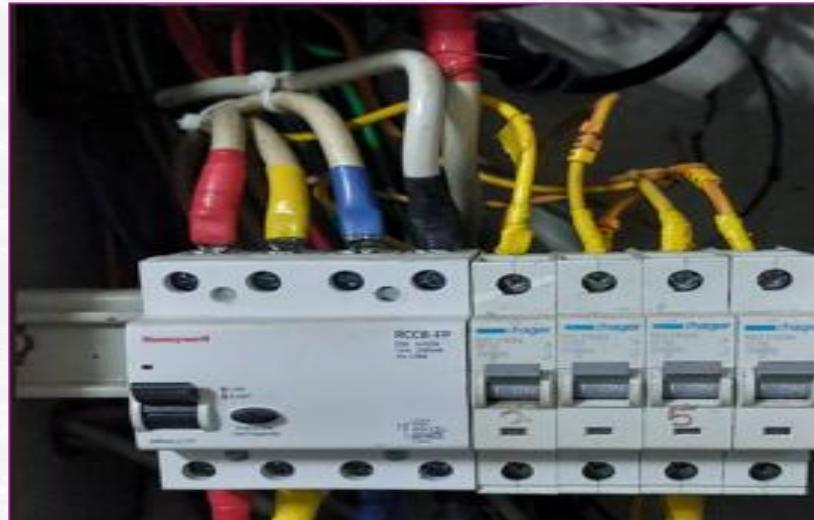
Lugs provided for electrical panel

CAP- Lugs and glands will be provided for electrical fitting.

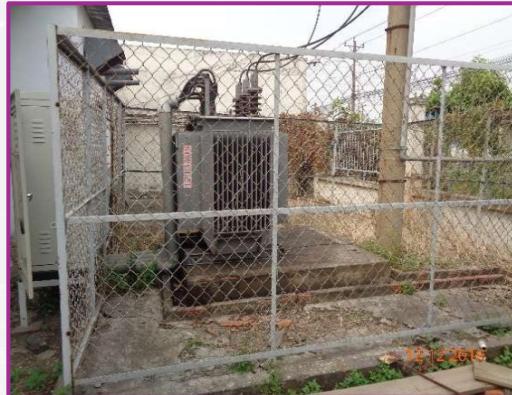
- Adequate warning/danger, voltage level signage were not posted over transformer, substation.

Remediation- The factory has provided warning signage over hazardous electrical installation.

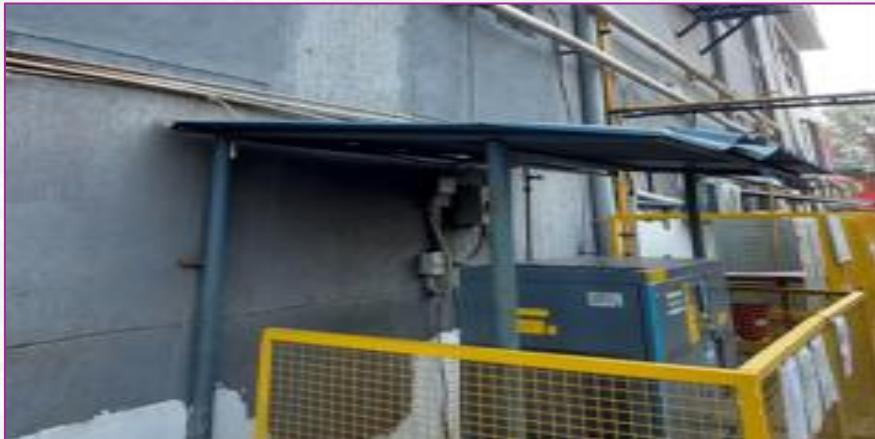
Observation – Hazardous installation installed adjacent to production with glass window towards production.

Window opening towards compressors has been closed

CAP- Separation need to be provided between production and high risk installation.

Remediation- The factory has provided separation between hazardous installation and production.

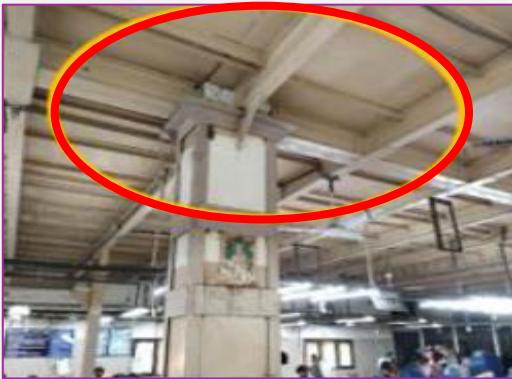
- Intermediate column stress check as jacketing work with steel angle section visible over column

Observation – Intermediate column were observed stress due to overloading.

CAP- Factory has appointed the Structural Consultant and the consultant has provided the stability certificate for first floor and below the floor level.

Remediation- The factory has assessed all column in building and provided jacketing of below column, verified through the structural engineer

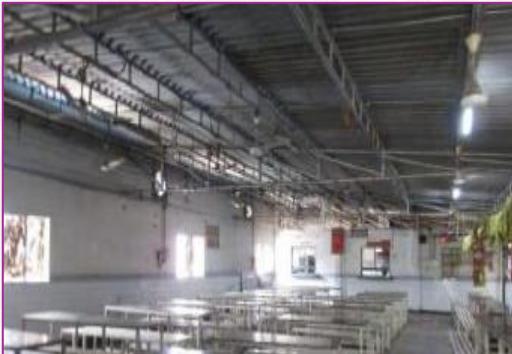
- Seismic bracings are not provided for added MS structures as lateral support structural system.

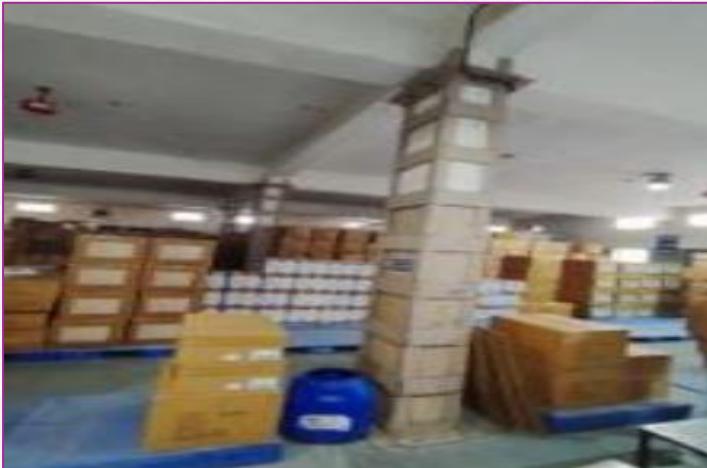
Jacketing provided for column level below

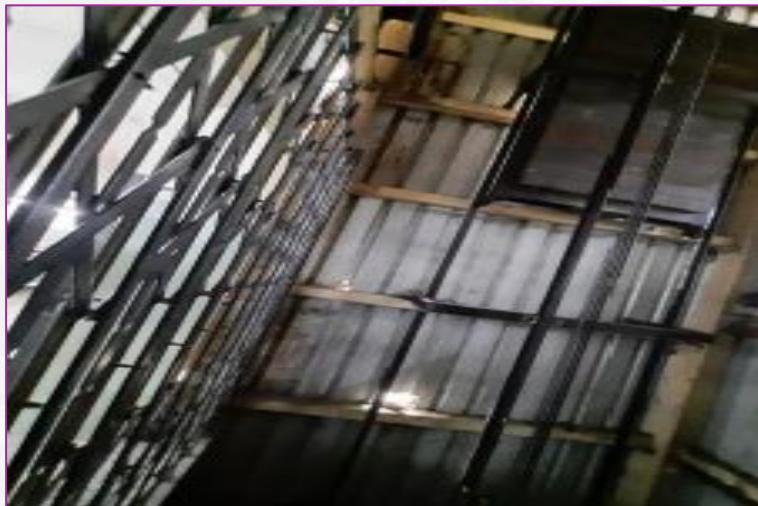
Observation — Goods Lift Side walls & 2nd floor External walls at North, West Side found to be inadequate to resist later forces.

Structural member has been reinforced

CAP- Factory to appoint a Structural Engineer to review the extent

Remediation- The factory has appointed structural consultant and provided support member in lift

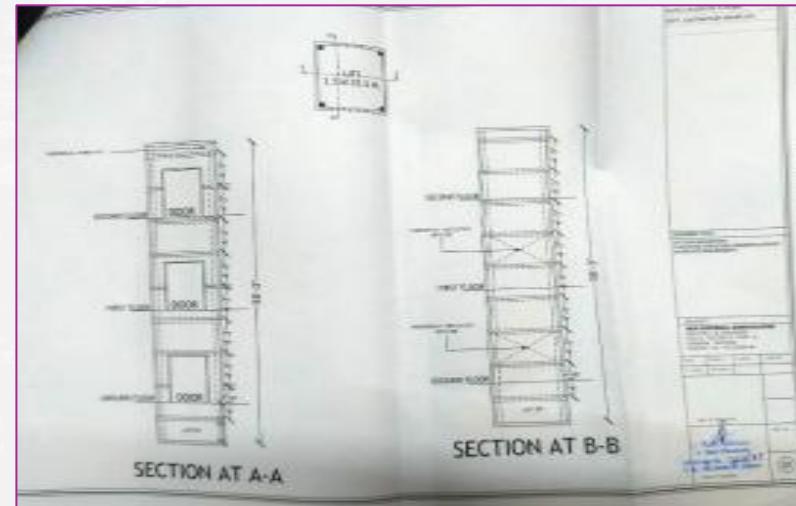
structural drawing of the Goods lift
