**LABS**  
Life And Building Safety

**LABS - GOOD PRACTICES SHARING**

**March 2025**

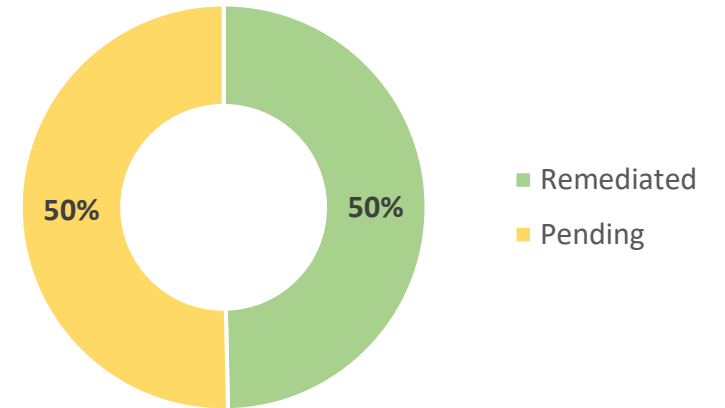
Total

- 276 of 511 (54%) electrical issues remediated
- 199 of 465 (43%) fire issues remediated
- 98 of 178 (55%) structural issues remediated
- 573 of 1154 (50%) total issues remediated

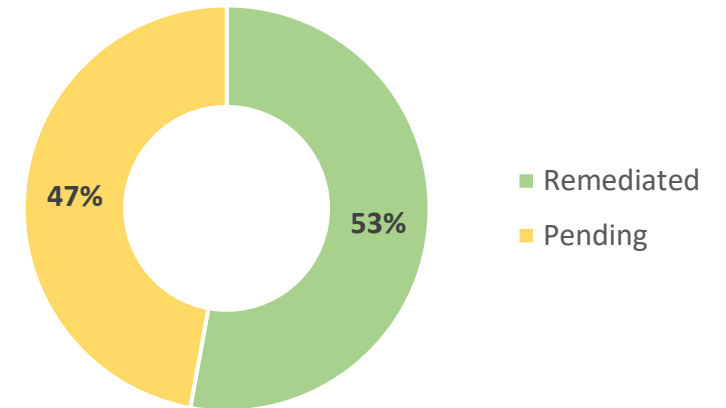
Total P1

- 31 of 42 (73%) **electrical** issues remediated
- 91 of 200 (45%) **fire** issues remediated
- 16 of 19 (84%) **structural** issues remediated
- **138 of 261 (53%) total issues remediated**

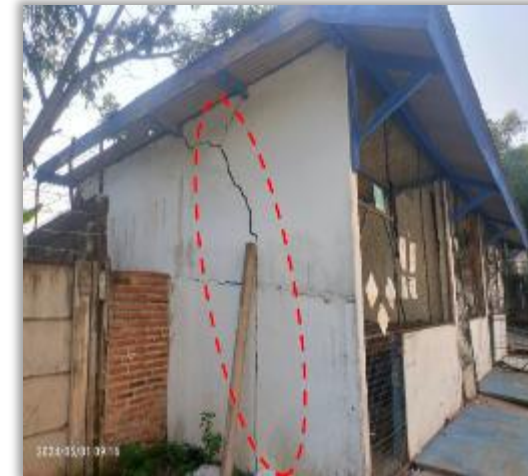
Crack on Non-Structural Member

- **Cracks on structural or non-structural members** observed throughout building.
- **Corrosion on steel structure** were observed.
- **Dampness** was observed at a few places inside the main building.

Description	LABS Standard
Appoint Structural Engineer to study the cracks and propose the remedial measures	8.5

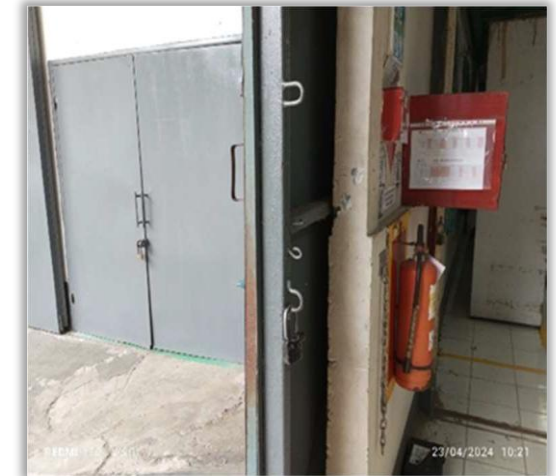
Locking mechanism on exit door

- **Locking mechanism** observed on exit doors.
- **Inadequate fire alarm system.**
- **Inadequate Fire fighting system.**
- **Emergency lights** were not working properly.

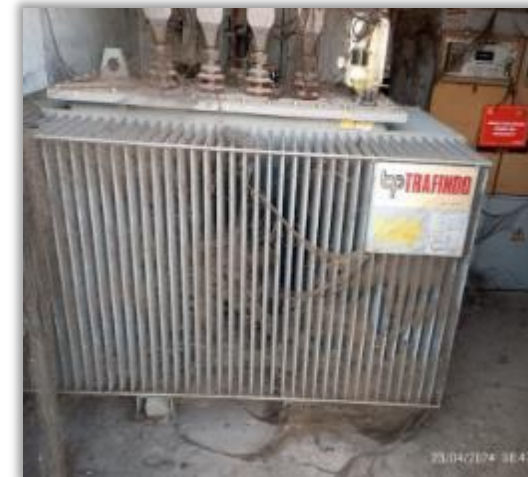
Lint and Dust in Electrical Equipment

- **High number of hotspots detected** with temperature ranging from 70°C to 110°C.
- **Lint and dust** were observed.
- **Single line diagram drawings** were not provided or updated.

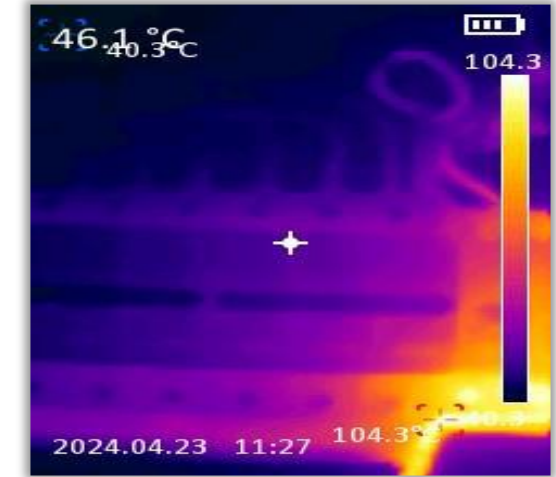
High temperature observed in the electrical panel

Description	LABS Standard
<p>Millivolt drop across terminal connections in panels to be measured (should be within 10mV). Alternately, thermographic survey can be carried out in live condition with due safety precaution (adequate work instructions &amp; PPEs to be available for conducting thermographic survey). The scope should cover all electrical joints which cannot be shut down for maintenance. Thermographic inspection of electrical equipment to be provided on a tri-annual basis.</p>	10.38.2.2

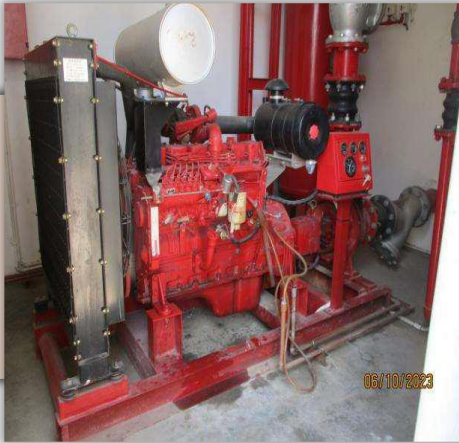
Inadequate Water Pump Set

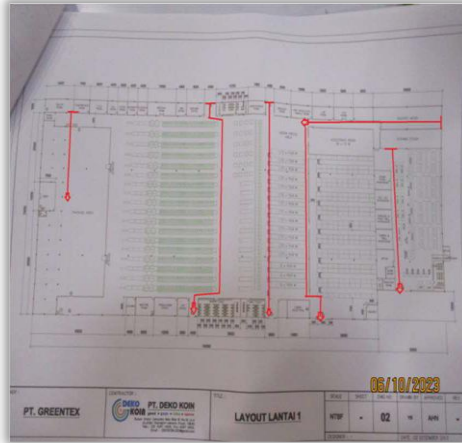
Excessive Travel Distance

Occupancy Type	Common Path Limit (single way)		Dead-End Limit (closed corridor branch)		Travel Distance Limit (alternate ways)	
	No auto suppression system	Automatic suppression system	No auto suppression system	Automatic suppression system	No auto suppression system	Automatic suppression system
Industrial - General	15 m	30 m	15 m	15 m	61 m	76 m
Industrial - Special Purpose	15 m	30 m	15 m	15 m	91 m	122 m
Industrial - High Hazard	Prohibited	Prohibited	Prohibited	Prohibited	Prohibited	23 m
Storage - Low Hazard	Unrestricted	Unrestricted	Unrestricted	Unrestricted	Unrestricted	Unrestricted
Storage - Medium Hazard	15 m	30 m	15 m	30 m	61 m	122 m
Storage - High Hazard	Prohibited	Prohibited	Prohibited	Prohibited	23 m	30 m
Parking - Open	15 m	15 m	15 m	15 m	91 m	122 m
Parking - Enclosed	15 m	15 m	15 m	15 m	46 m	60 m
Other	Refer to NFPA 101 (2015) Table A.7.6

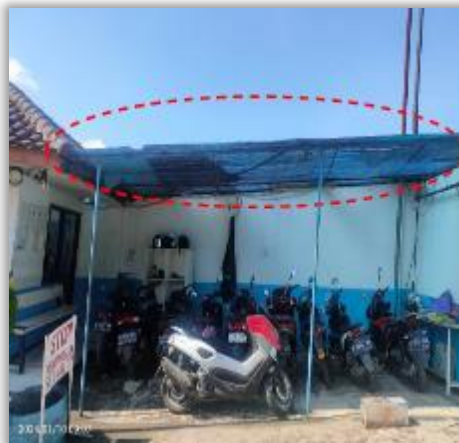
Broken Roof

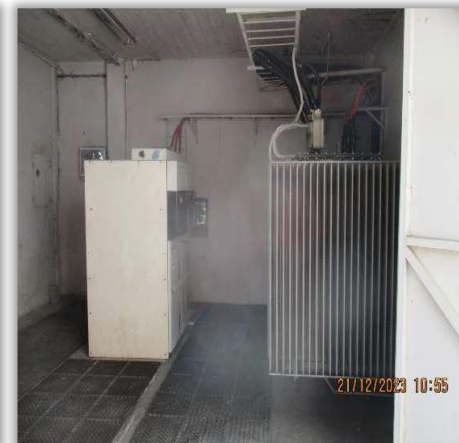
No Oil Soak Pit for Transformer

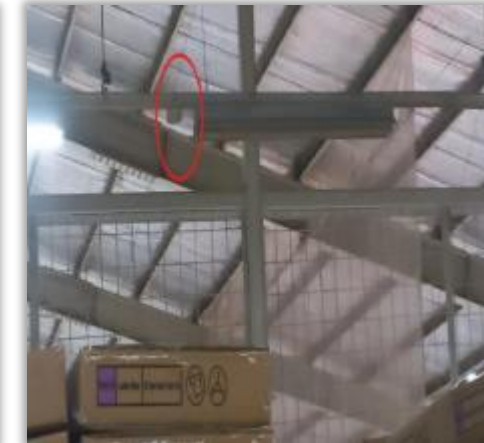
Local Type Smoke Detector Observed

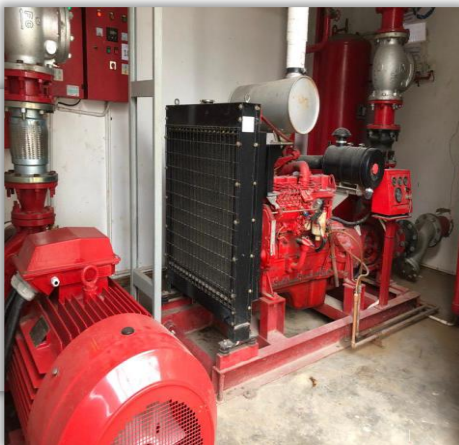
Water Pump Set Provided

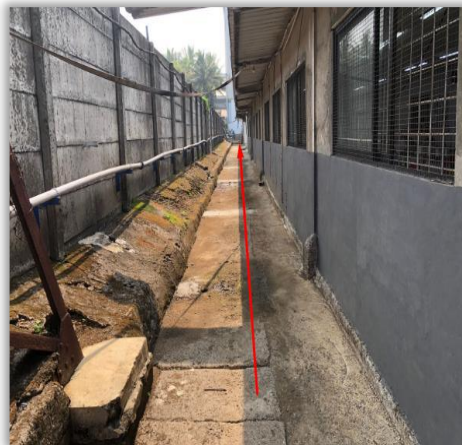
Additional Exit Provided

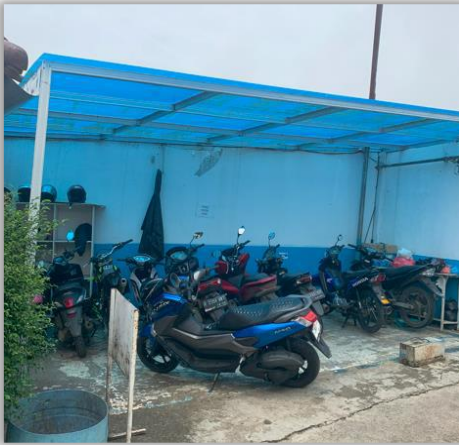
Broken Roofing Replaced

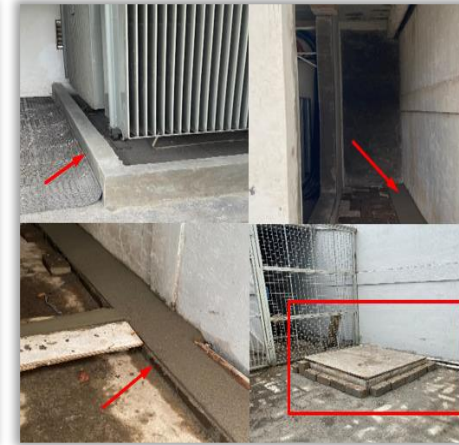
Soak Pit Provided

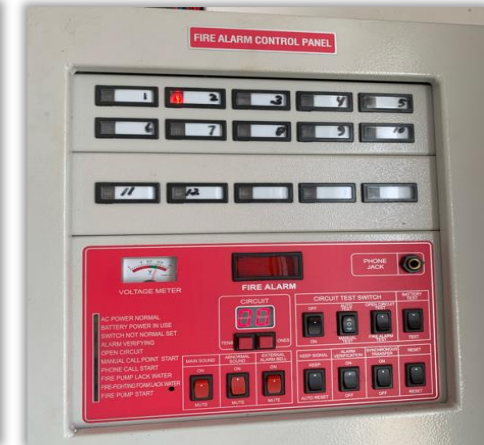
Integrated Alarm System Provided

Description	LABS Standard
<p>Test decibel levels of alarm sounders in all areas. Add sounders for all areas where the alarm decibel level is not sufficient. Hooter Cum strobe installation is recommended.</p> <p><b>Note: Minimum sound level usually around 65dB throughout the building but importantly 5dBA above any background noise</b></p>	5.9

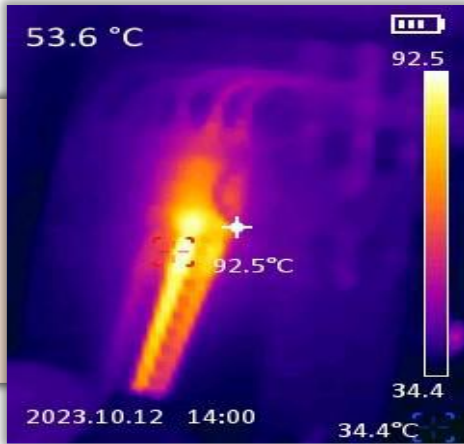
High temperature of 92.5°C observed in electrical panel

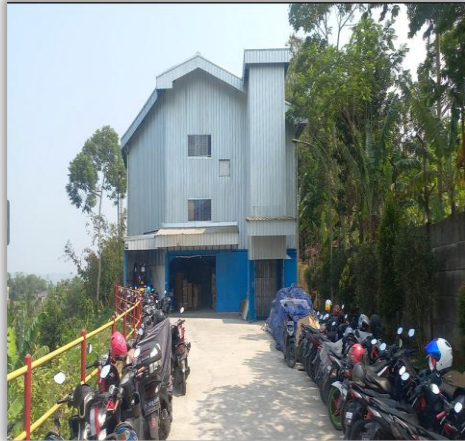
No Emergency Exit Observed

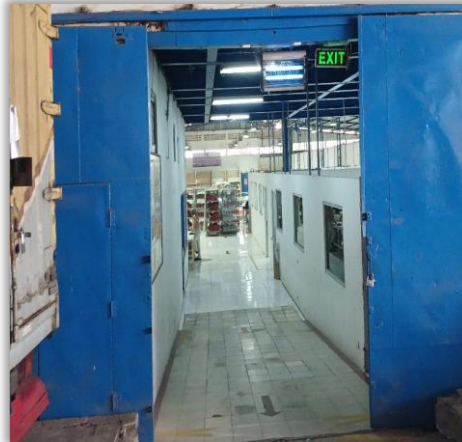
Sliding Doors used as Emergency Exit

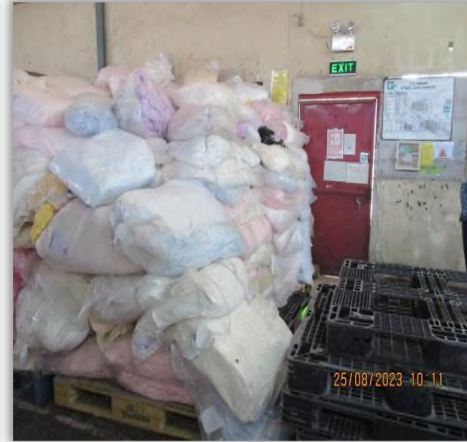
Obstructed Emergency Exit

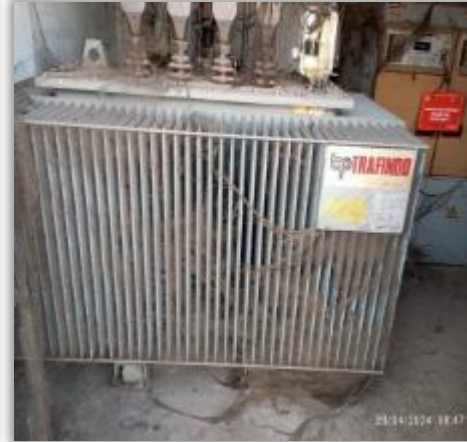
Lint and Dust in Electrical Equipment

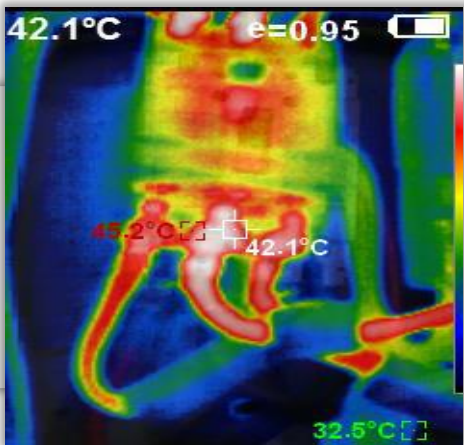
High temperature remediated

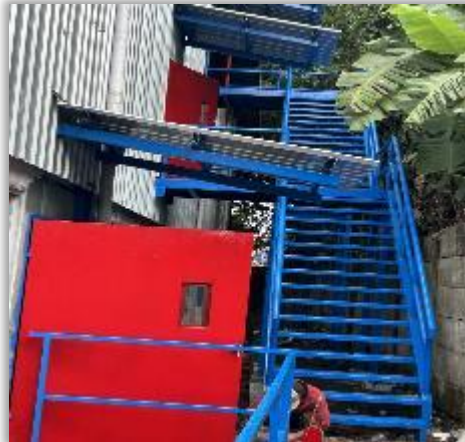
Emergency Exit with FR Door Installed

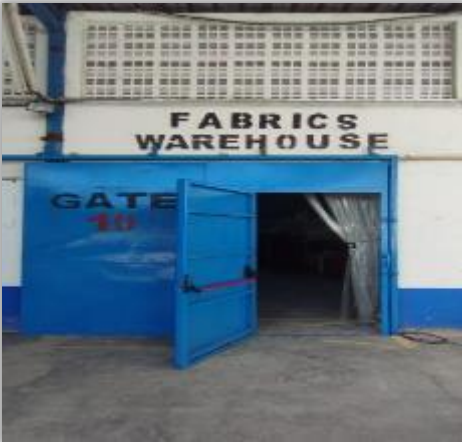
Locking mechanism removed

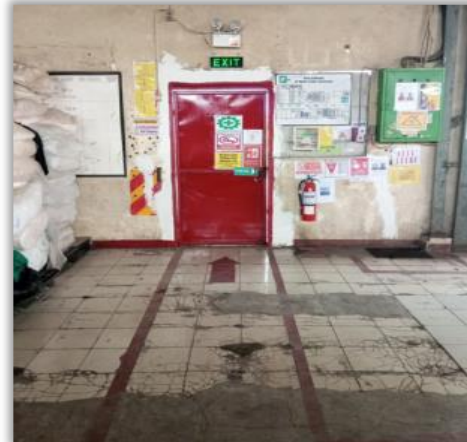
Emergency Pathway Secured

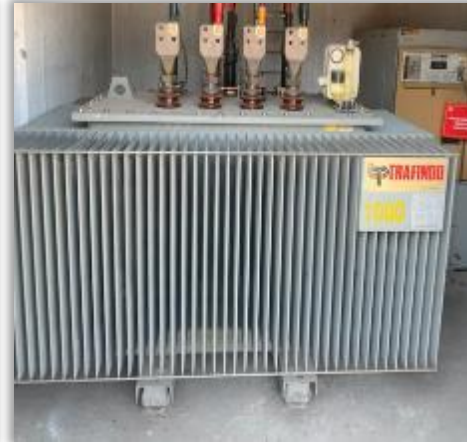
Lint and Dust Removed

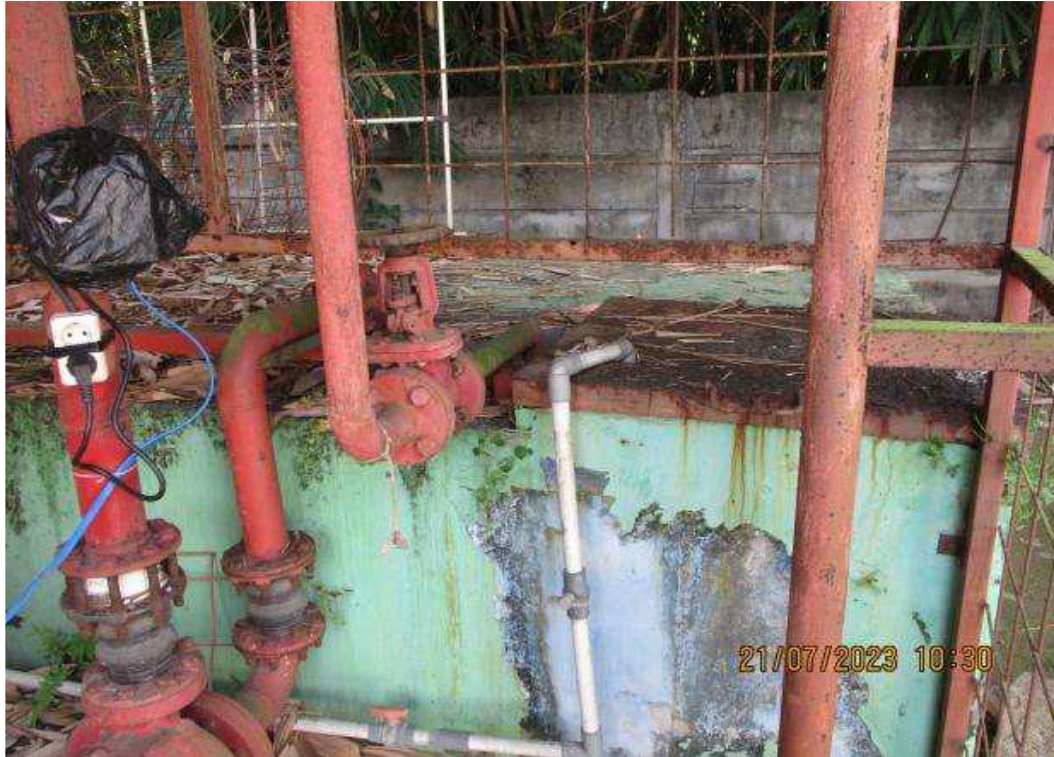
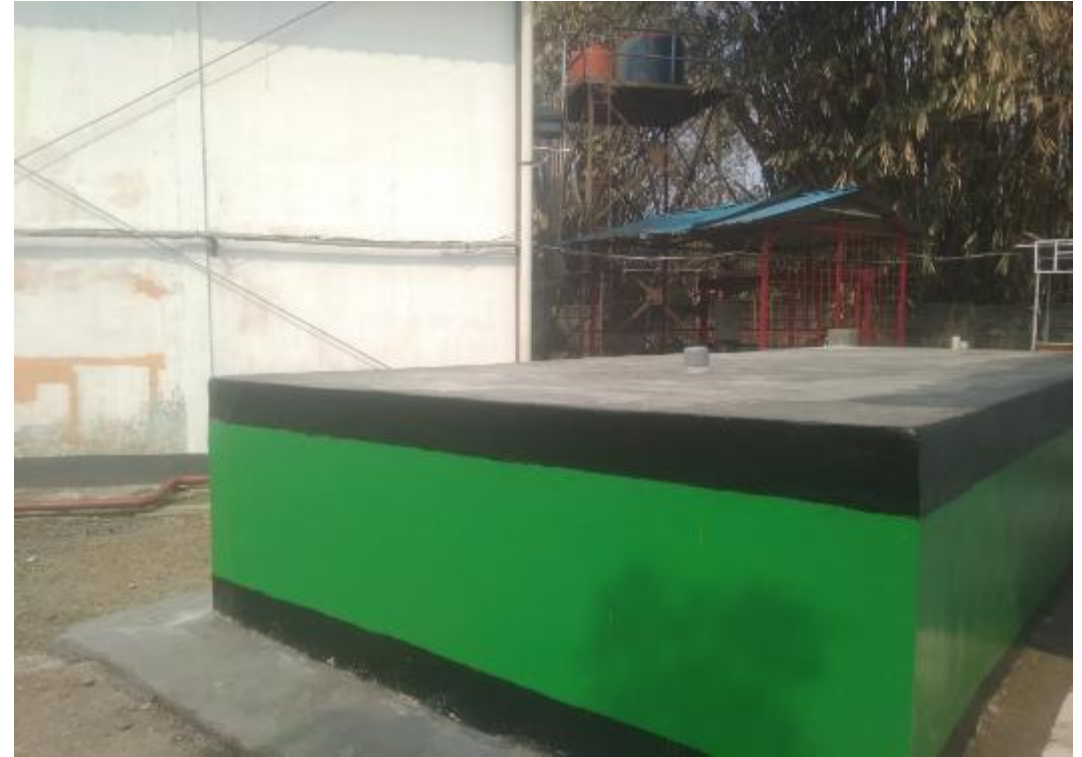
## Insufficient water storage

Fire Water requirement should be maintained

5.8.1.2

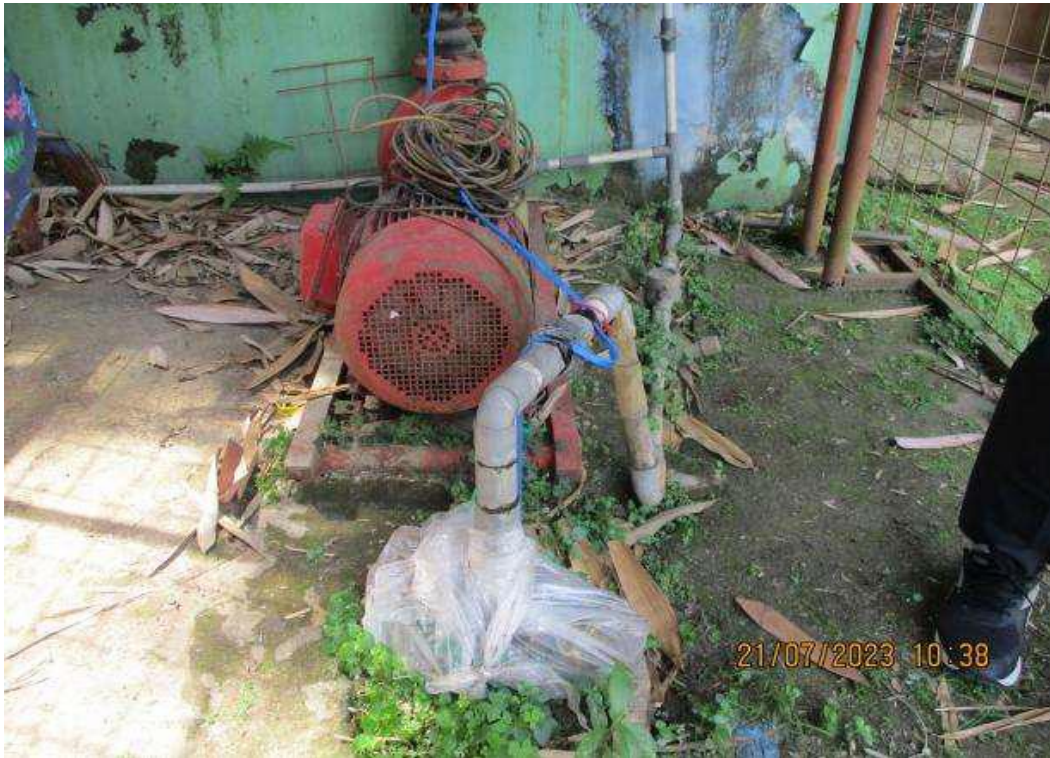
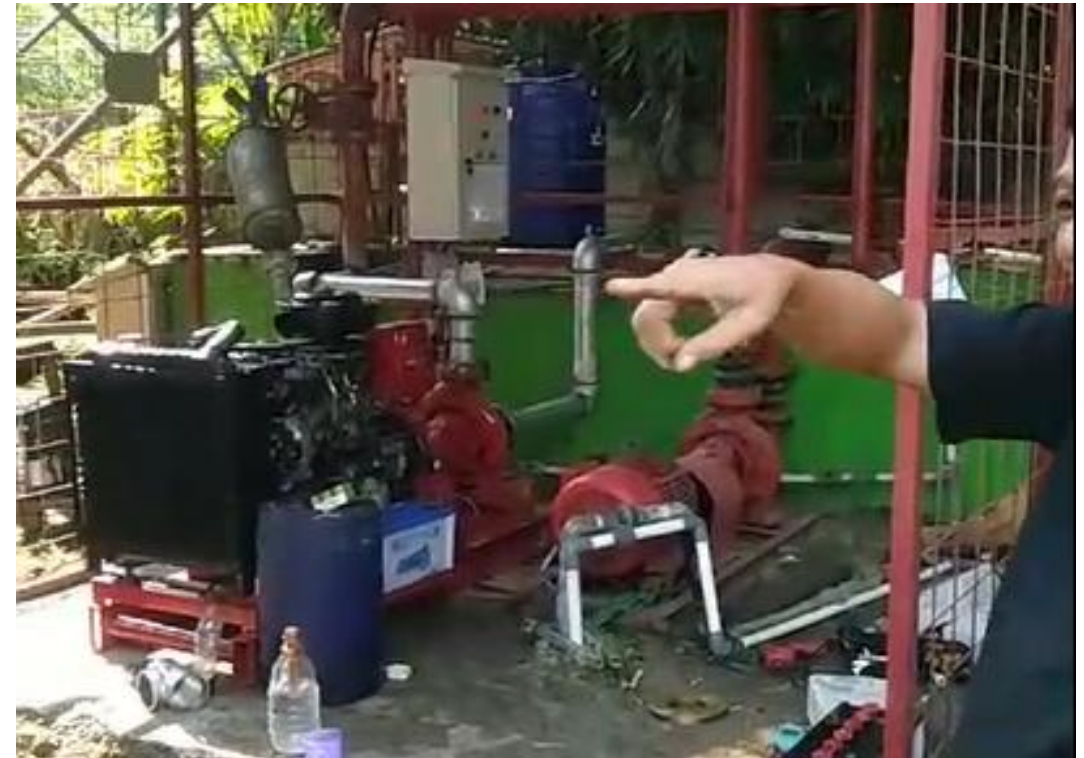
## Fire pumps

Description	LABS Standard
Provide new pumps that meet the pressure and flow capacity	5.4

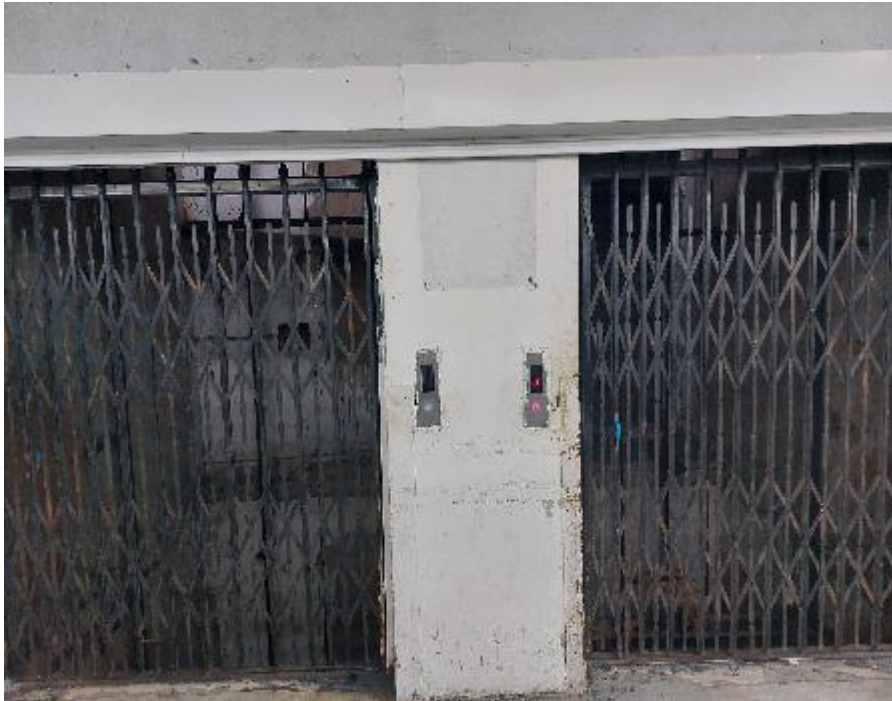
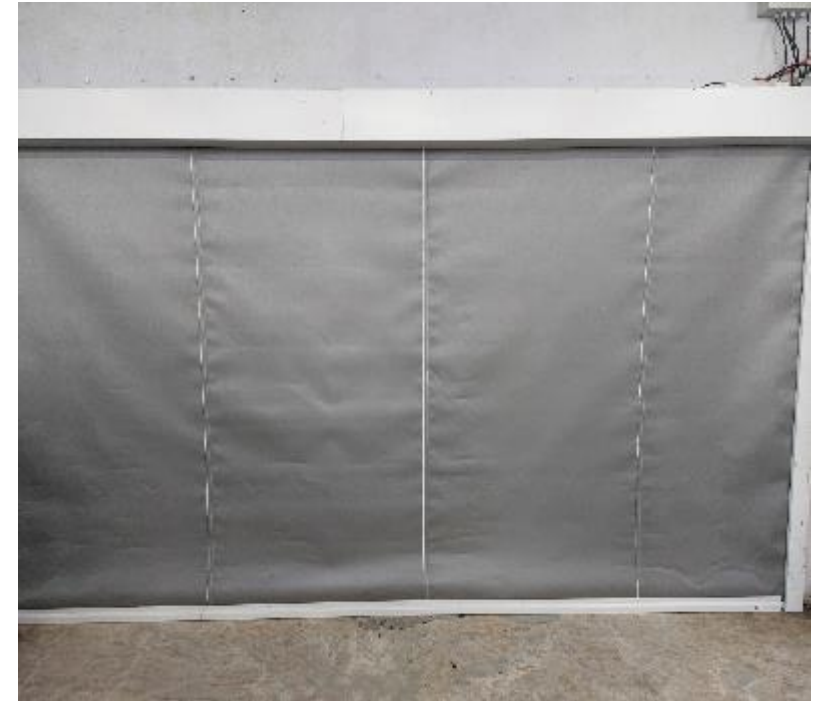
## Lift Separation

Description	LABS Standard
Openings through floors shall be enclosed with fire barrier walls	4.10.1

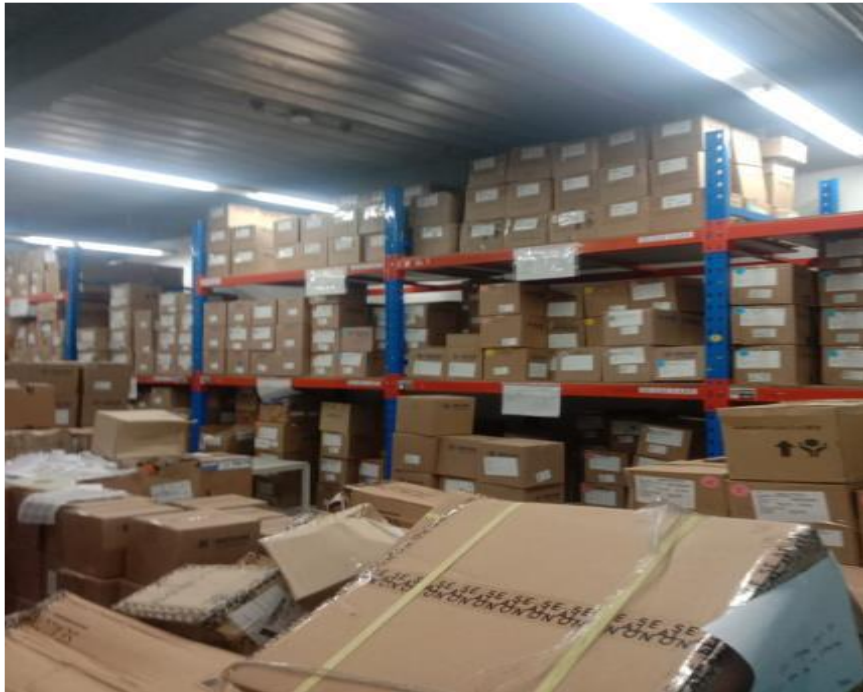
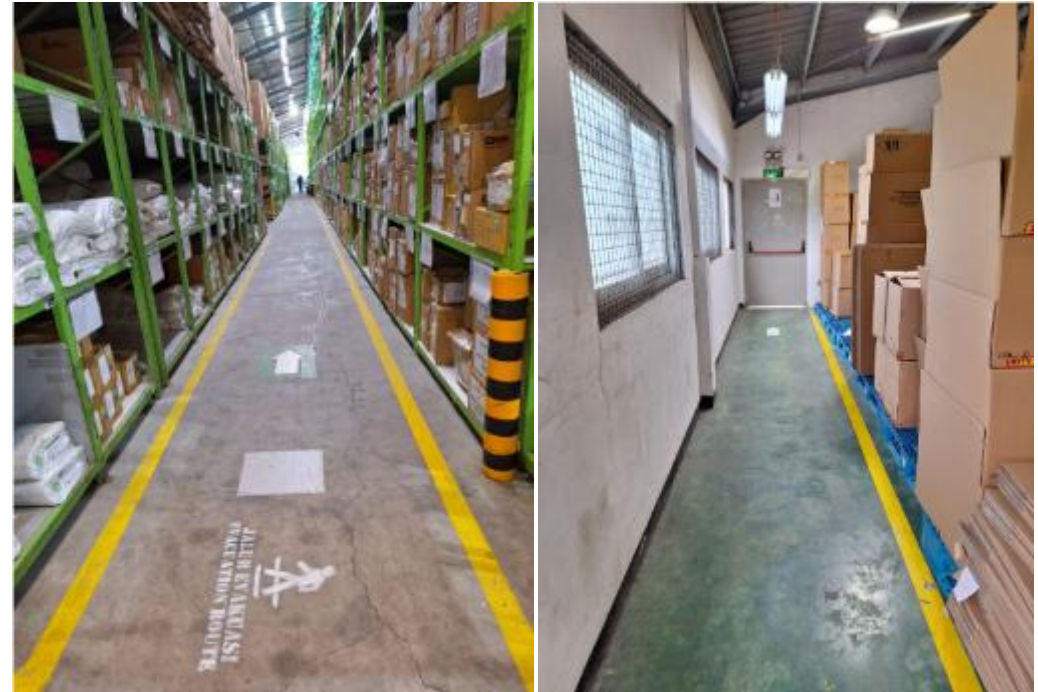
## Means of Escape

Description	LABS Standard
No furnishings, decorations, or other objects shall obstruct exits and access to exits	6.3.9
A means of escape shall be a continuous and unobstructed way of exit travel from any point	6.1.1

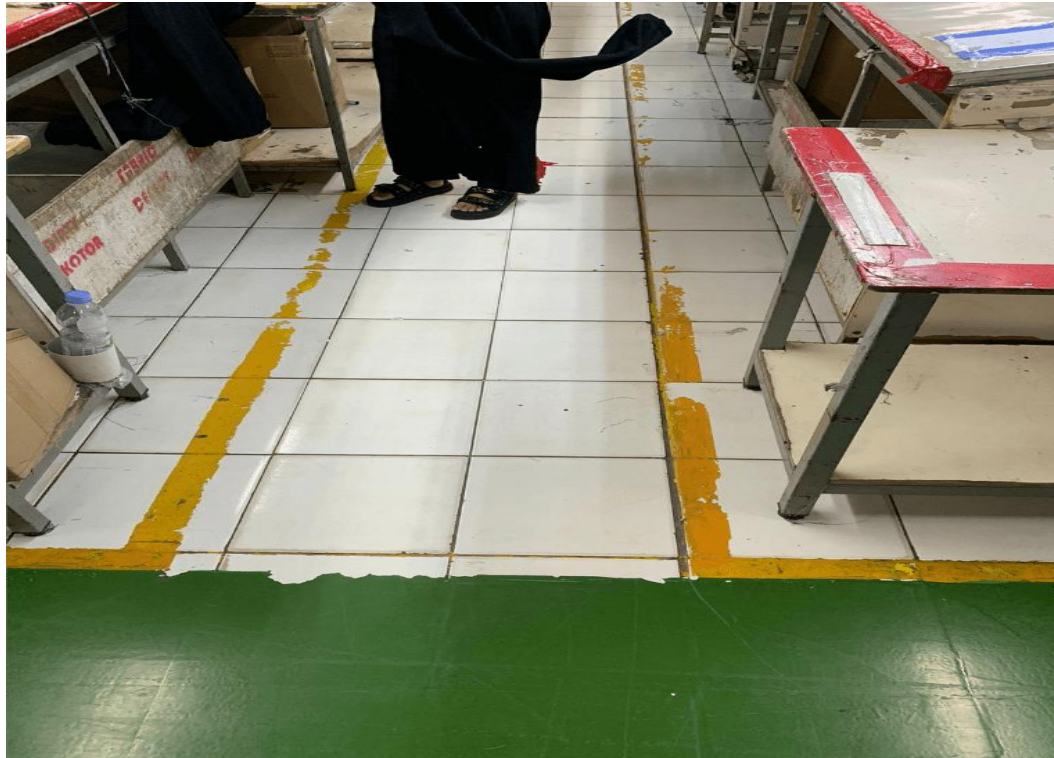
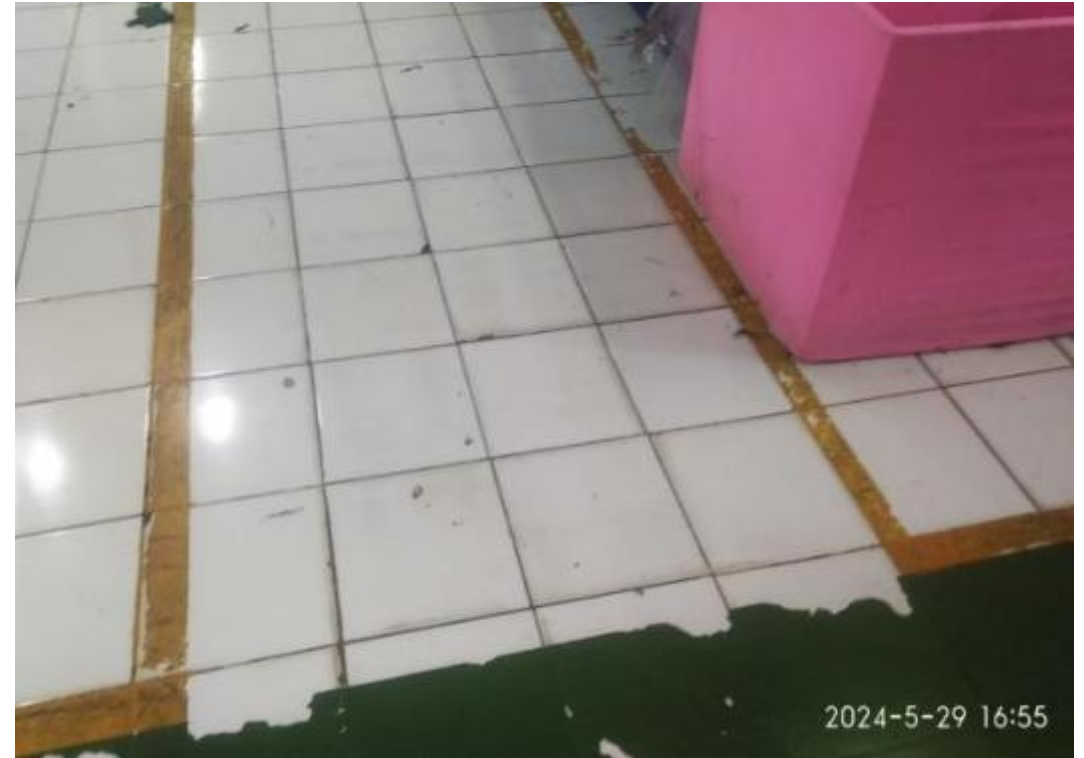
## Means of Escape

Aisles shall be provided with a minimum unobstructed clear-width of 915mm.

6.5.6.1

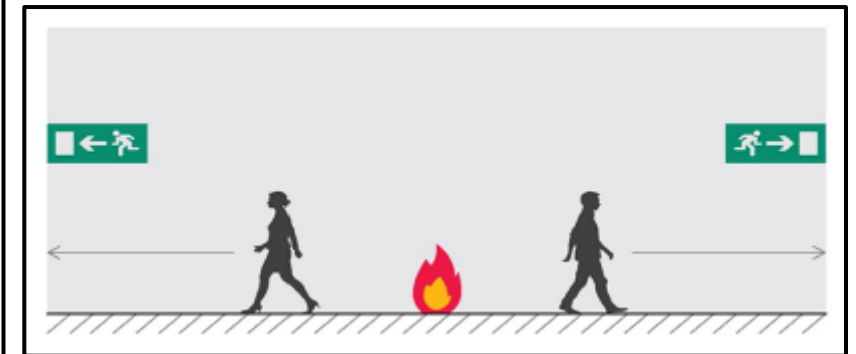
**Table 6.7 Common path, Dead-End and Travel Distance Limits (by occupancy)**

Travel distance to reach an exit for new or existing building shall not be exceed the values listed as below

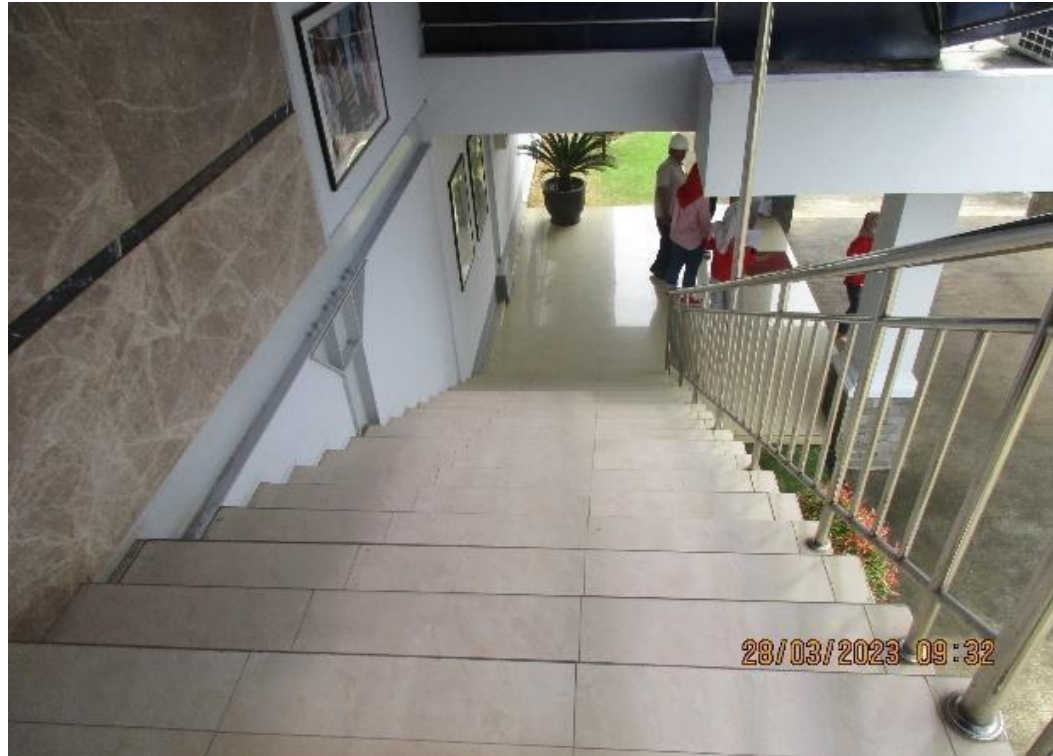
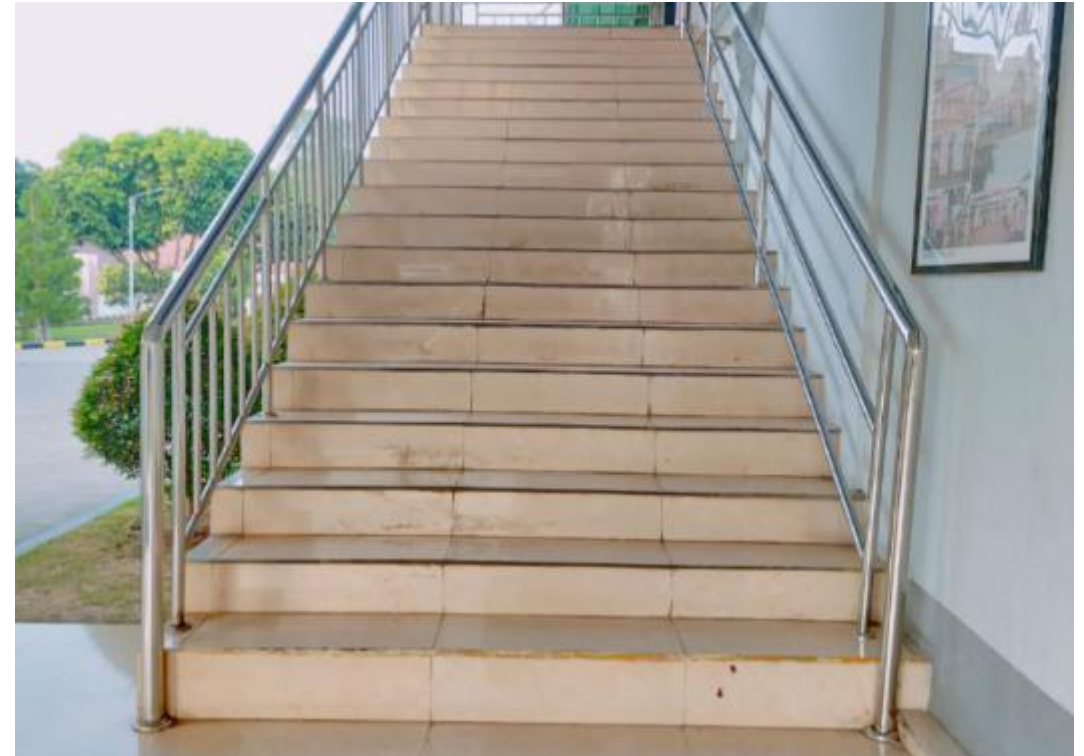
## Means of Escape

Handrails shall be provided on both sides of each stairway

6.10.8

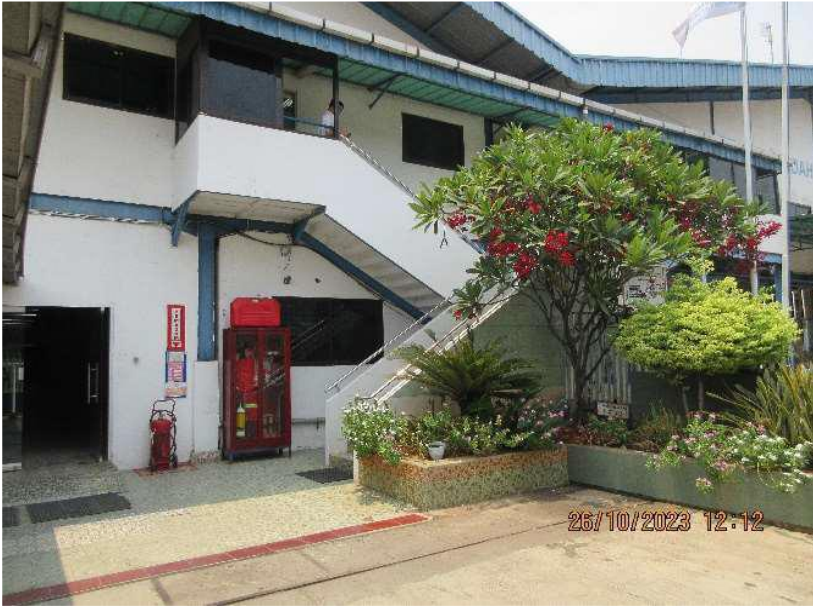
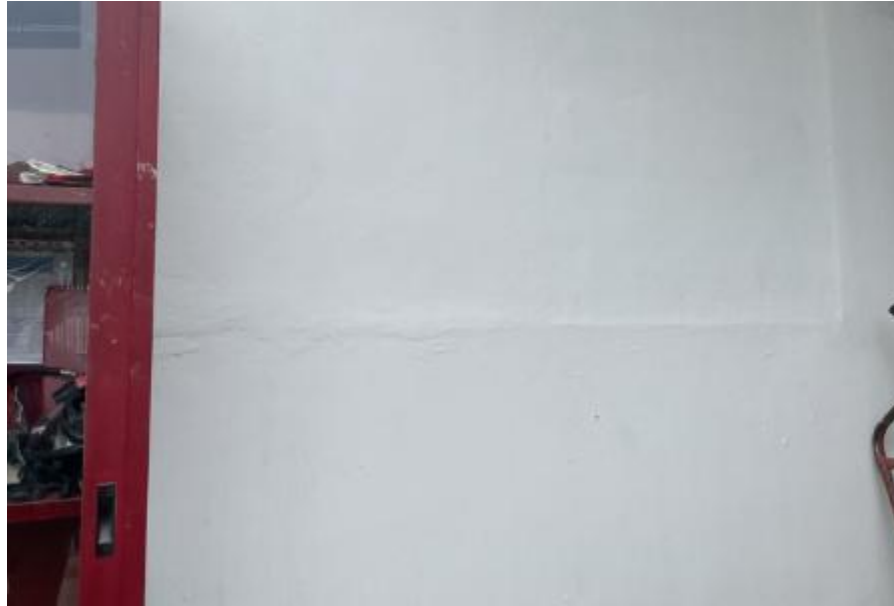
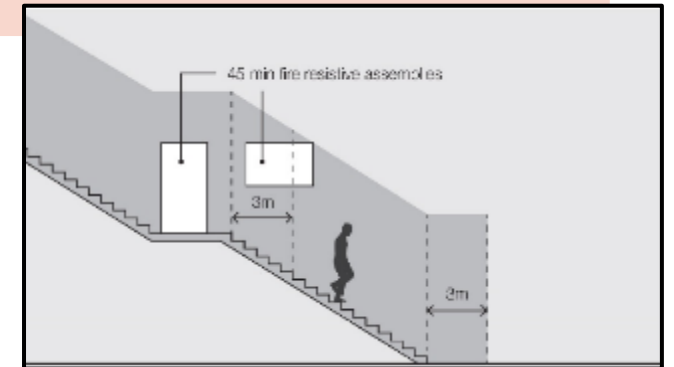
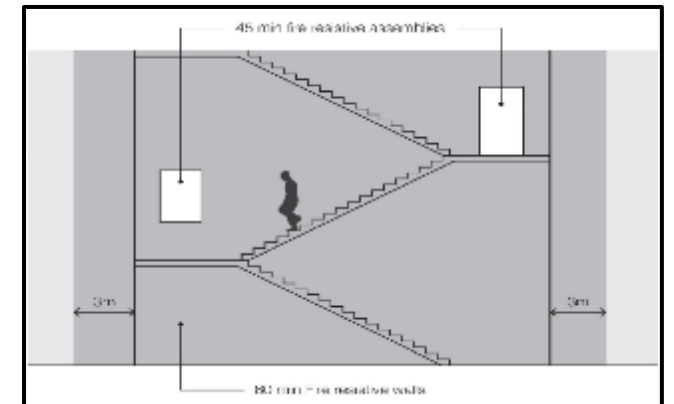
## Means of Escape

Exterior exit stairs shall be separated from the building with Exits connecting three or fewer stories shall be enclosed with a minimum 1-hr fire-resistance rating. The rating of the exterior wall shall extend 3.0 m beyond the ends of the stair structure

6.3.1.3

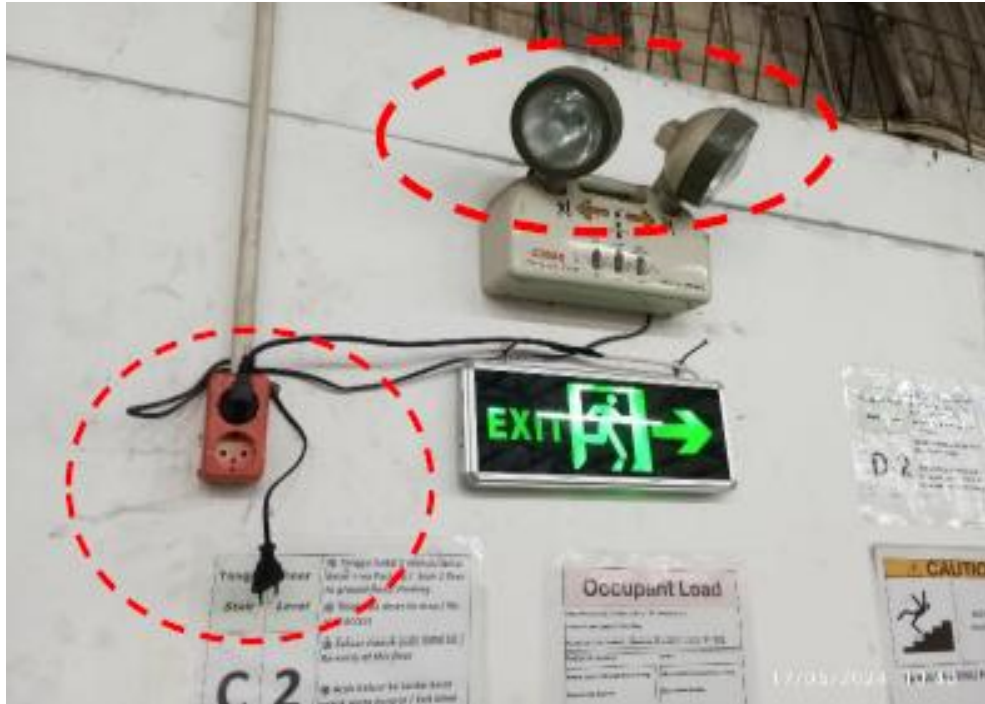
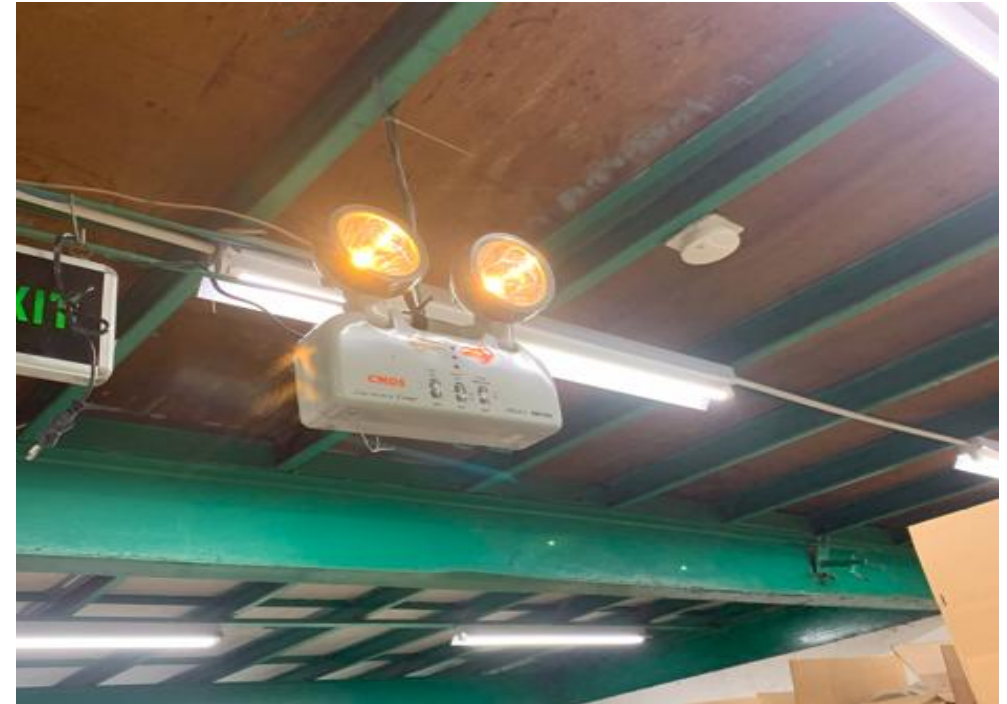
## Means of Escape

All paths of egress shall be provided with illumination, Emergency illumination shall be provided for not less than 90 minutes in the event of failure of normal lighting

6.8

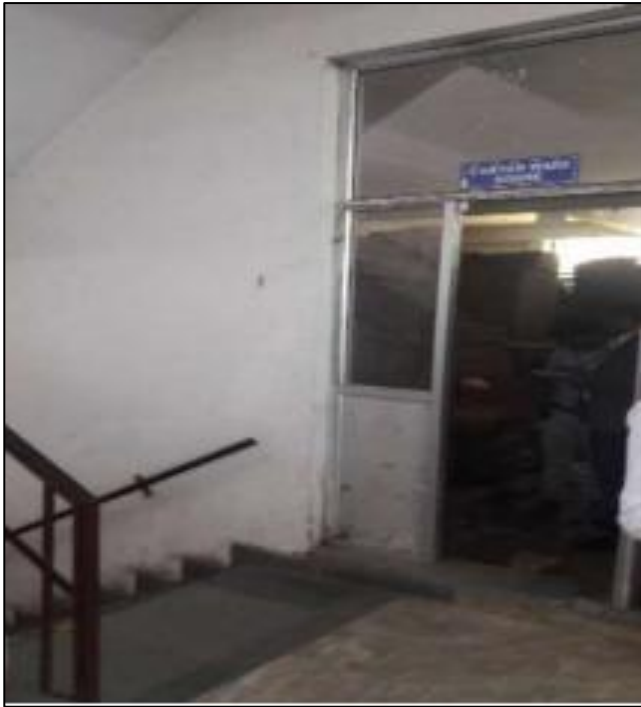
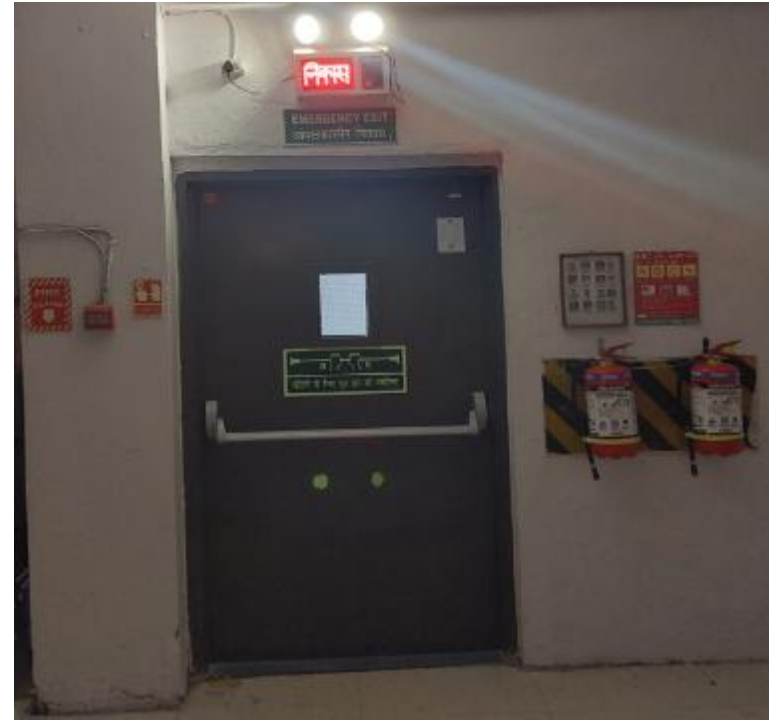
## Fire Safety Construction

Description	LABS Standard
Provide fire rated protective enclosures to the exit stairs	4.8, 4.10 ,6.14

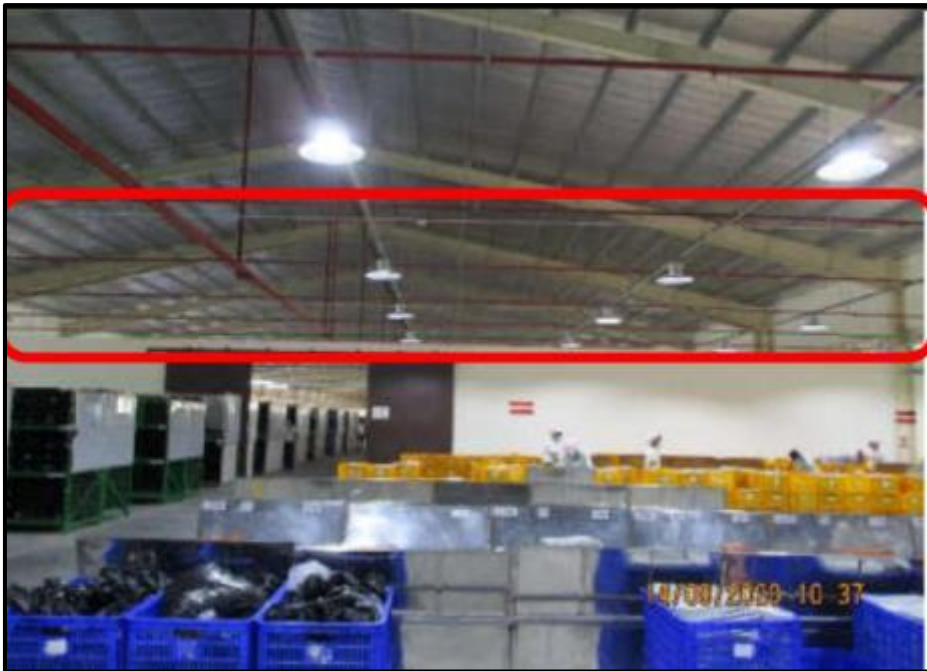
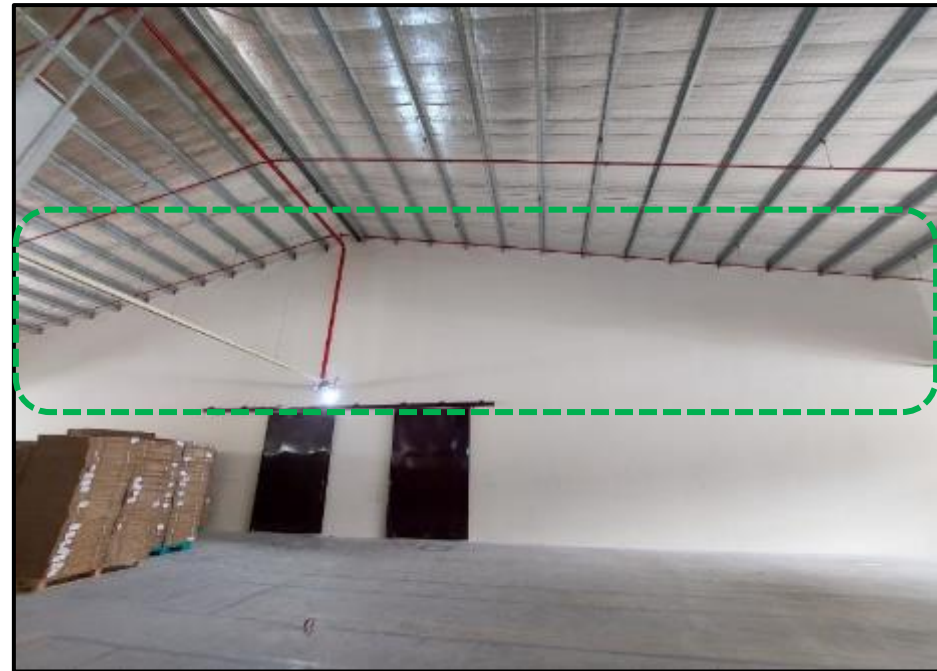
## Fire Safety Construction

Description	LABS Standard
Separate storage areas from adjacent areas by means of 1-hour fire rated construction	3.10 & 3.11

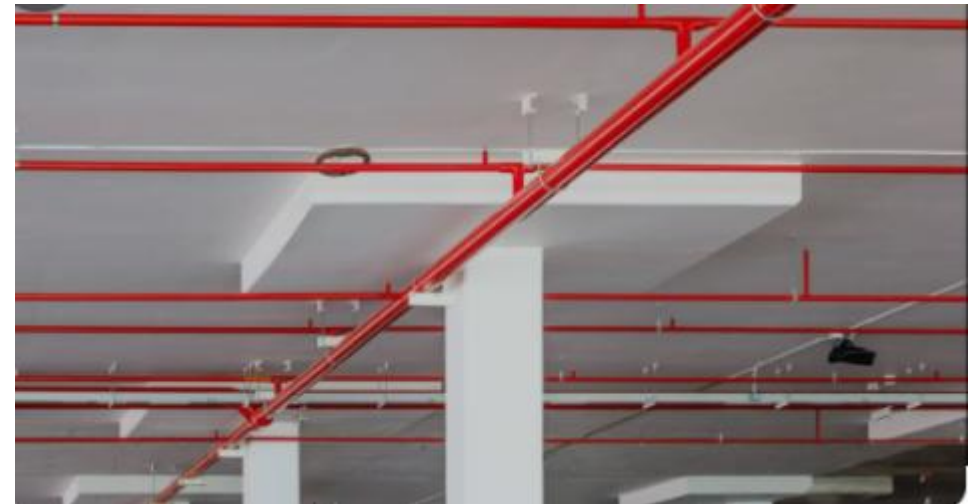
## Fire Safety Construction

Separate storage areas from adjacent areas by means of 1-hour fire rated construction

3.14.3

Alternative Option  
Drencher System Installing

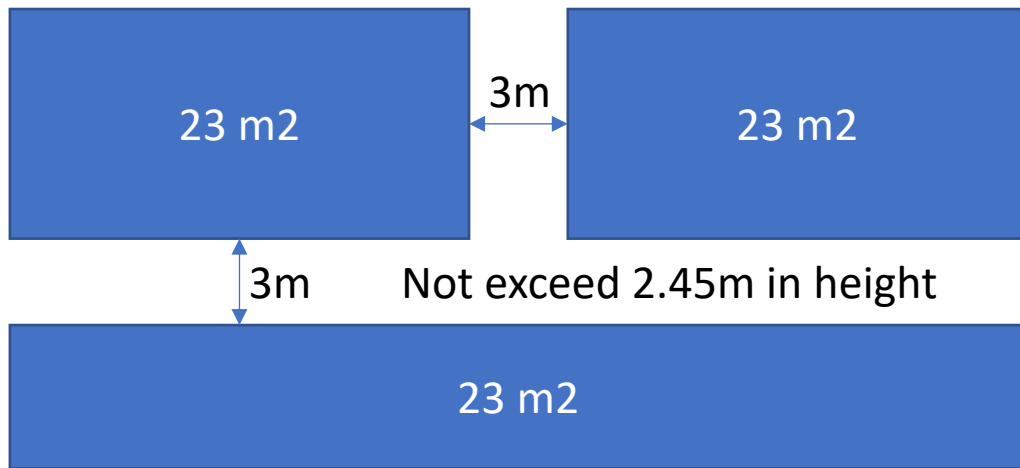
Non-Sprinkler area

Description	LABS Standard
in-process temporary storage arrangement for non-sprinklered areas material should be stored as per LABS compliance	3.14.11
