**LABS**  
Life And Building Safety

**LABS - GOOD PRACTICES SHARING**

**March 2025**

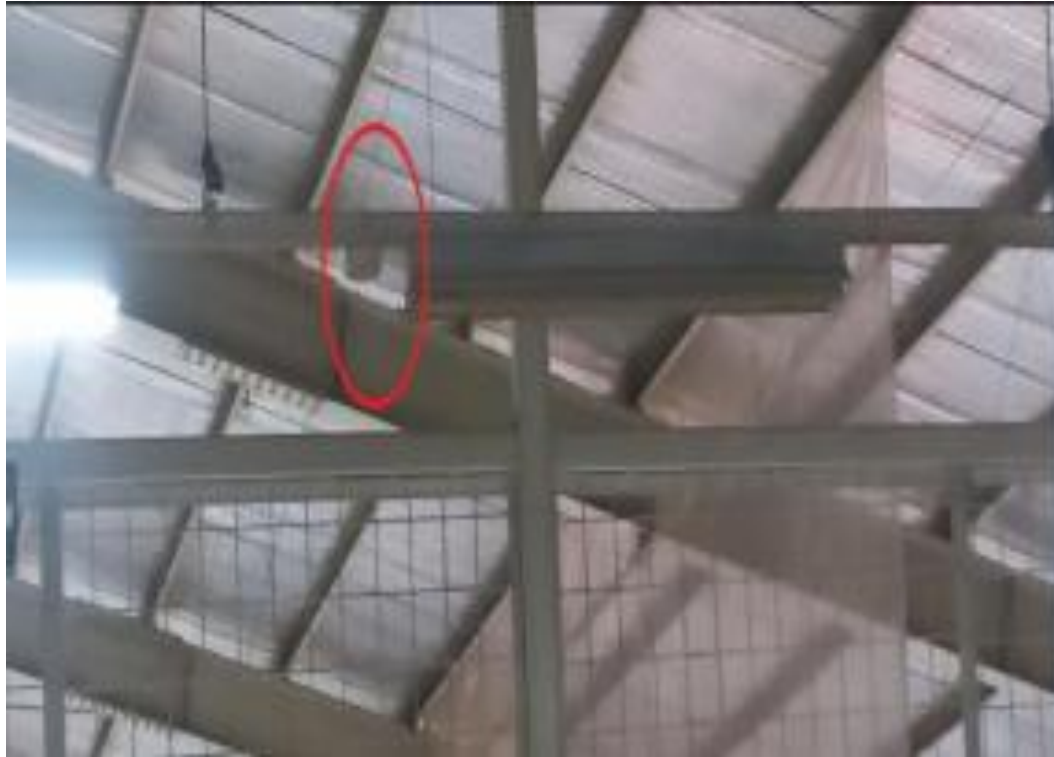
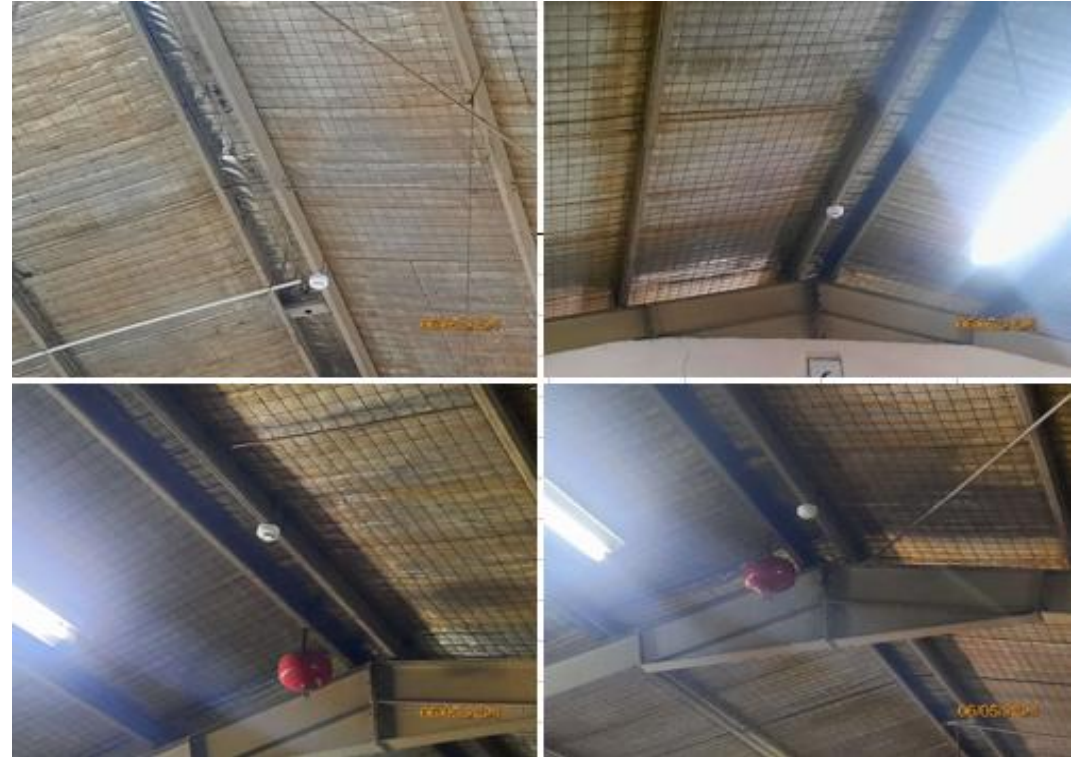
## Fire Safety Systems

Description	LABS Standard
Automatic and manual fire alarm and detection systems shall be provided throughout all new and existing buildings, regardless of occupancy type	5.9.3

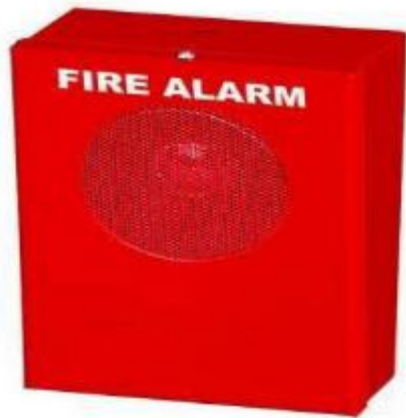
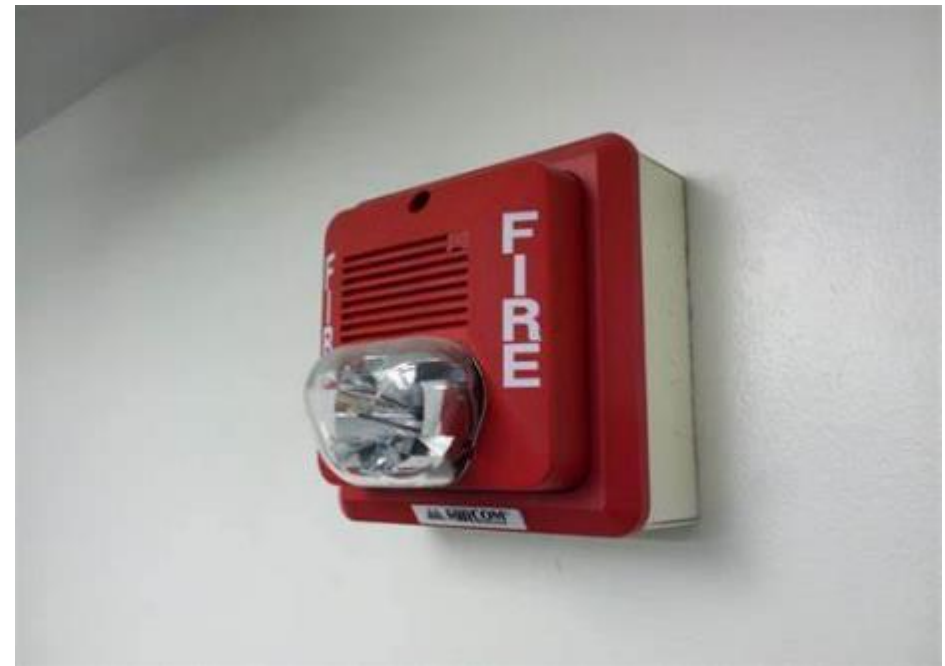
## Fire Safety Systems

Description	LABS Standard
<p>Test decibel levels of alarm sounders in all areas. Add sounders for all areas where the alarm decibel level is not sufficient. Hooter Cum strobe installation is recommended.</p> <p><b>Note: Minimum sound level usually around 65dB throughout the building but importantly 5dBA above any background noise</b></p>	5.9

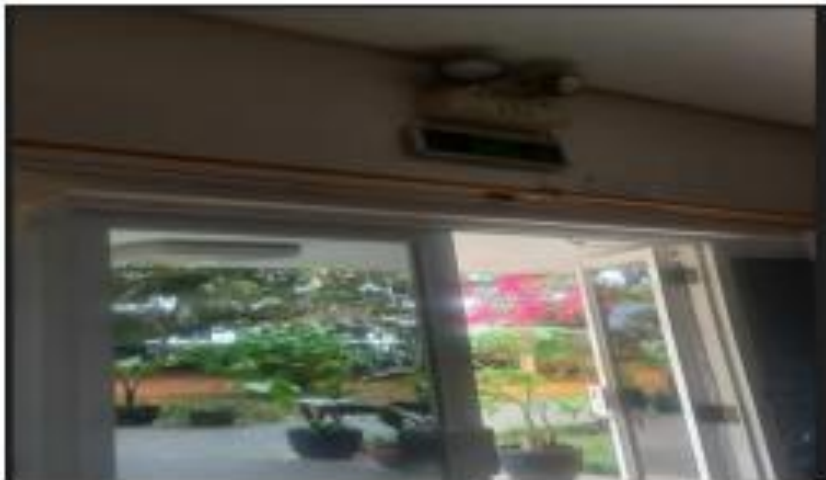
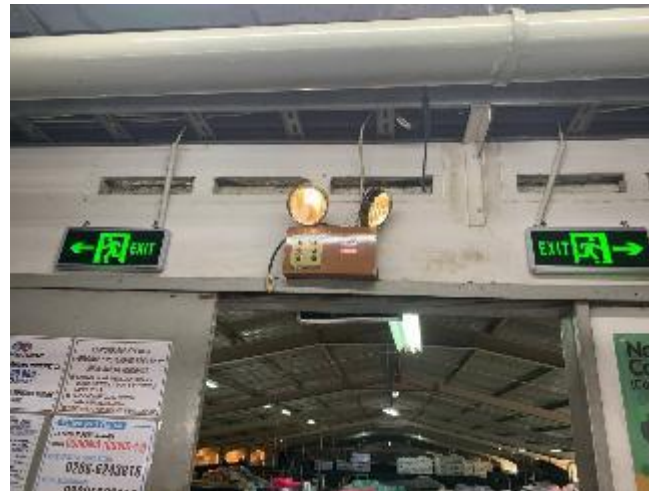
## Fire Safety Systems

Emergency illumination shall be provided for not less than **90 minutes** in the event of failure of normal lighting. Emergency lighting facilities shall be arranged to provide initial illumination that is not less than an average of 10.0 lux (lumen/m<sup>2</sup>)

**Escape lighting luminaires should be sited to cover the following locations:**

- Near each intersection of corridors
- At exits and at each exit door
- Near each change of direction in the escape route
- Near each staircase so that each landing of stairs receives direct light
- Near any other change of floor level
- Outside each final exit and close to it
- Near each fire alarm call point
- Near firefighting equipment

For the purpose of above clause 'near' is normally considered to be within 2m measured horizontally.

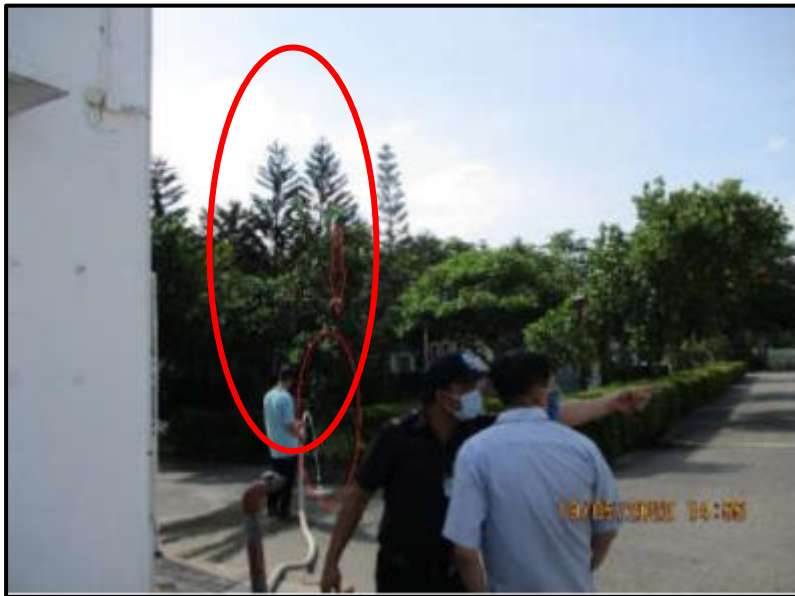
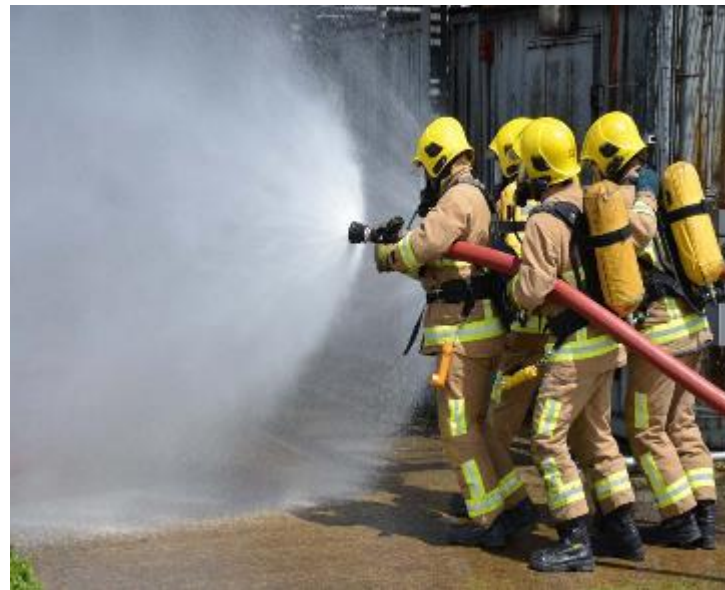
## Provisions for Fire Fighting

Provide adequate fire water pumps and water storage tanks with capacity required by Cl.5.7 of the LABS standards.

Comprehensive fire hydrant and wet riser system (fully charged at the rated pressure and pumps maintained on Auto mode at all times) designed and installed as per TAC rules/

Diesel driven and electrical (with independent power supply) standby pump and jockey pump to be provided. (Chart of jockey, main and standby pumps cut-in and cut-off pressures should be displayed in the pump room)

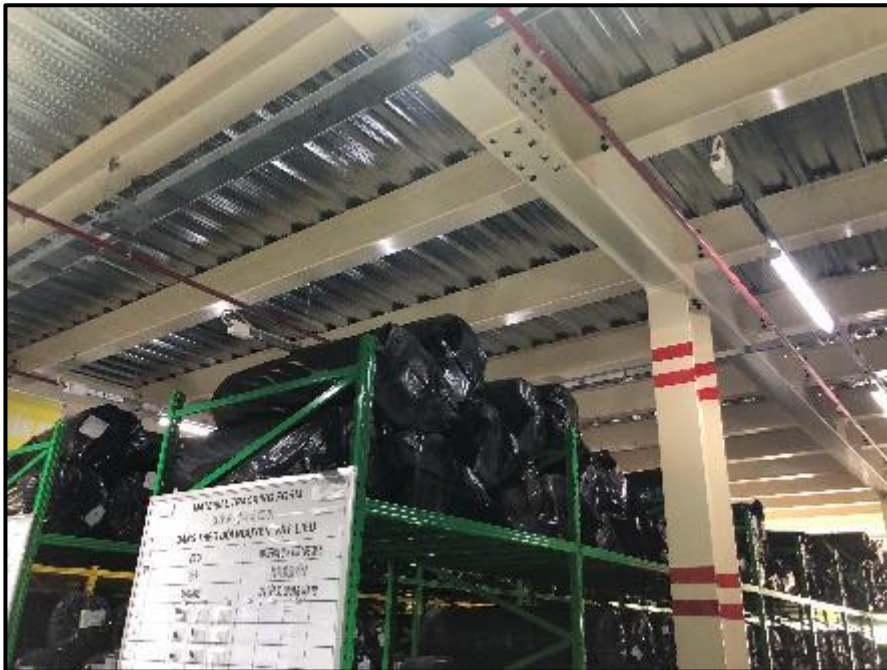
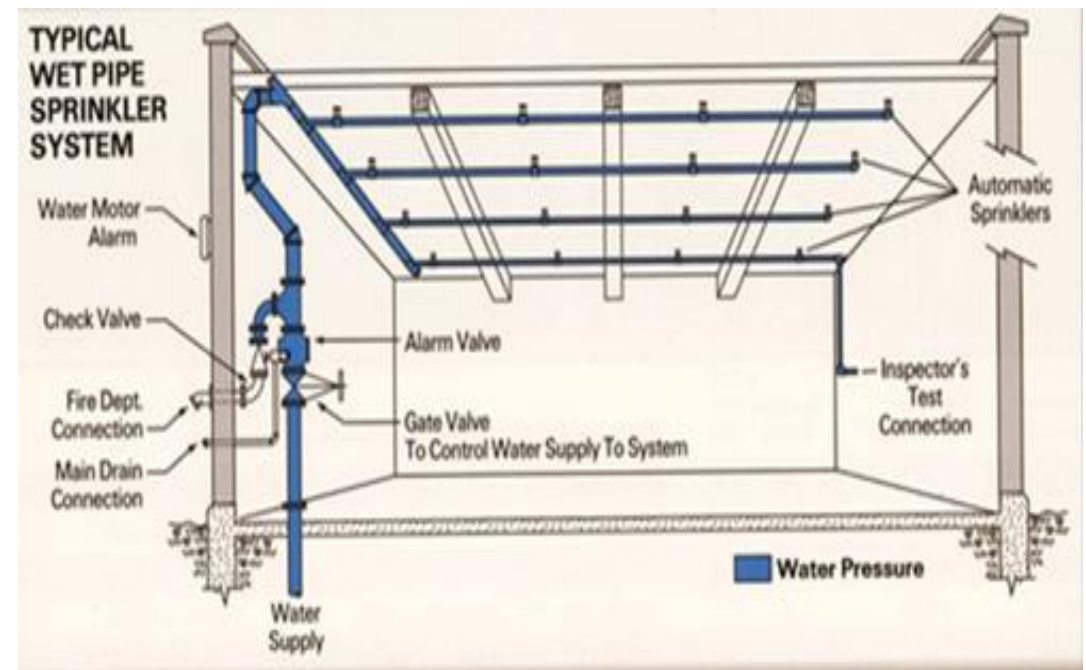
## Provisions for Fire Fighting

To ensure the protection coverage of sprinkler for materials, all storage shall be maintained with 460 mm minimum clearance from the top of storage to sprinkler deflector. Automatic sprinklers system designed, as per TAC rules. Guidelines to be provided in all manufacturing, storage, utility and service areas, including fire pump rooms.

5.3.8

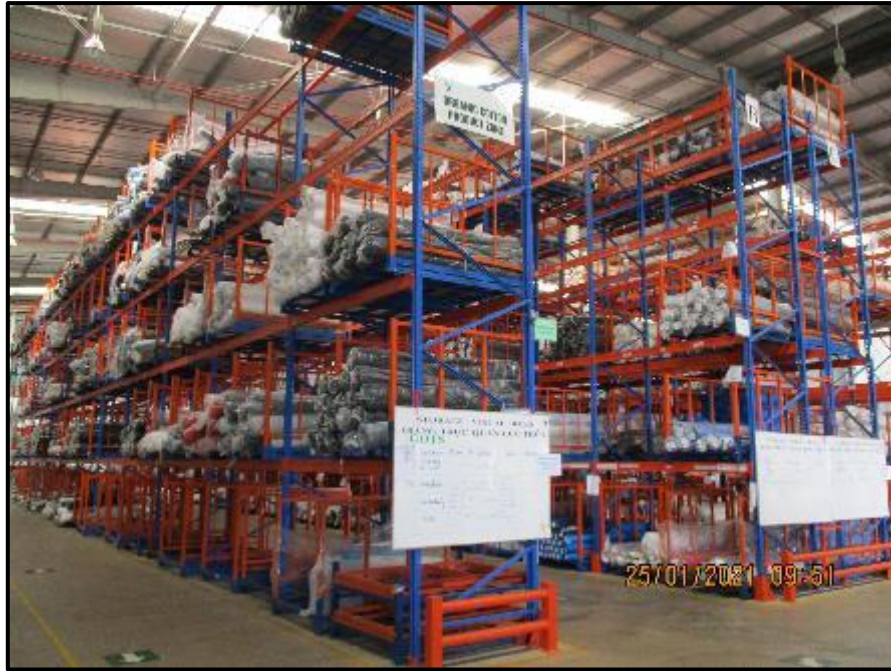
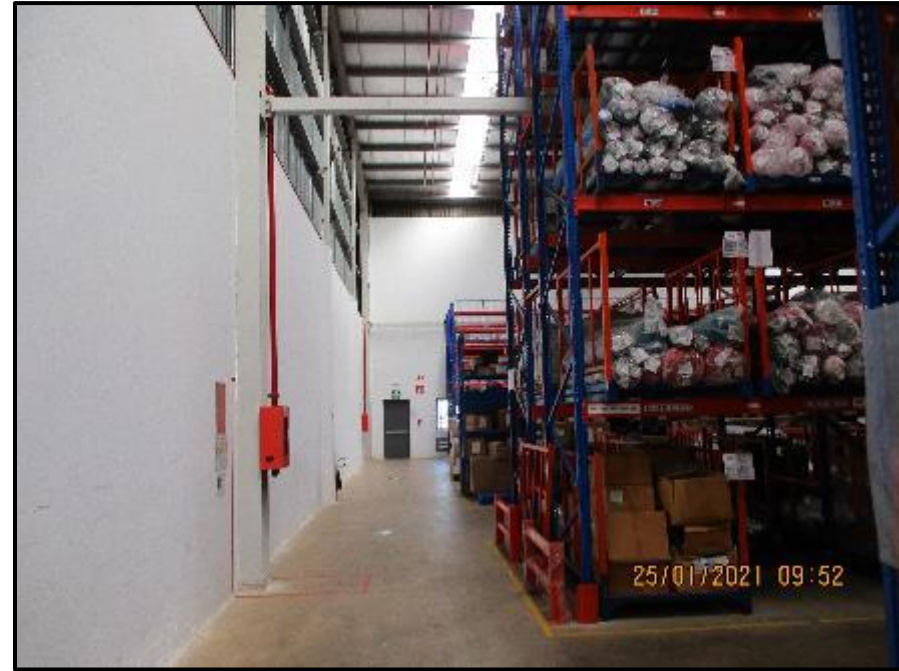
## Provisions for Fire Fighting

Description	LABS Standard
Unless in-rack automatic sprinklers have been designed and installed, solid shelf racking shall not be used	5.3.8.2

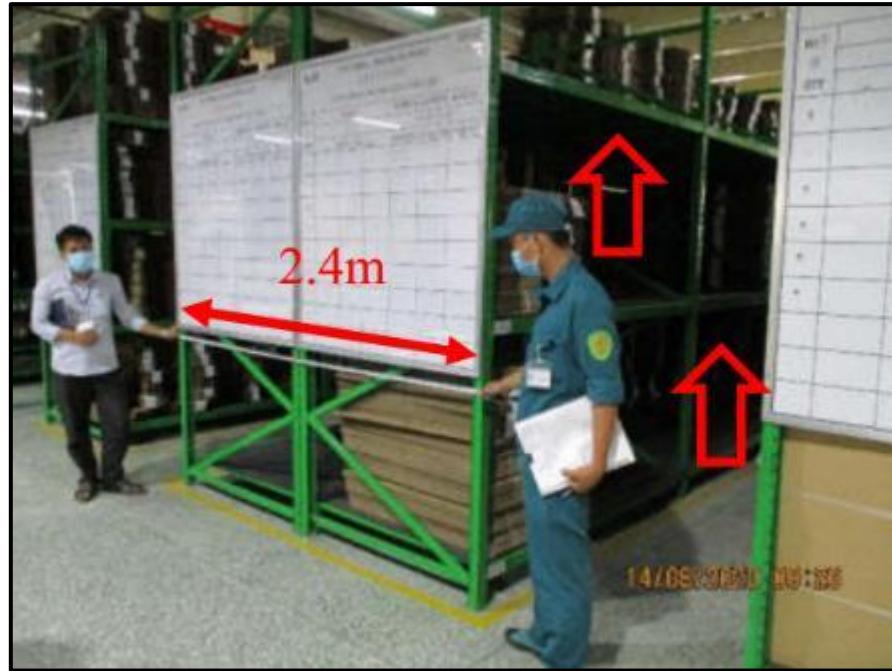
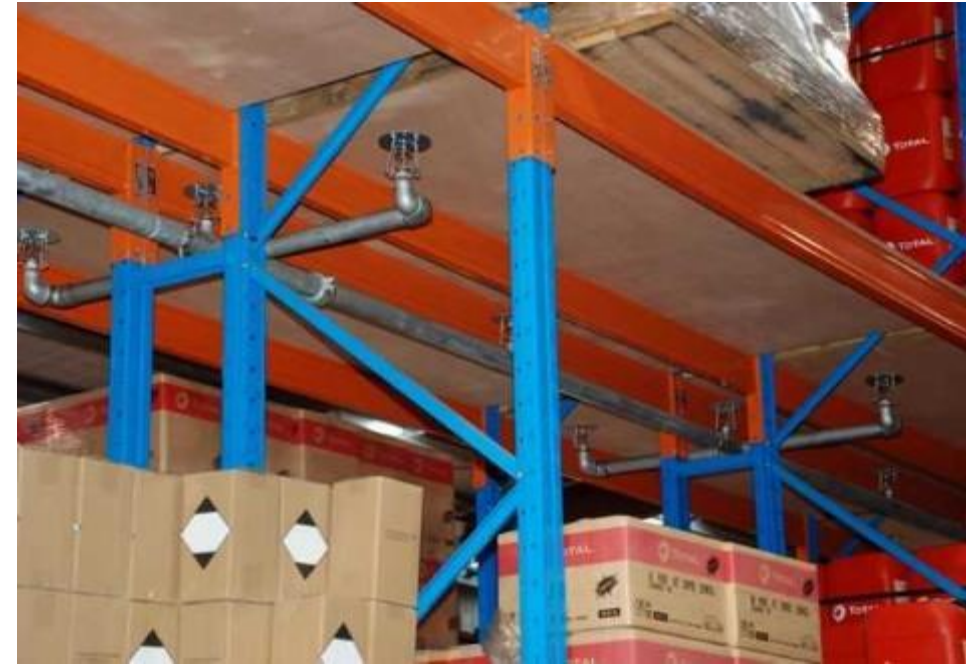
## Provisions for Fire Fighting

Description	LABS Standard
Unless in-rack automatic sprinklers have been designed and installed, solid shelf racking shall not be used	5.3.8.2

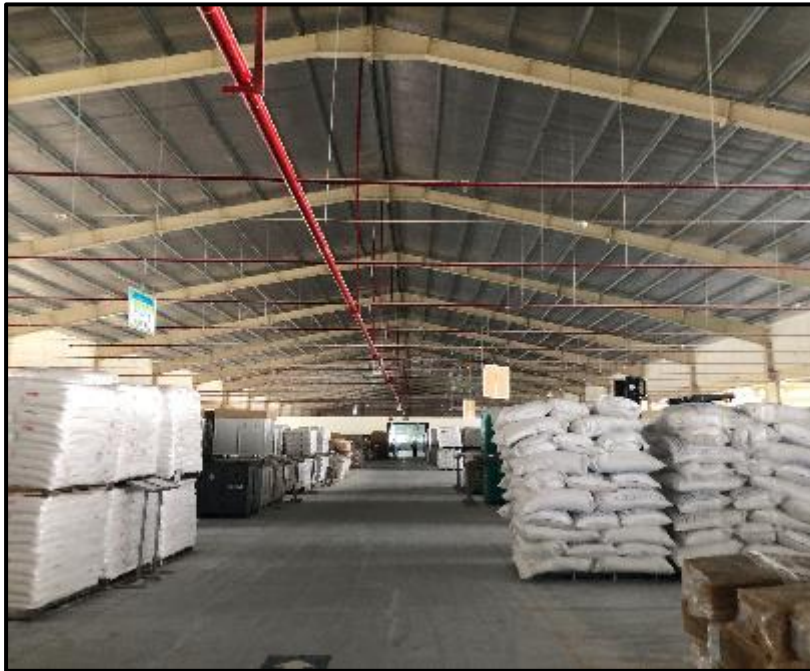
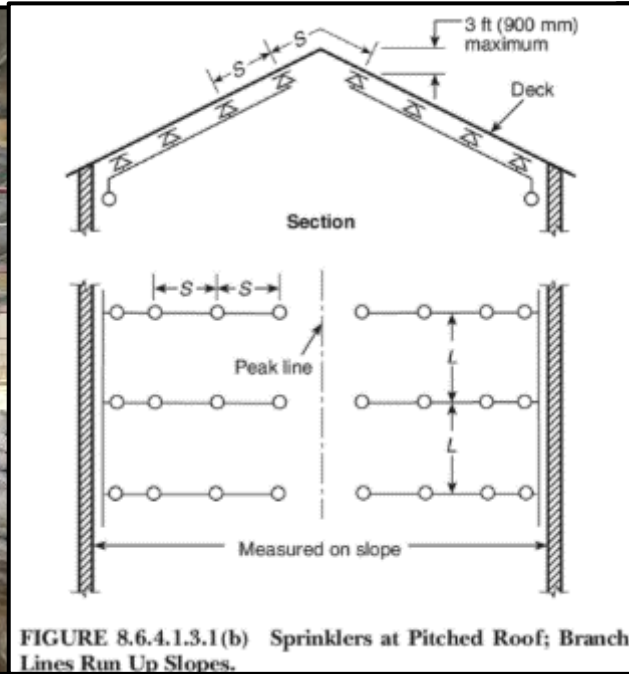
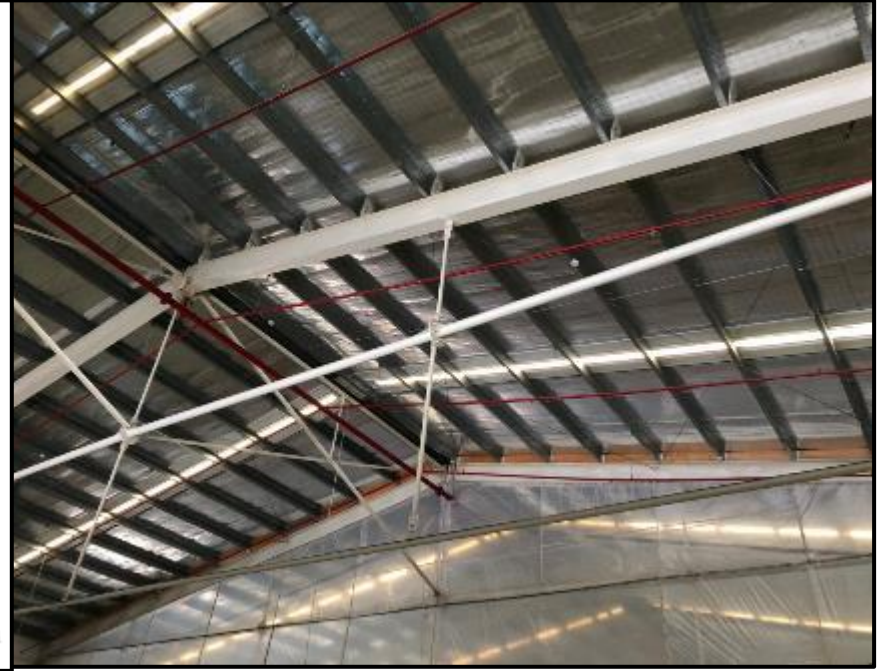
The distance between the sprinkler deflector and the ceiling shall be from 1 in. (25 mm) to 12 in. (300 mm) throughout the area of coverage of the sprinkler

5.3.4

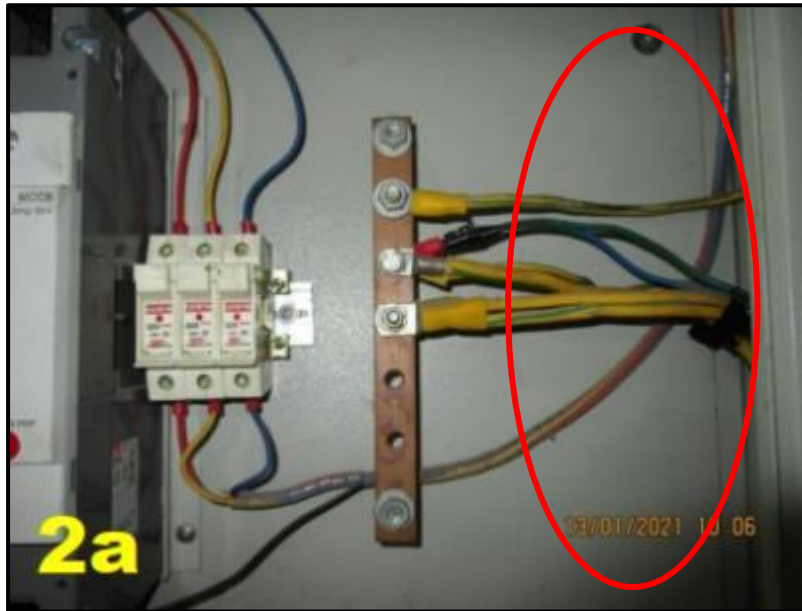
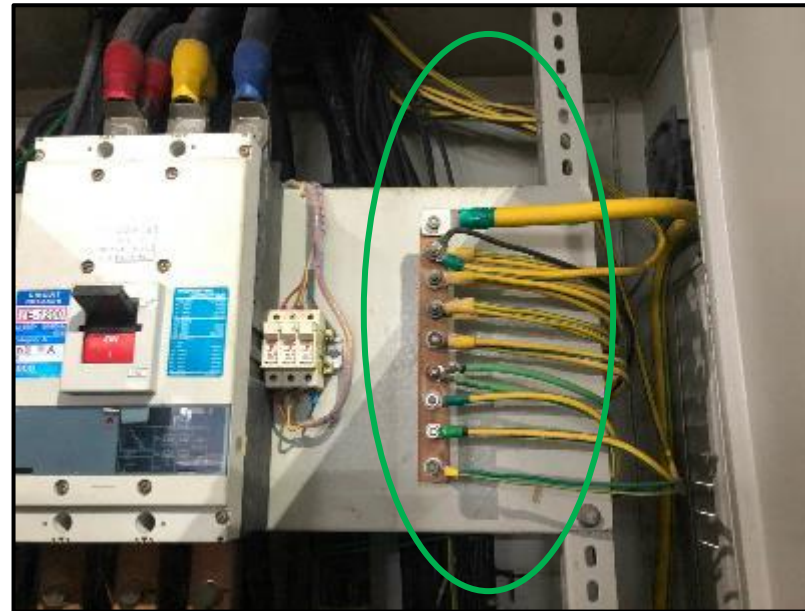
## Earthing and Bonding

Cross sectional area check of all conductors with respect to short circuit current levels e.g., cable, PE Conductor sizing calculations for short circuit current, etc.

10.25.2.2 and 10.32.1  
10.33.2.5

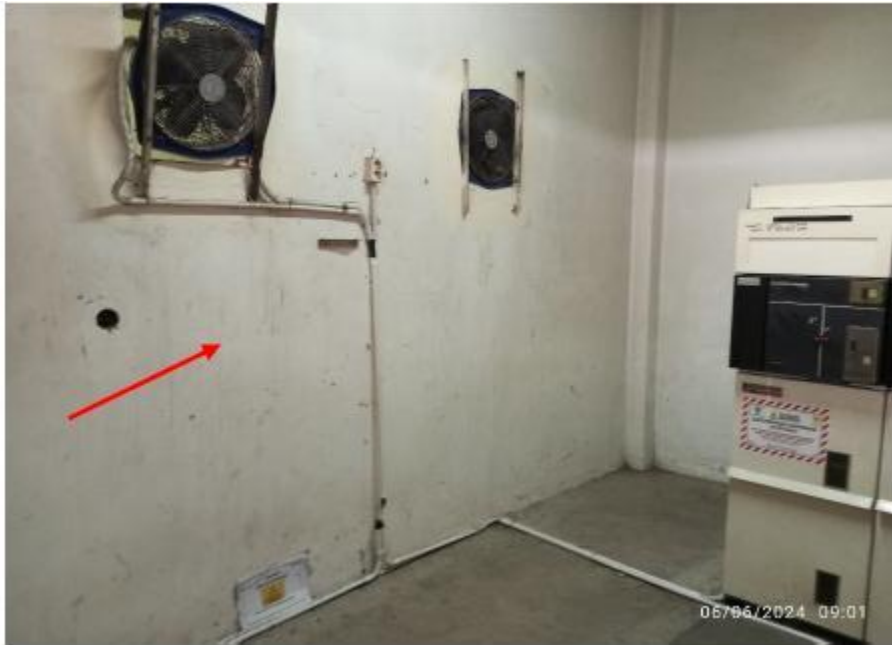
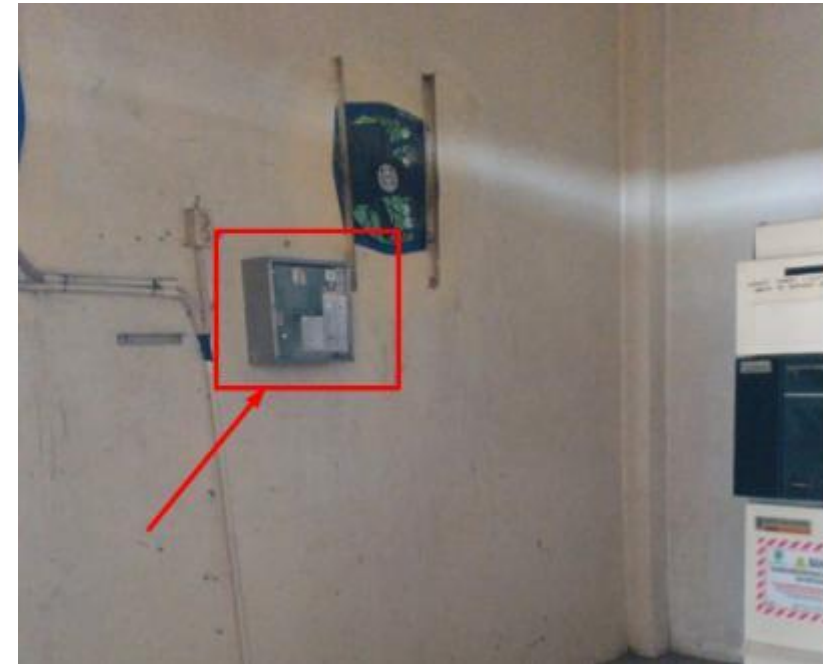
Post first aid signage and provide first aid equipment in Main distribution panel room

10.7.6

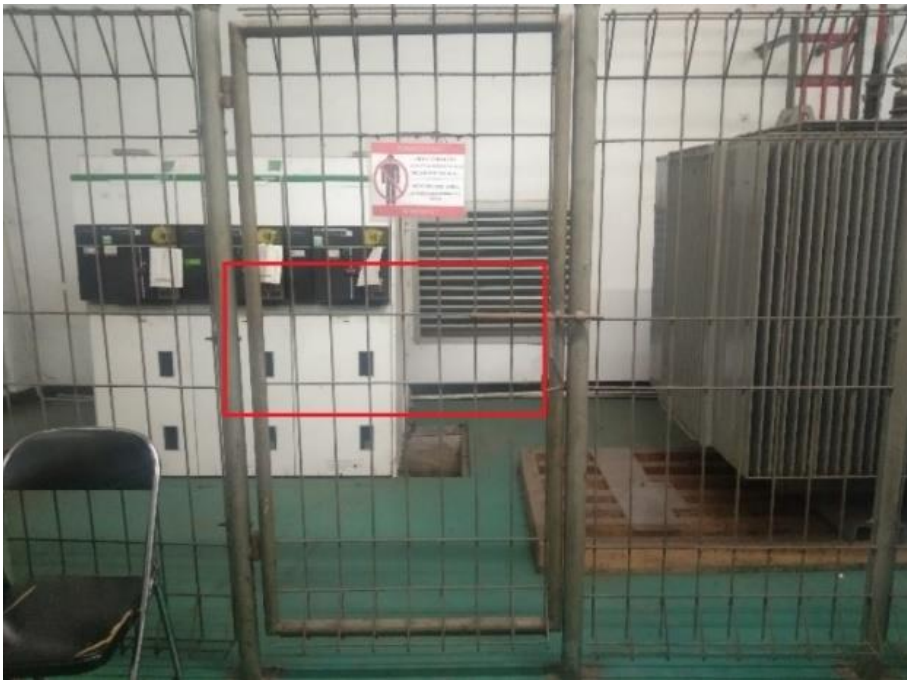
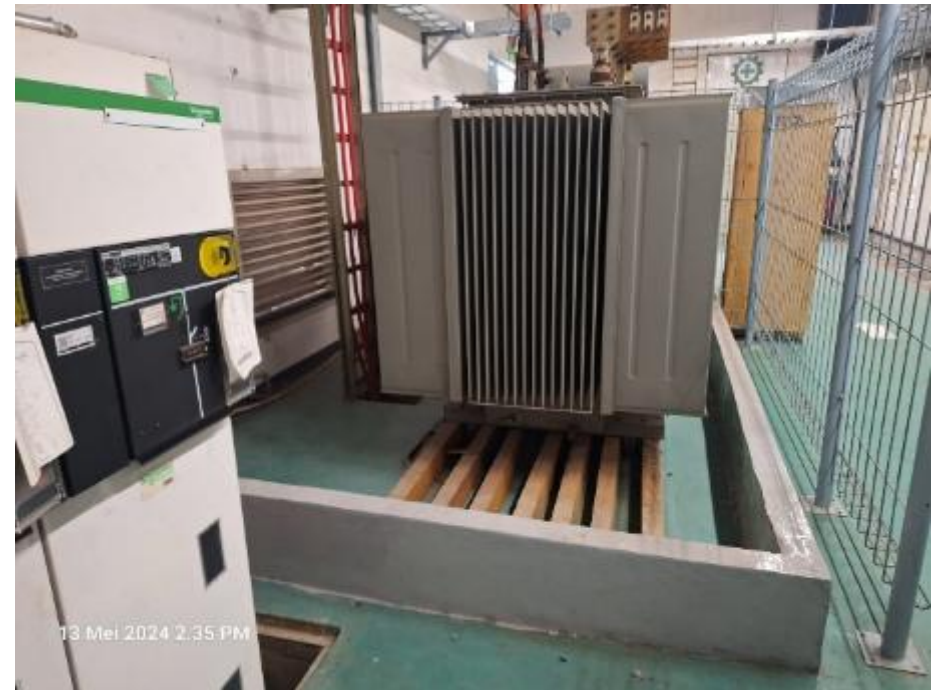
Transformers and equipment installed outdoors (having an individual or aggregate oil content of 2000 liters or more) to be located in a suitably fenced & locked enclosure separated. At least 6m from any building including substation.

10.7.7

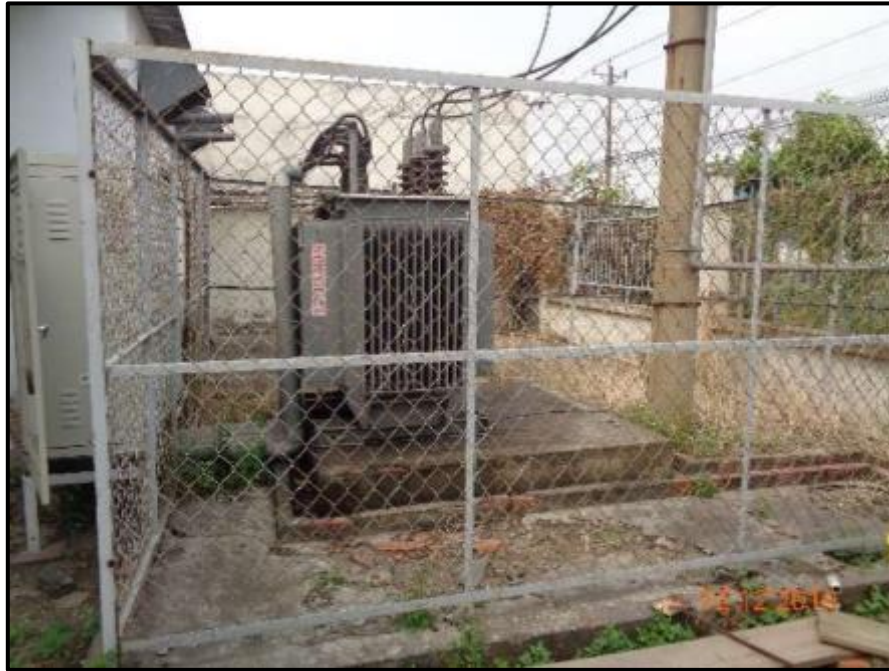
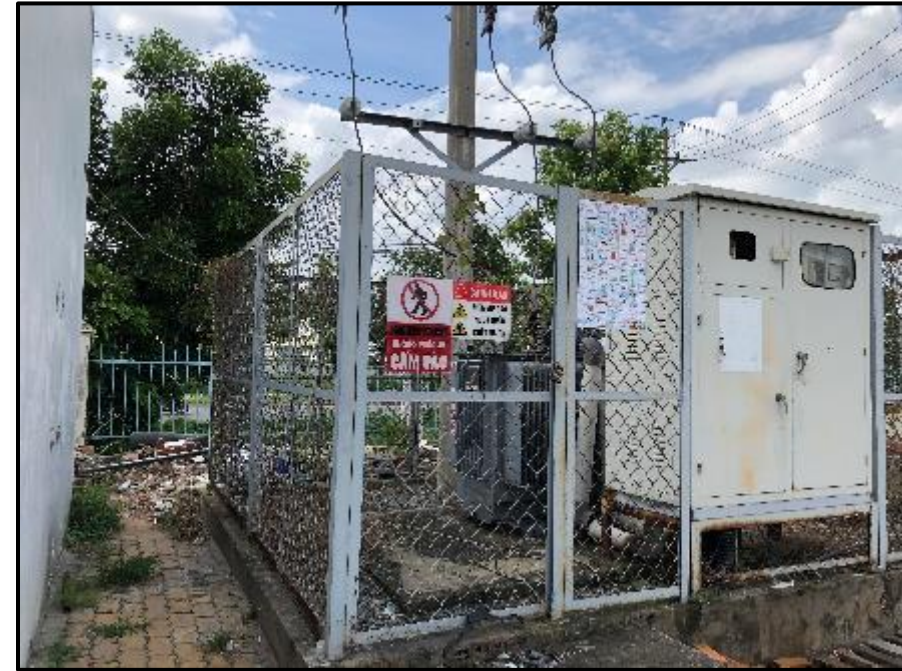
Post adequate warning/danger, voltage level signage & also it should be legible at transformer/substation areas

10.7.6

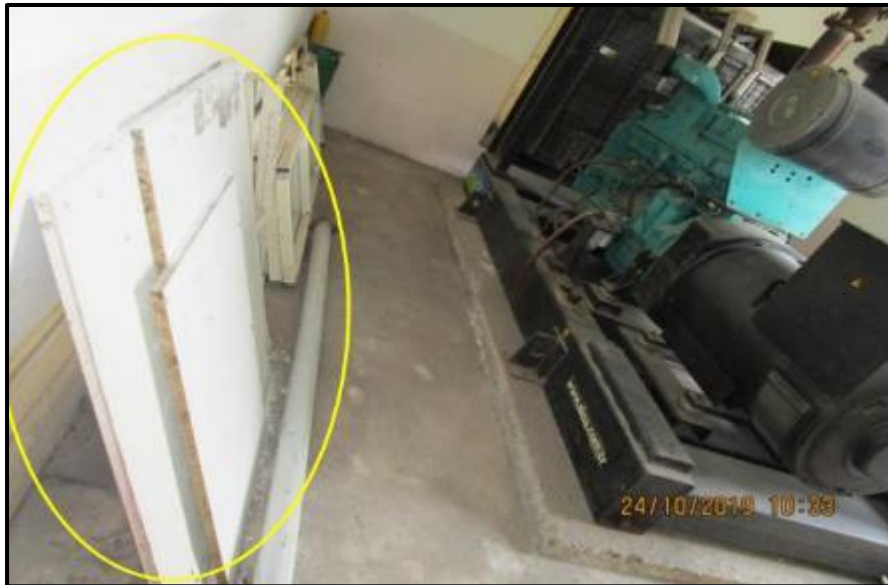
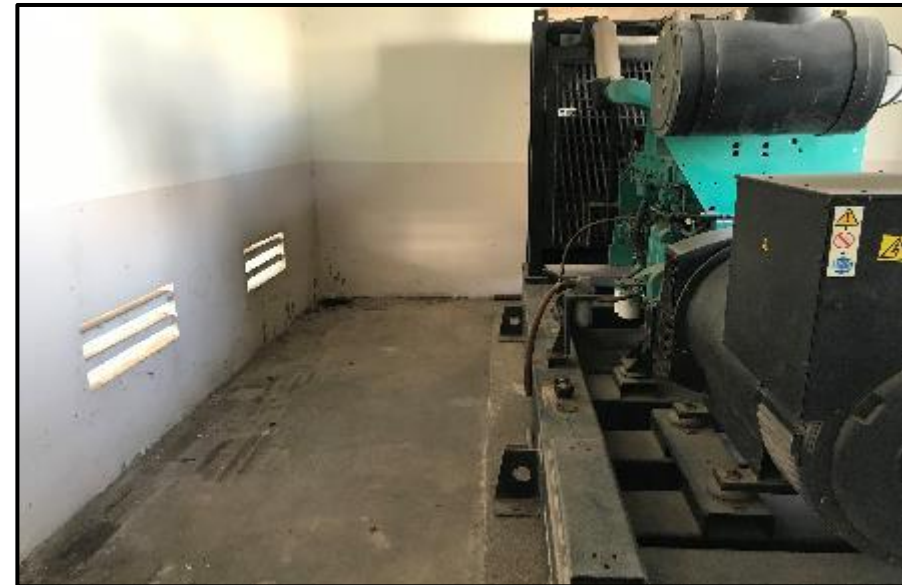
Electrical safety is the overriding concern of all electrical design work. Safety is basically governed by the electrical codes and standards as adopted by government agencies, commercial entities and good engineering judgement on the part of the designer.

10.6.3

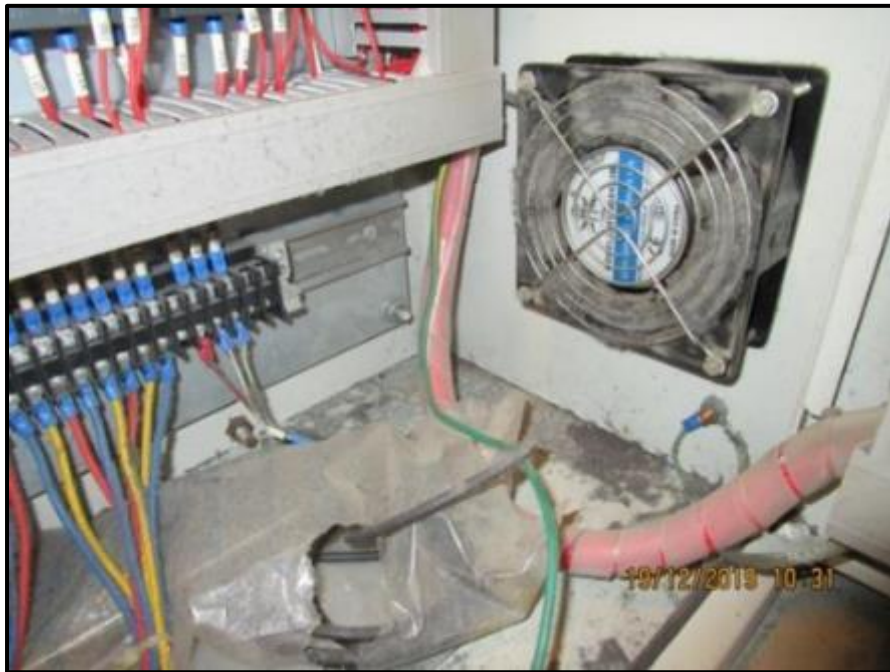
Description	LABS Standard
Housekeeping and hygiene go hand in hand with safe working practices. Contractors and sub-contractors must leave work areas in a clean, tidy and safe condition at the end of each working period. Special attention must be paid to potential fire hazards, trip hazards and equipment left in a hazardous condition.	10.11.1.2

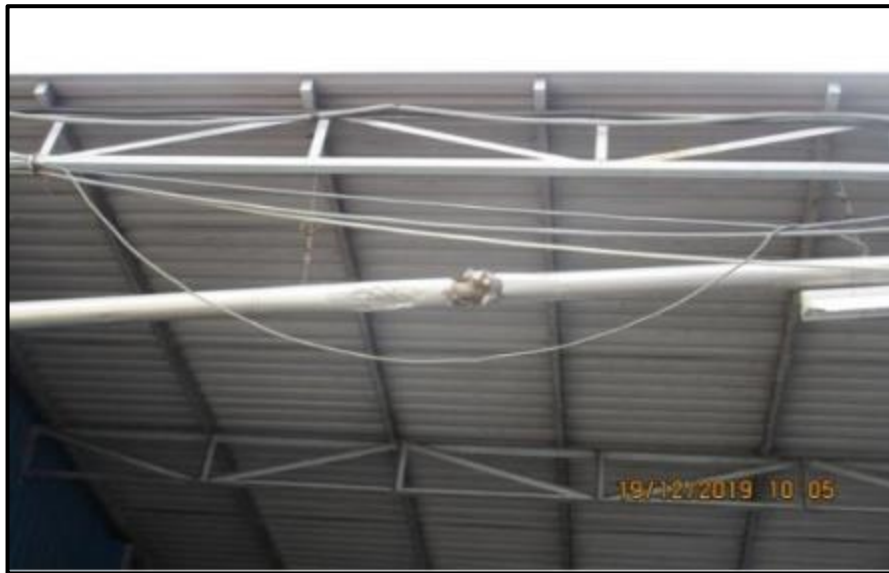
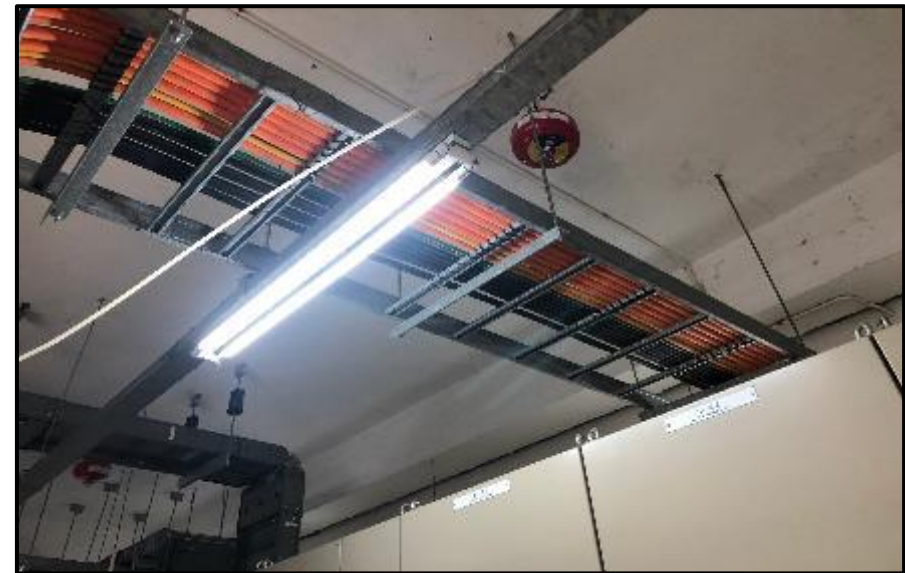
Description	LABS Standard
<p>1) For good electrostatic &amp; electromagnetic shielding galvanized steel cable trays with solid aluminium top and bottom covers are recommended. 2) For corrosive atmosphere stainless steel or GI with corrosion resistant coating are recommended. 3) Ladder type trays are recommended for power circuit and less sensitive control circuits.</p> <p>4) For cables used on circuits that are very noise sensitive, the path between the cable tray and equipment should be via metallic conduits.</p>	10.16.4

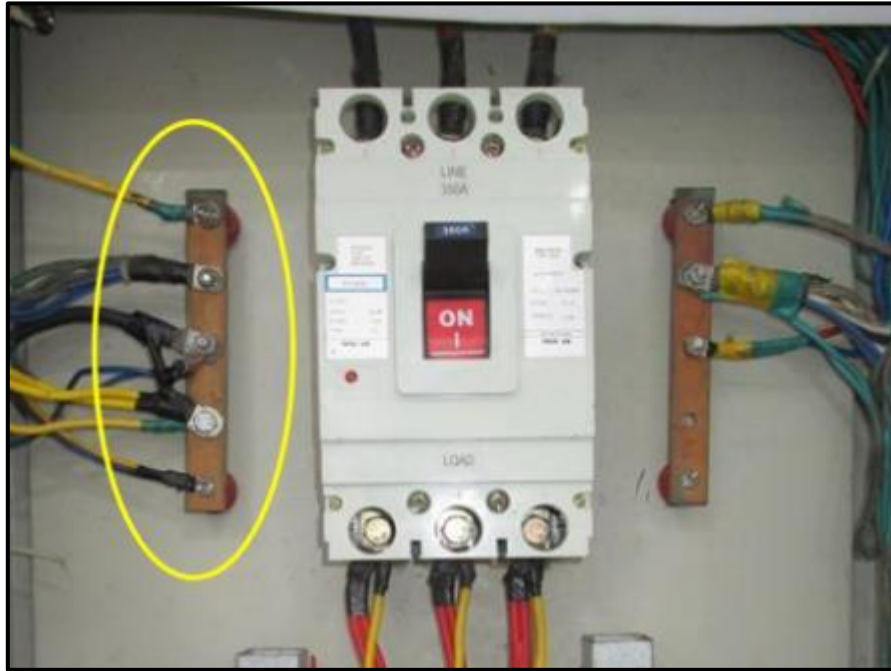
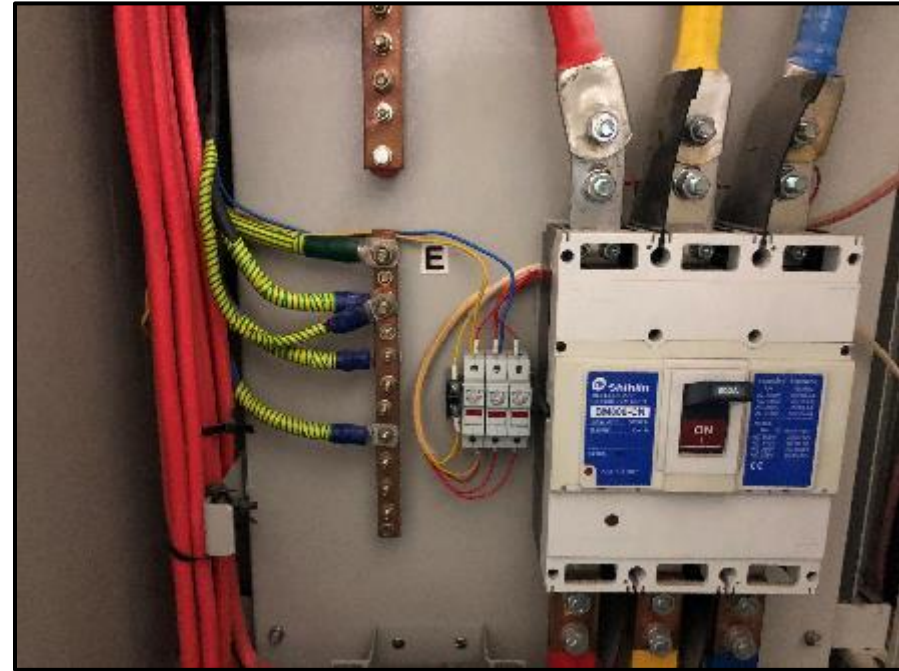
PE and Neutral cable should be identified with proper installation

10.15.1.4

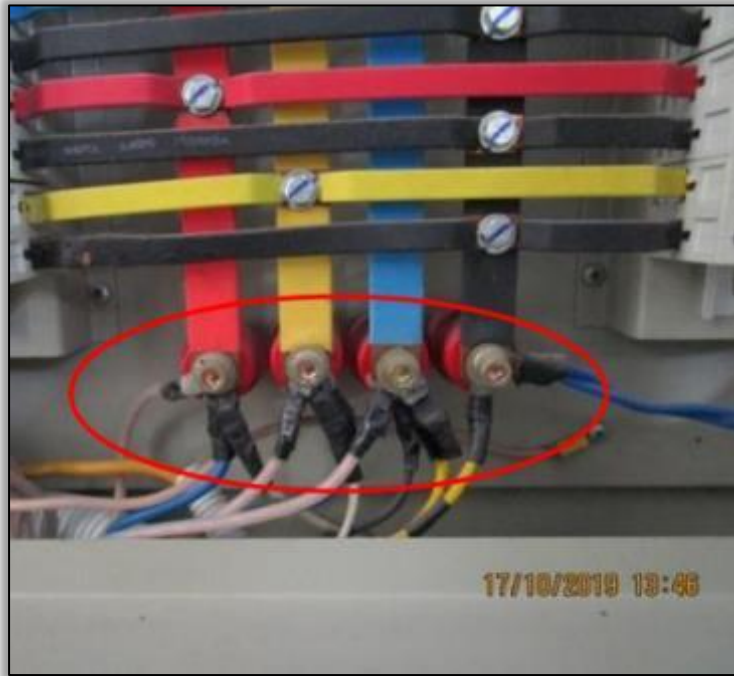
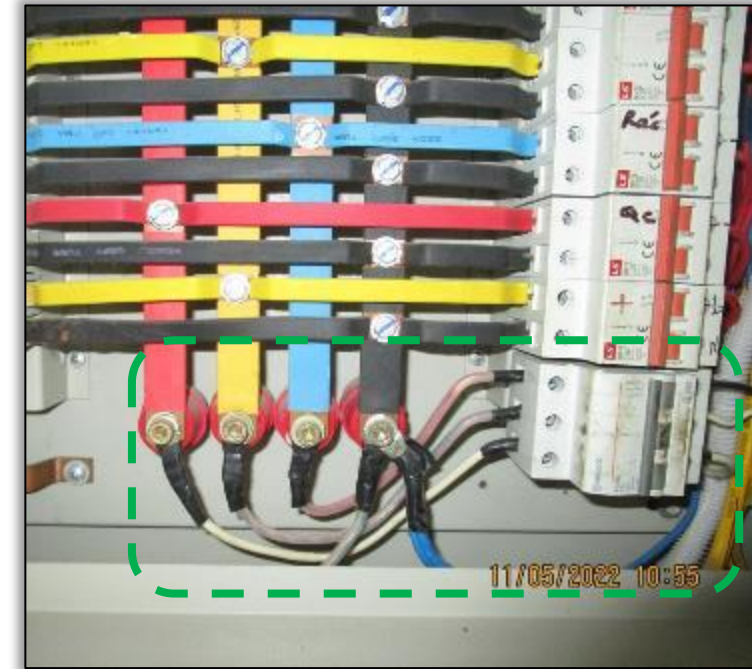
The circuit should be protected by suitable Protective Devices

10.27.1 and 10.29

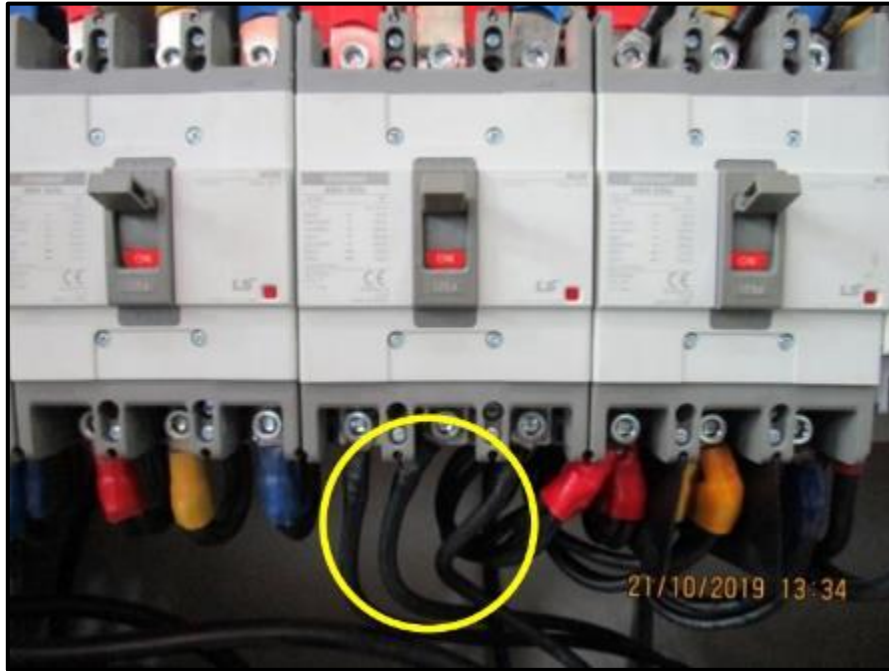
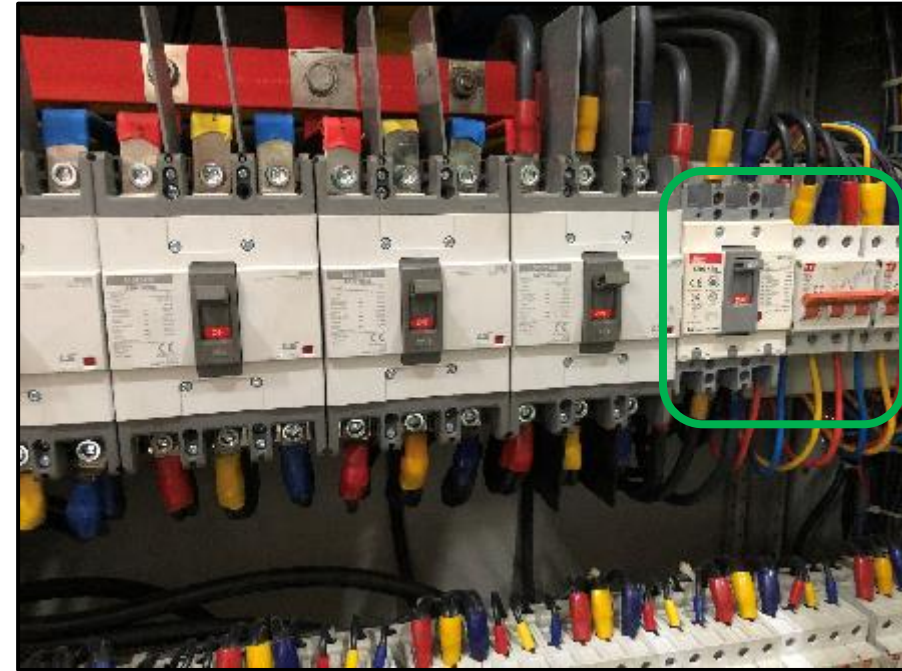
The small cable should be separated with the suitable Protective Device

10.27.1 and 10.29

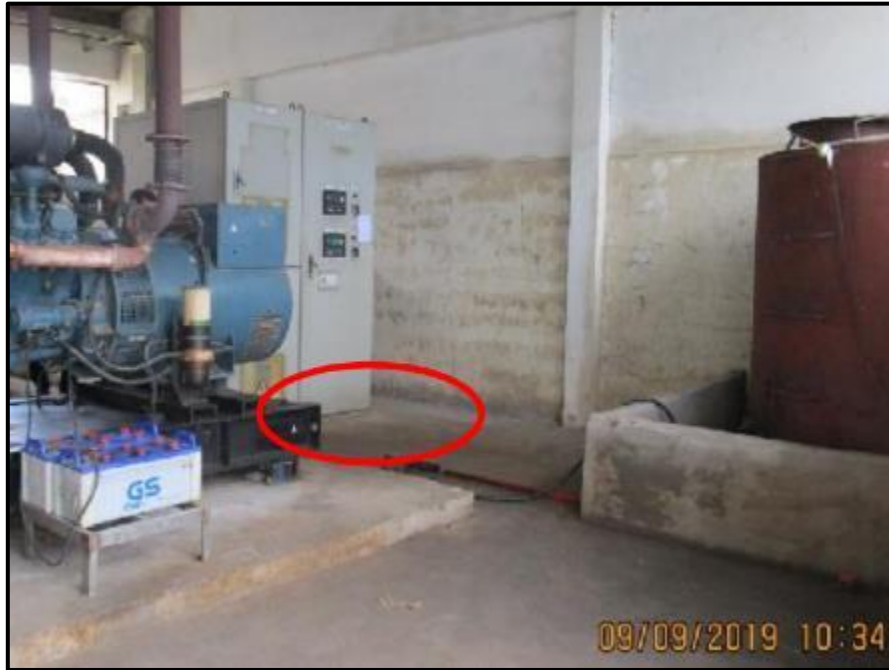
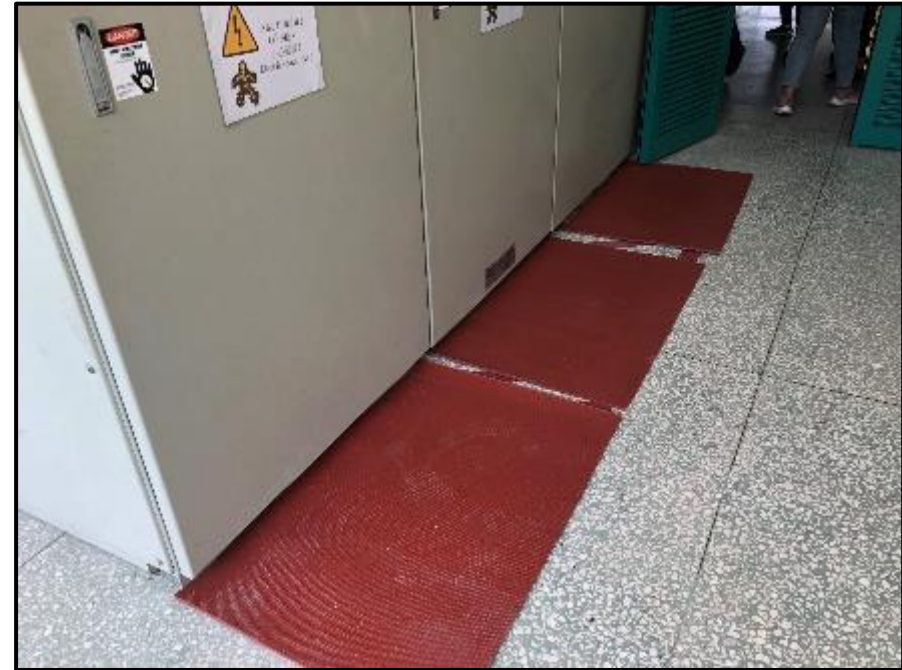
Insulation and shrouding of electrical live parts is not only a must for the performance of electrical system but also safety of the operation and maintenance personnel.

10.5.2.1
