**LABS**  
Life And Building Safety

**LABS - GOOD PRACTICES SHARING**

**March 2025**

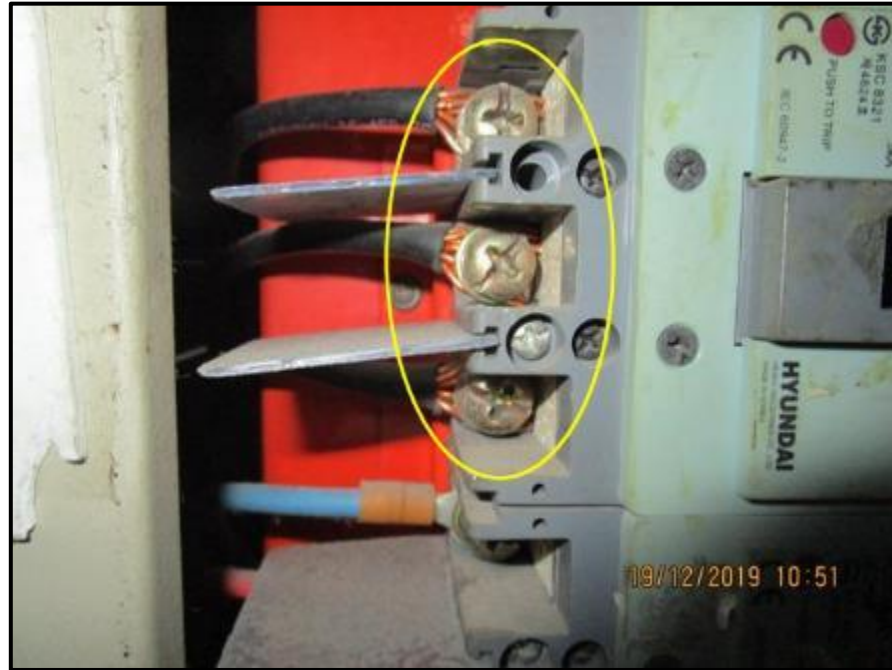
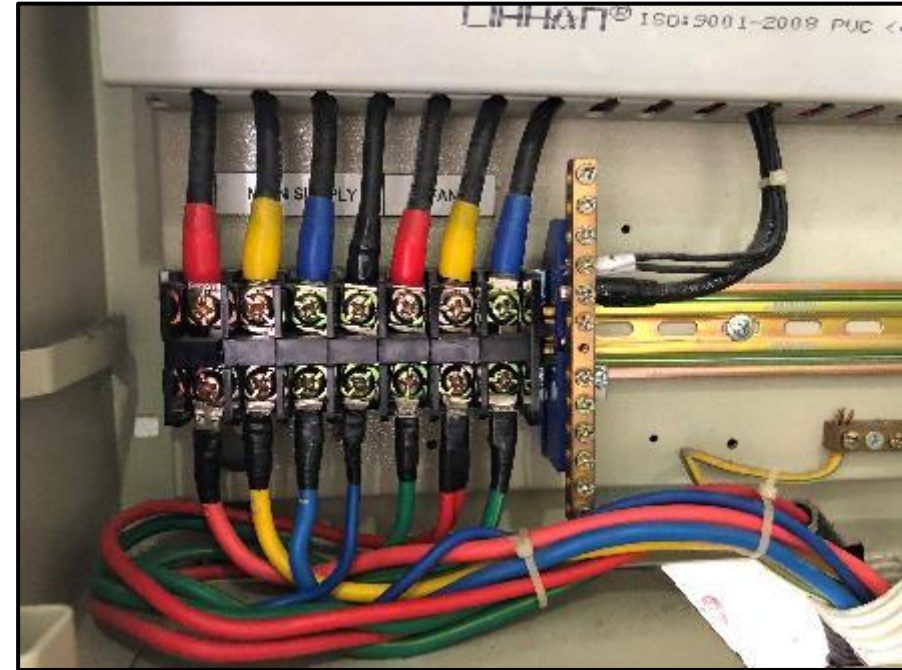
Description	LABS Standard
All lighting and small power circuit and point wiring to be provided with circuit identification labels at DBs, switches, sockets, etc. Cable sockets/ferrules should be used for cable with the cross-sectional area from 6mm <sup>2</sup> and above	10.15.3

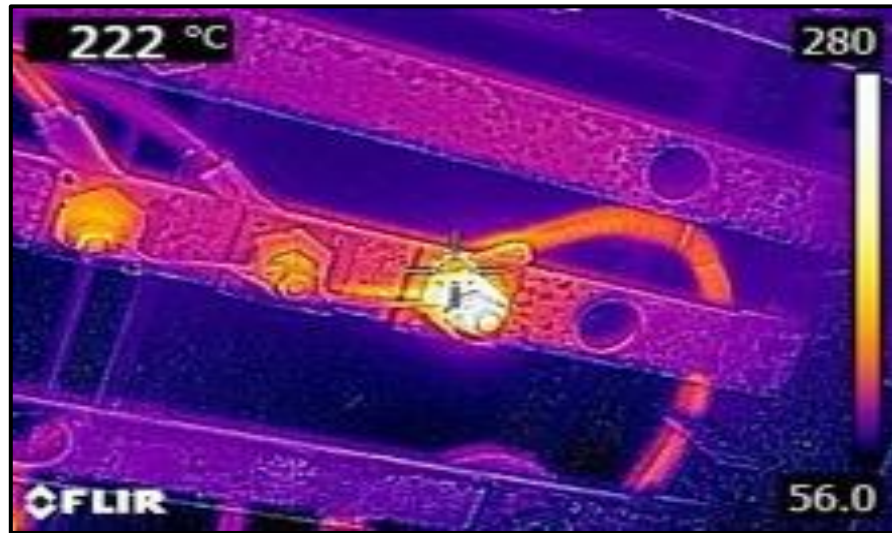
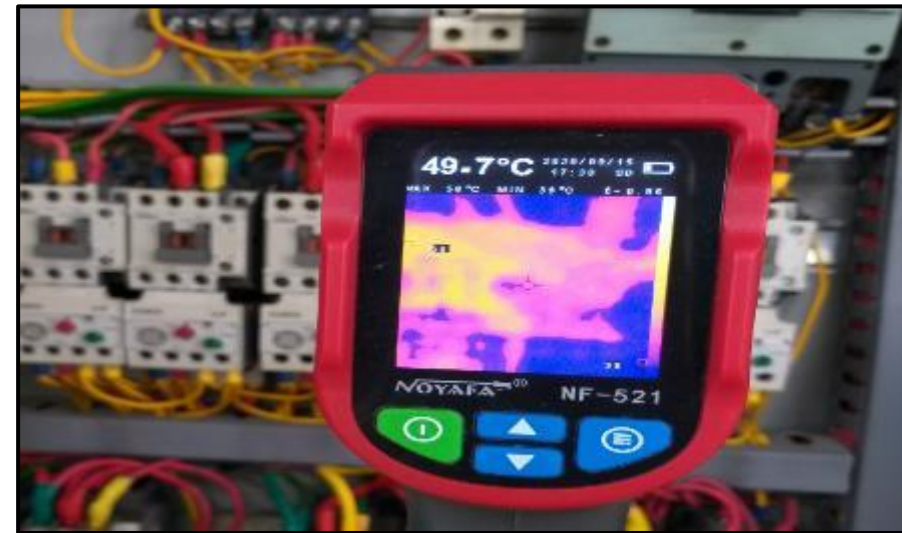
Description	LABS Standard
<p>Millivolt drop across terminal connections in panels to be measured (should be within 10mV). Alternately, thermographic survey can be carried out in live condition with due safety precaution (adequate work instructions &amp; PPEs to be available for conducting thermographic survey). The scope should cover all electrical joints which cannot be shut down for maintenance. Thermographic inspection of electrical equipment to be provided on a tri-annual basis.</p>	10.38.2.2

- **High number of hotspots detected** with temperature ranging from 70°C to 110°C.
- **Lint and dust** were observed.
- **Single line diagram drawings** were not provided or updated.

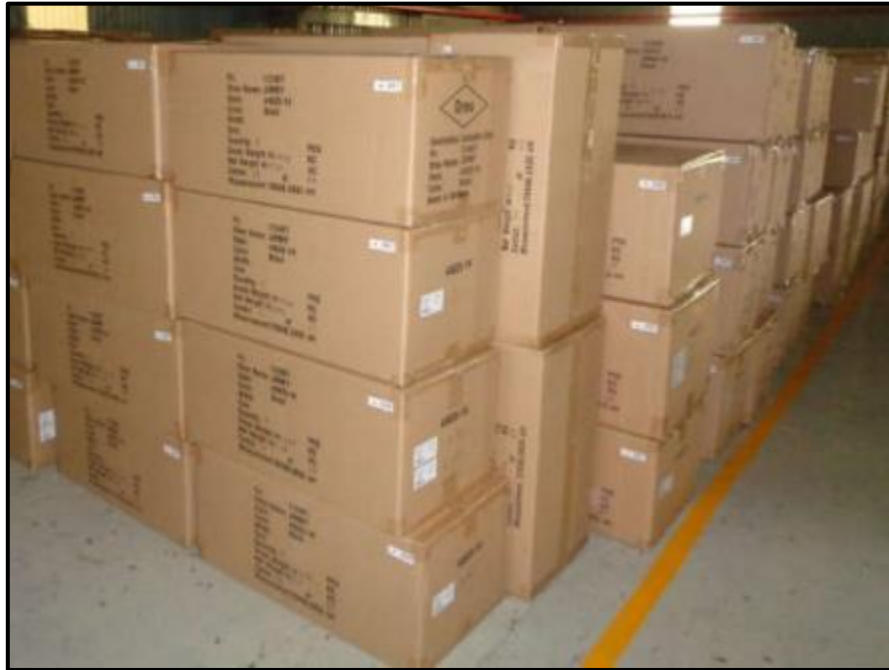
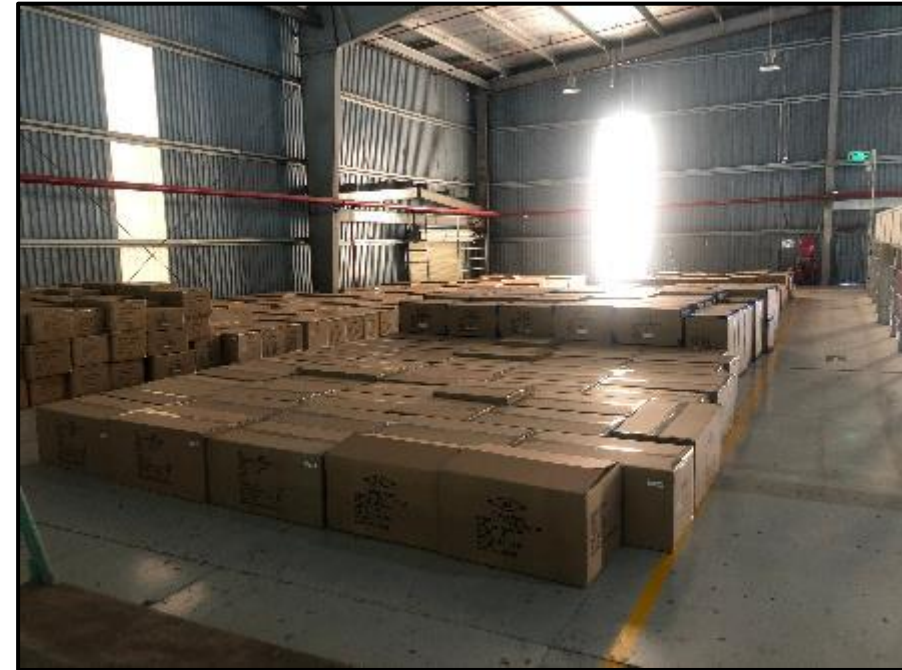
Appoint Structural Engineer to produce safe load plans for all mezzanine/ second floors, giving consideration to floor capacity and column capacity.

8.8, 8.9 and 8.10

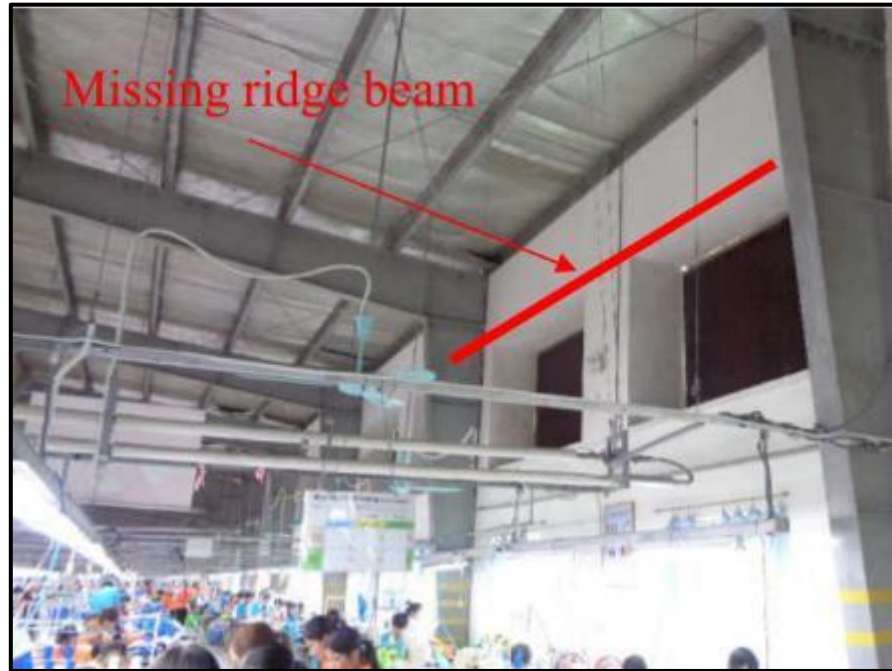
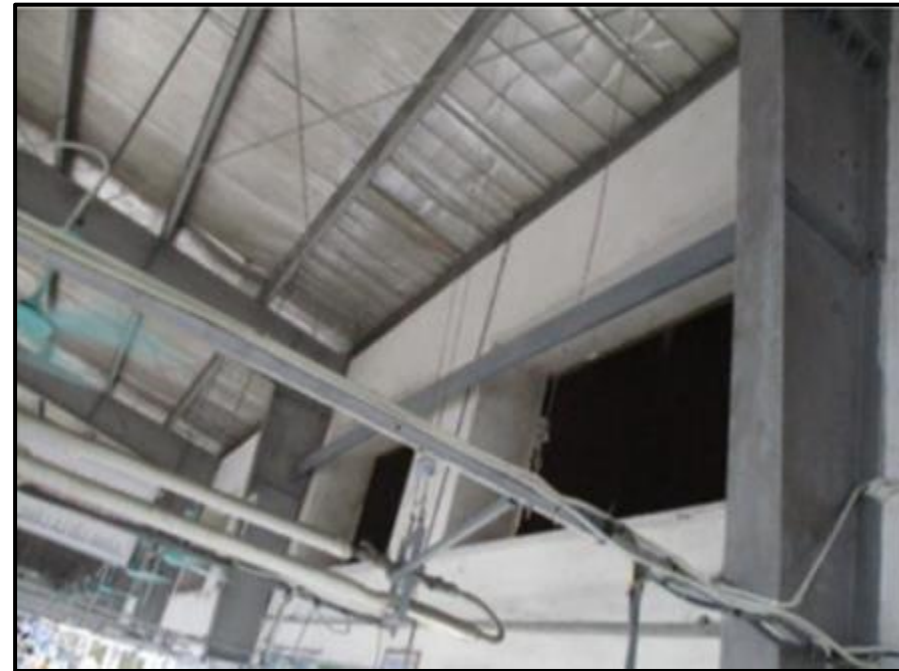
Description	LABS Standard
Installing the missing or sagging column/roof bracings in the Pre-engineered buildings	8.18

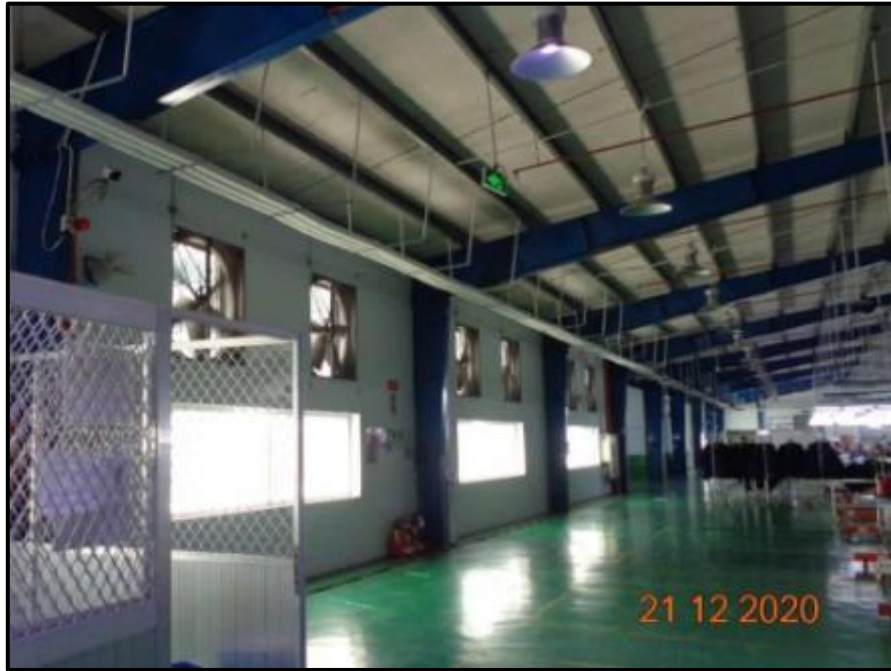
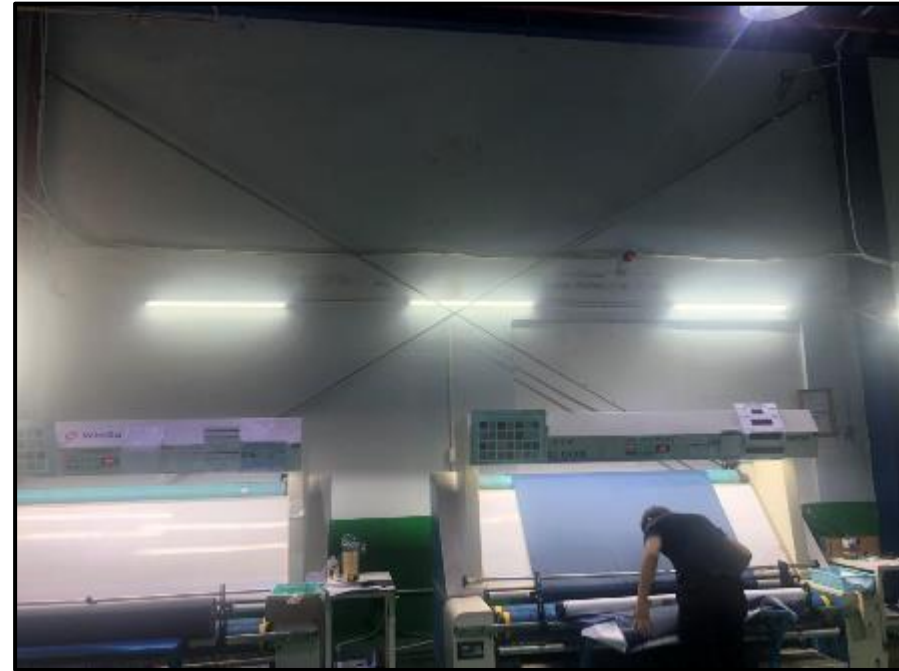
## Lateral Structural System

Description	LABS Standard
Installing the missing or sagging column/roof bracings in the Pre-engineered buildings.	8.18

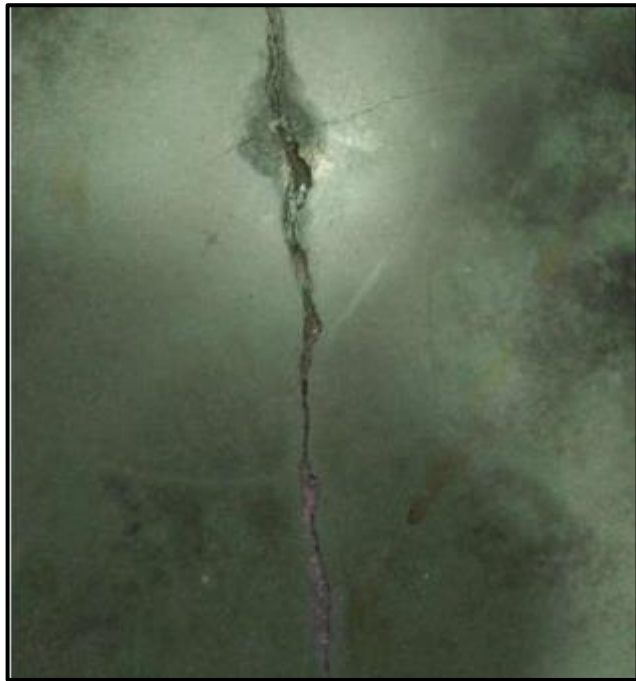
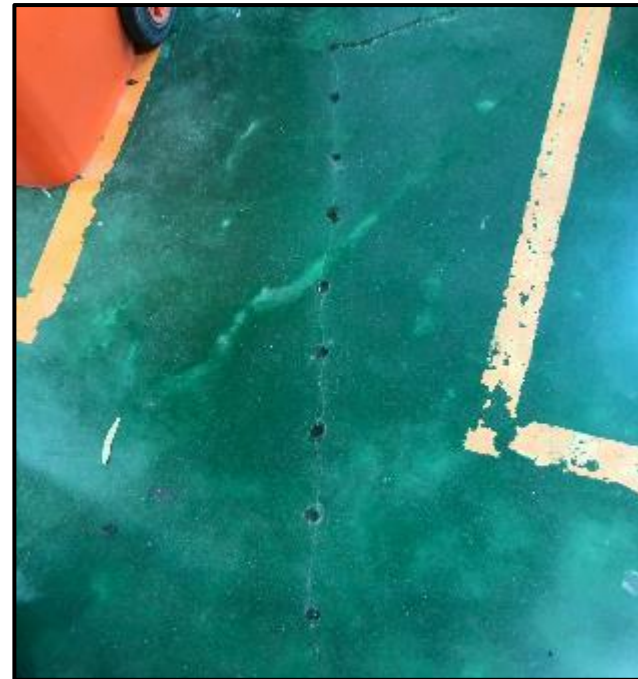
## Visible Distress

Description	LABS Standard
Appoint Structural Engineer to study the cracks and propose the remedial measures	8.5

- **Cracks on structural or non-structural members** observed throughout building.
- **Corrosion on steel structure** were observed.
- **Dampness** was observed at a few places inside the main building.
